NTSB National Transportation Safety Board

General Aviation Focus at the NTSB

AOPA Aviation
Summit 2012

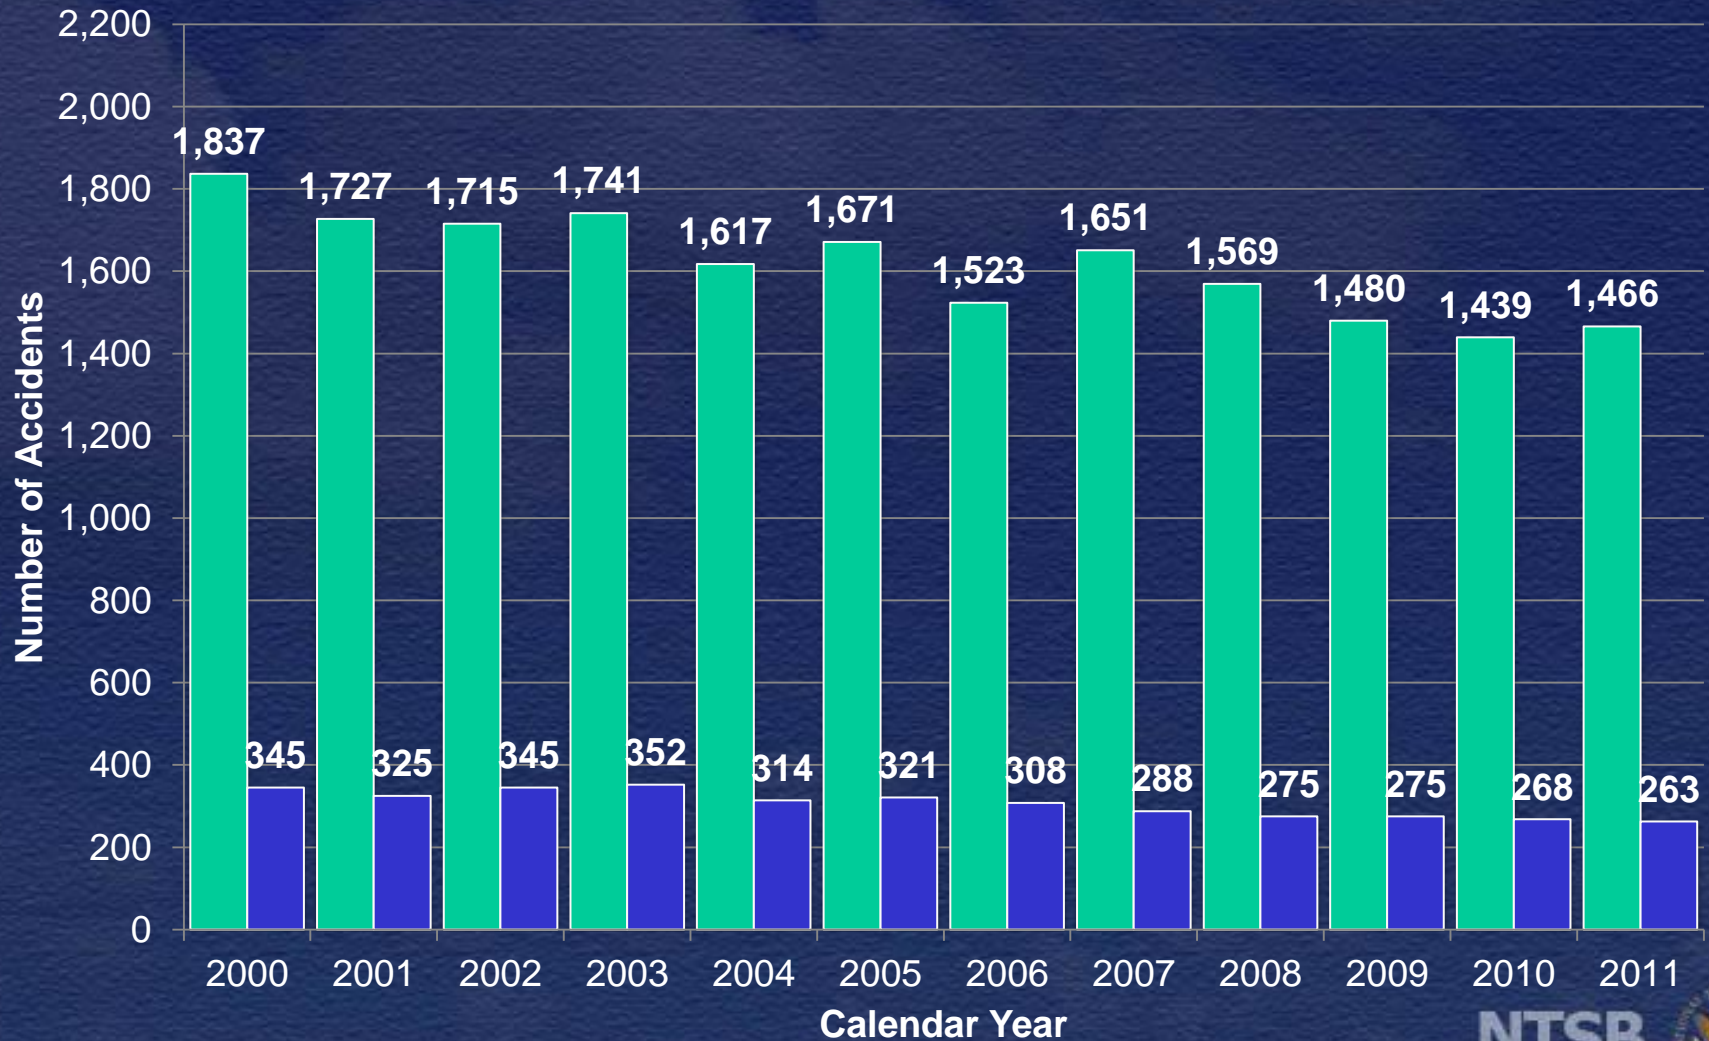
All GA Accidents (Part 91)

■ Total ■ Fatal

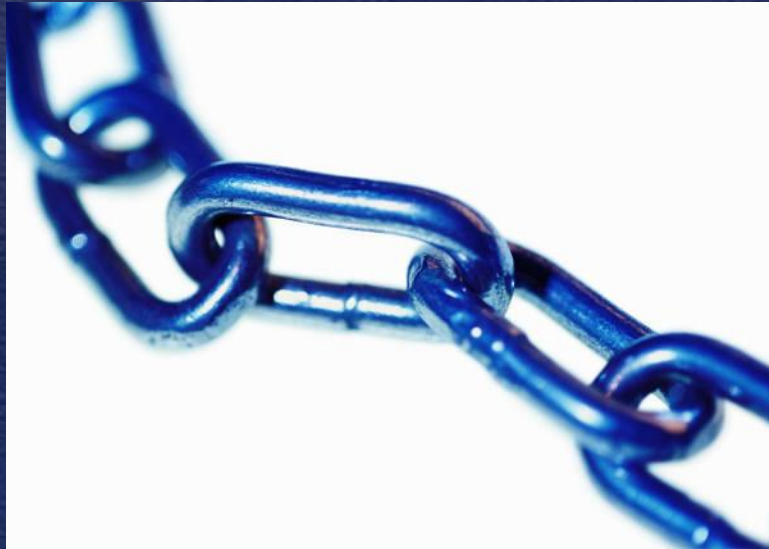
Accident Chain-of-Events

- An accident is typically the end of a sequence of events
- Interruption of this chain-of-events could eliminate the accident
- Look for opportunities to break the chain
