JAHSA

Joseph A. Holmes Safety Association

May June July
2012

**Sunday Creek Coal
Company No. 6 Mine
Explosion of 1930**

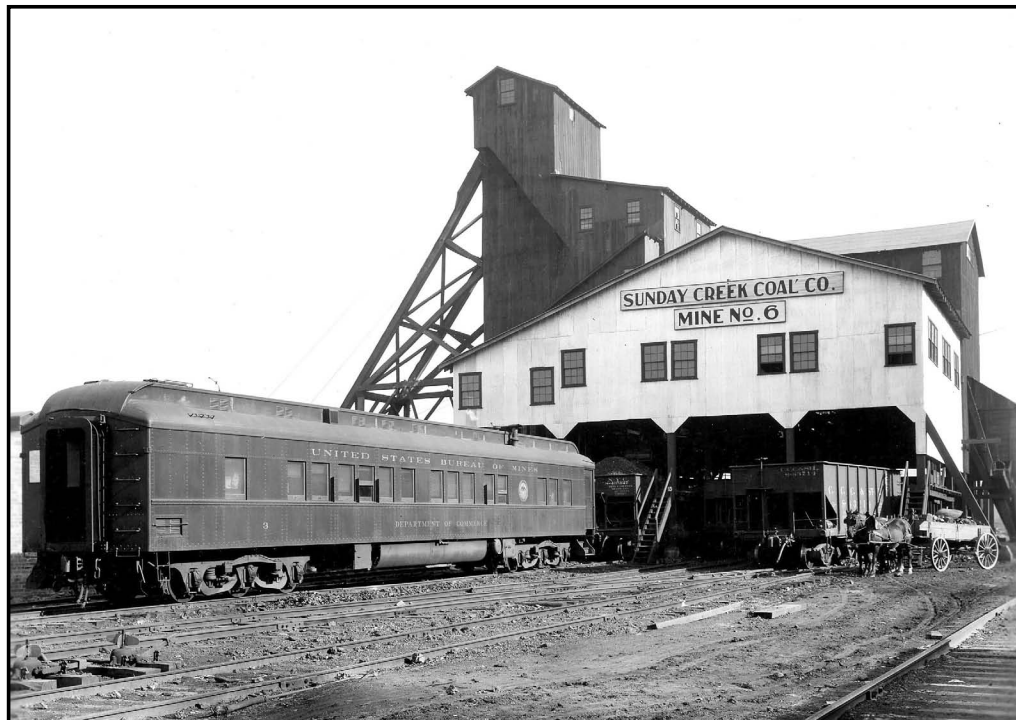
Sunday Creek Coal Company – Tipple, loading dock and Mine Safety Car No. 3. Photo Bureau of Mines

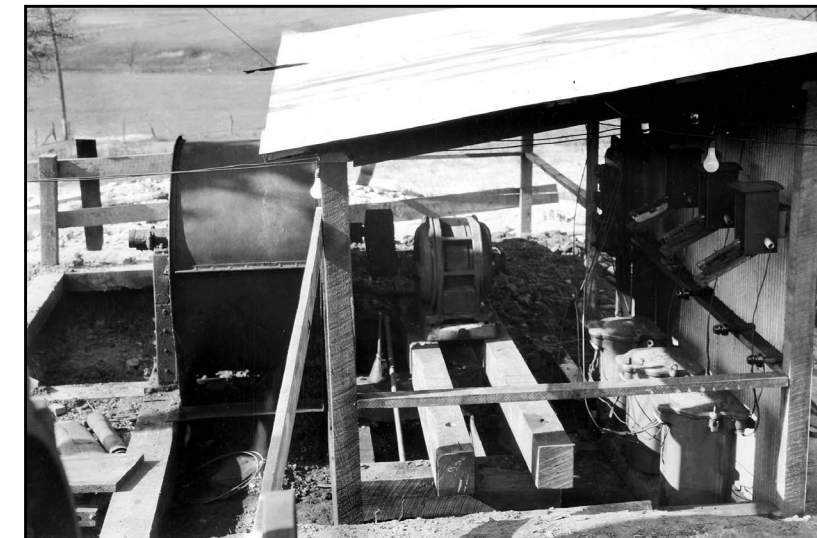
Sunday Creek Coal Company – Fan motors, transformers, and seal of the new air shaft. Photo Bureau of Mines

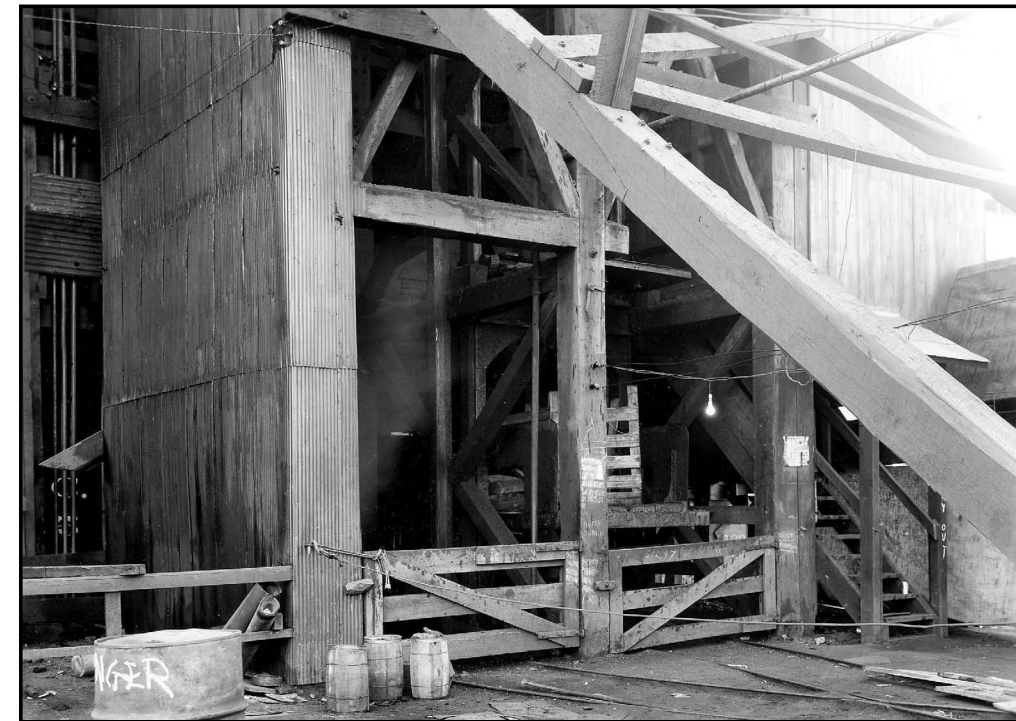
Sunday Creek Coal Company – Surface landing of the main shaft. Photo Bureau of Mines

Mine No. 6 of the Sunday Creek Coal Company is a shaft mine. It was operating in the No. 6 bed which generally in this field dips southwesterly about 28 feet per mile. The mine is served by three shafts, a 3 compartment main shaft, 187.5 feet deep, which is the full main return for the ventilation, and equipped with cages operated in balance used for hoisting coal and rock, raising and lowering men and supplies. The dimensions of this shaft are 24 feet by 10 feet, 6 inches.

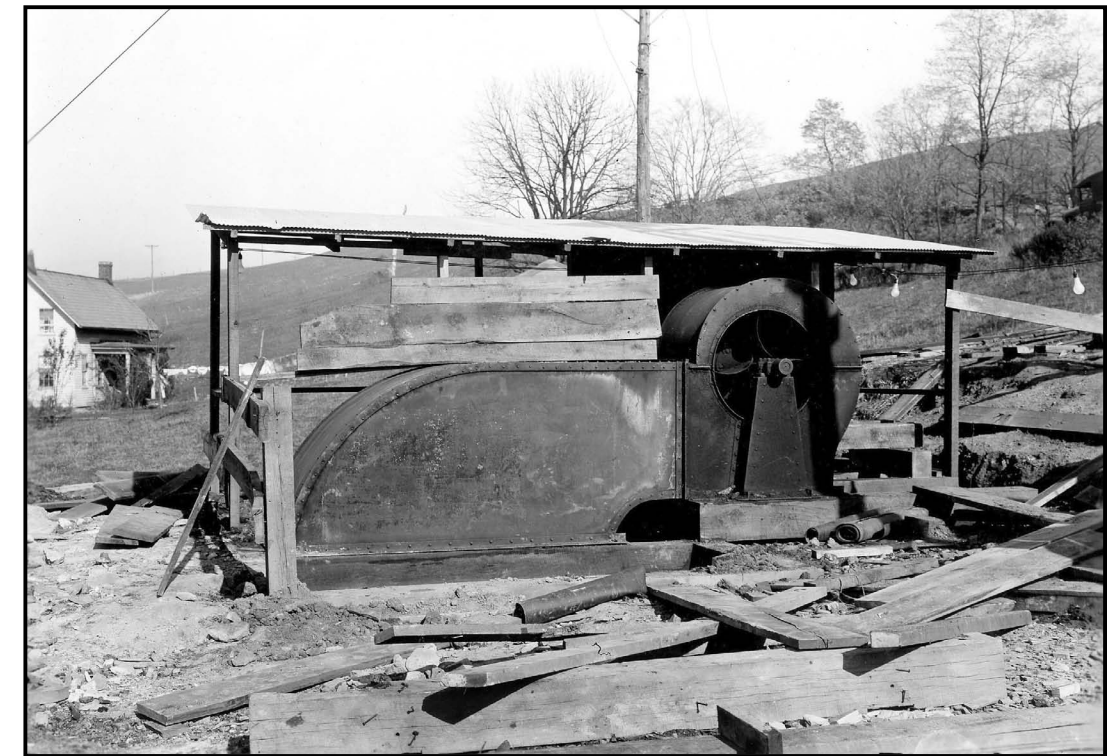
Sunday Creek Coal Company – Fan, new air shaft. Photo Bureau of Mines
