CHAPTER II

The Construction of Teal Bridge

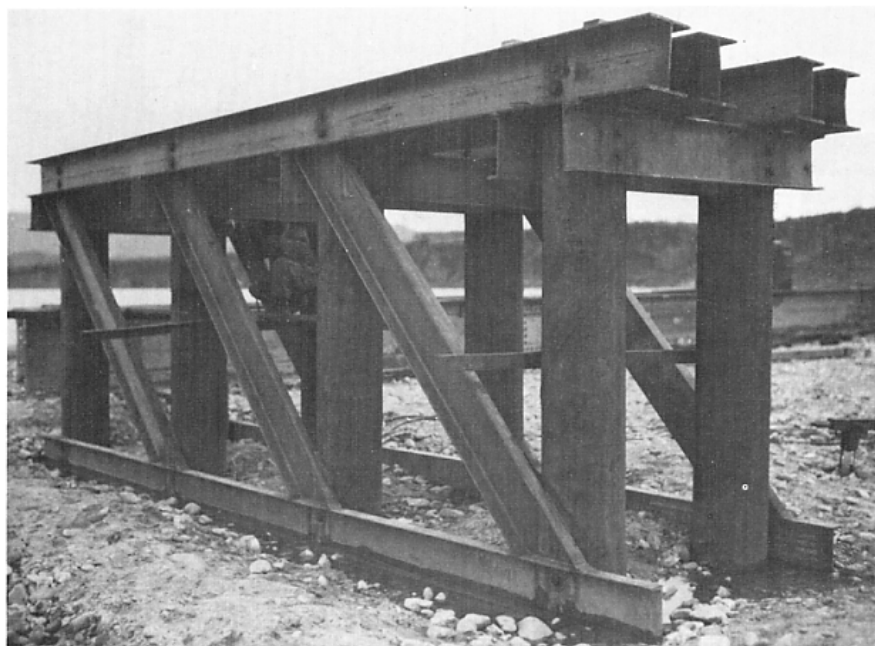
Figure 22. A nearly completed pier featuring diagonal channel-iron bracing.

Colonel O’Grady recommended to the 2d Engineer Construction Group that diagonal bracing be added to the pier design to strengthen the bridge against overturning. (*Figure 22*) This consisted of a diagonal brace of 12-inch channel iron, running from the top of each pile to the bottom of the next downstream pile, bolted and welded in place. The four piles in each of the two rows in the pier were connected seven feet down from the bottom of the H-beam cap (approximately at causeway level) with 12-inch channel iron bolted in place, and the lower ends of the diagonal brace were welded to this. The purpose of this bracing was to transmit the shock of debris and pressure of the water from the top of each pile to the bottom of the next downstream pile, thus actually exerting downward pressure rather than horizontal pressure which might overturn the pier. This recommendation was accepted, and this feature was added to the bridge design.⁶

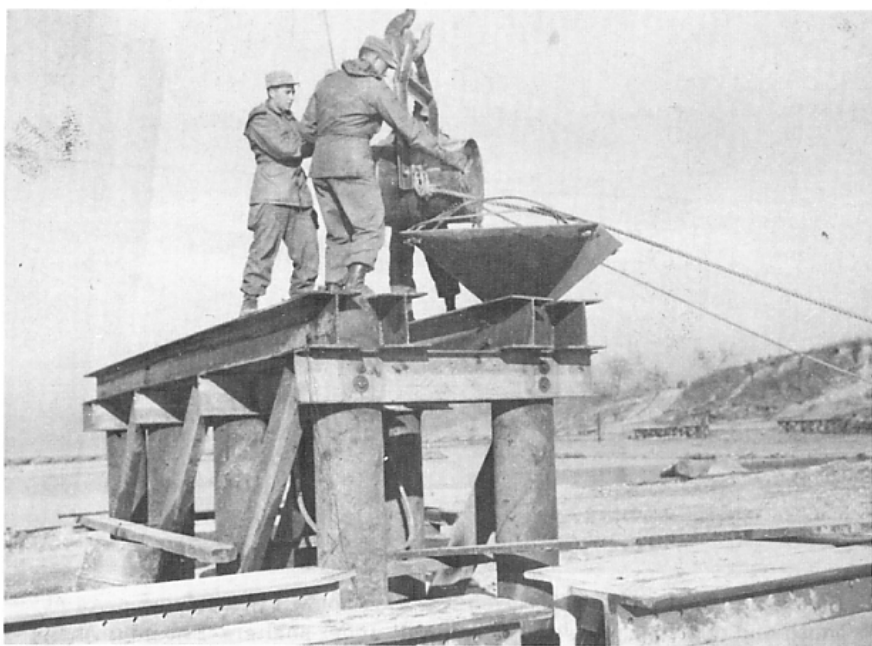
Figure 24. Troops filling the hollow Armco piles with concrete, with 36-inch I-beam girders in the foreground.

On 20 November the welding on pier 11 was completed, and concrete was poured into the piles. (*Figures 24 and 25*) The canvas shelters were put to a new use at this time, as it was necessary to provide heat to keep the concrete in the piles from freezing before it cured. (*Figure 26*) A shelter was set up around the pier, and a hot-air blower maintained a suitable temperature, about 60°, until the concrete was cured.⁸

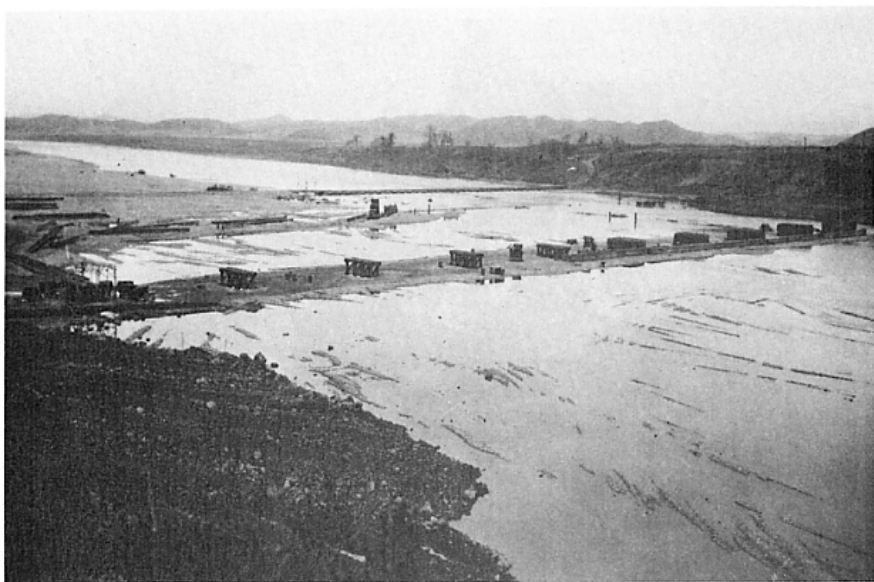
Figure 26. Teal site on 26 November 1952 showing completed piers at south end of bridge, left, and others still under shelters. I-beam girders and the Imjin River flowing north of the causeway are visible at right.

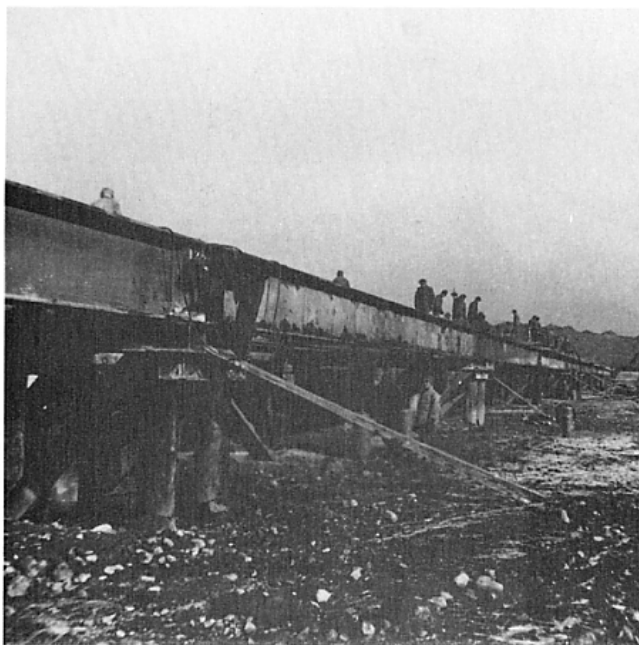
Figure 28. Side view of girders in place. Crew on right is placing decking.

On 29 November, when the tops of the piles were sealed with asphalt and the bearing plates set in place, the first girders were lifted into place in span 11 with cranes. The I-beams used as girders were of three different types: ten spans were made up of four 36-inch, rolled-steel I-beams; six spans were of four 36-inch, built-up (bolted splices) steel I-beams; and the remaining span, from pier 16 to the north abutment, was made up of six 24-inch, rolled-steel beams. (*Figures 27, 28, and 29*) The first two types were salvaged from the old Teal bridge.

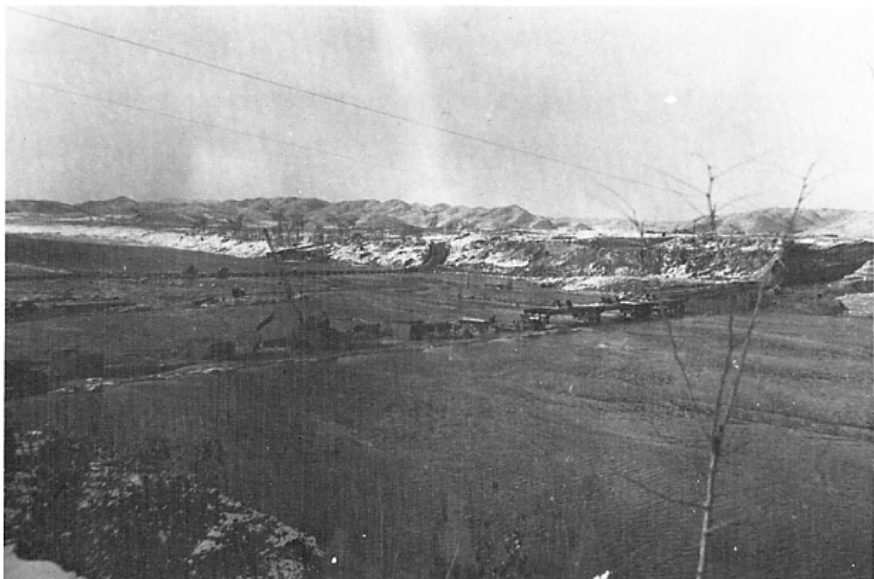
Figure 30. Girders in place on piers 8 through 11 allowing the passage of water below these spans and the construction of a causeway to pier 11 from the north bank.

As soon as the steel was in place from pier 11 to pier 9, the causeway was cut between them to allow passage of water, and the causeway from the north shore was pushed out to pier 11. (*Figure 30*) It was then possible to drive the piles for the last four piers (12 through 16). Penetration, to bedrock on all piles, varied from 15 feet to 32 feet, 8 inches; average penetration was around 27 feet.¹⁰

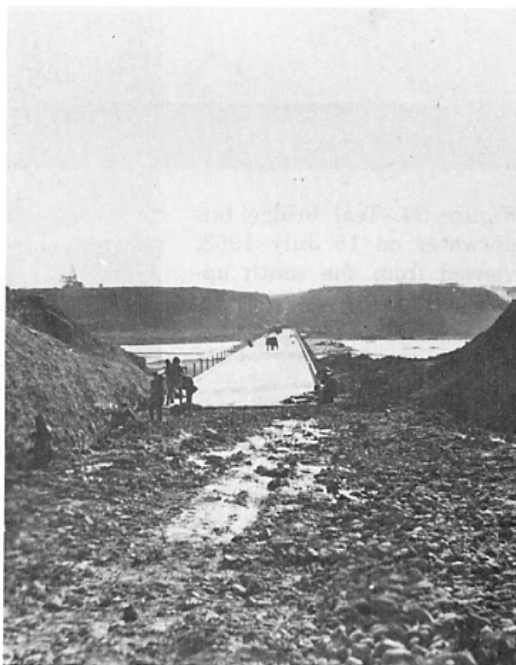
Figure 32. Teal bridge from the north shore on 16 January 1953 when almost completed. This view shows the removable guardrail.

By 10 January, the decking, curbing, and guardrail were in place on all of the bridge except span number one, which had to await the completion of the south abutment. The guardrail on Teal consisted of half-inch wire rope strung through pipe posts which were set in sockets bolted to the outside of the curbing.¹² (*Figure 32*) The guardrail was so designed that it could be removed quickly before floods topped the bridge, thereby allowing freer flow of water and debris over the bridge.
