Subject: Fwd: FW: EST Activation IOR, Space Shuttle Columbia Disaster

The designers of the thermal protection system (TPS) for the space shuttle had to solve a series of complex problems due to the wide range of environments in which the orbiter has to operate. A single-component design could not meet all the necessary requirements of withstanding extreme temperatures and vibrations while remaining light weight and flexible and lasting for 100 missions. Instead, a complete, integrated system was developed relying on different components to solve different problems (Cooper and Hollaway, 1981.)

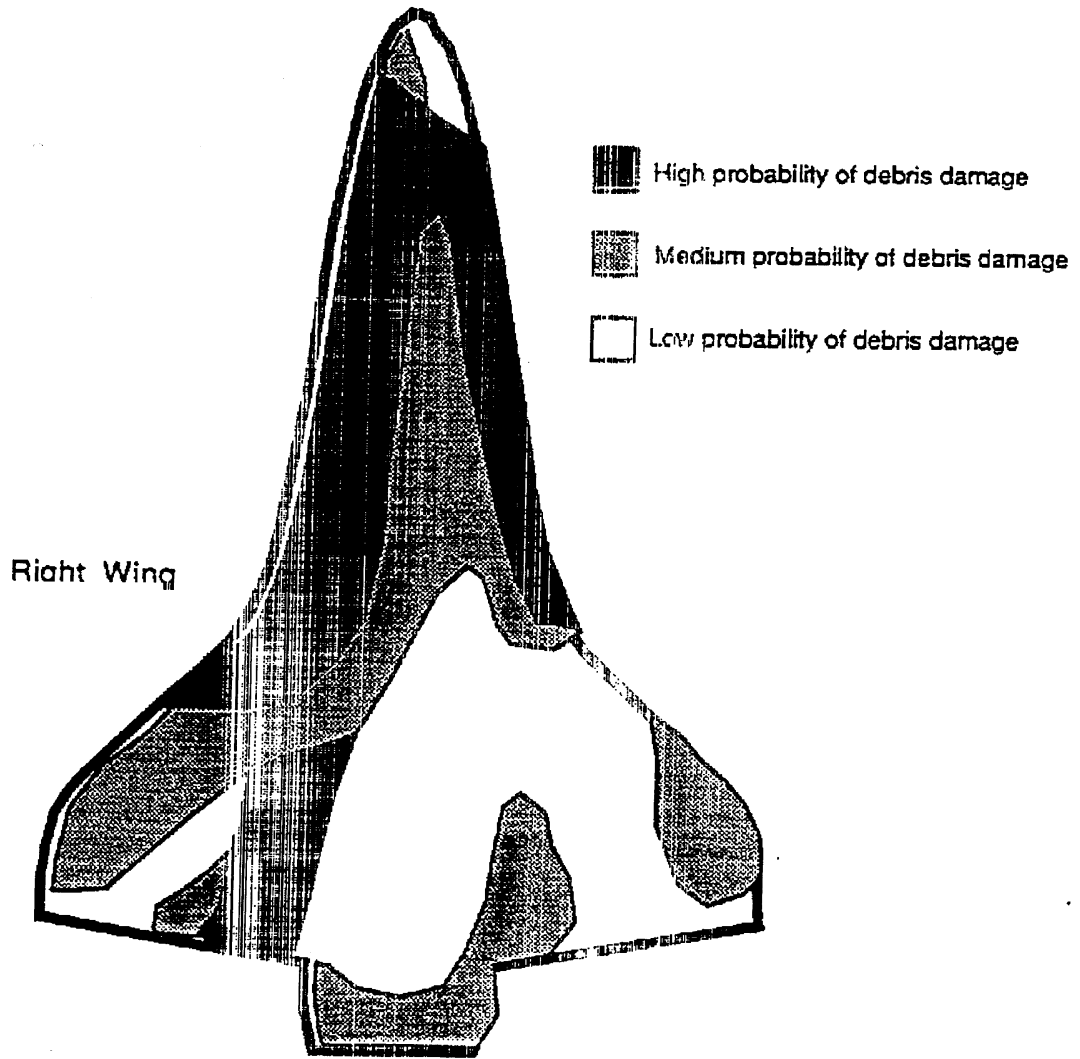
Figure 10: Partition of the orbiter's surface into three types of debris zones (index: h)

To define the debris zones, we plotted all known debris damage from the first 33 flights on a single shuttle layout (see Figure 6.) These data came from J. W. McClymonds (1989) at Rockwell in Downey. Areas with similar damage intensity were grouped together into high, medium, and low debris damage areas (see Figure 10.) An estimated probability of tile damage due to debris per flight was determined by dividing the number of hits by the number of tiles in each area and by the number of flights. A similar plot and calculation was done for all damage to black tiles over one inch in size. (Historically about one fourth of the damage has been greater than one inch in size.) It should be noted that the only missing tile to date caused by debris is in one of the "high debris damage areas".

Table 2: Probabilities of debris hits in the different areas shown in Figure 10

Table 3: Probabilities of tile loss due to debris in the different areas shown in Fig. 10
