NOAA

Florida Keys National Marine Sanctuary

Dive Fatality Incident

September 5, 2008

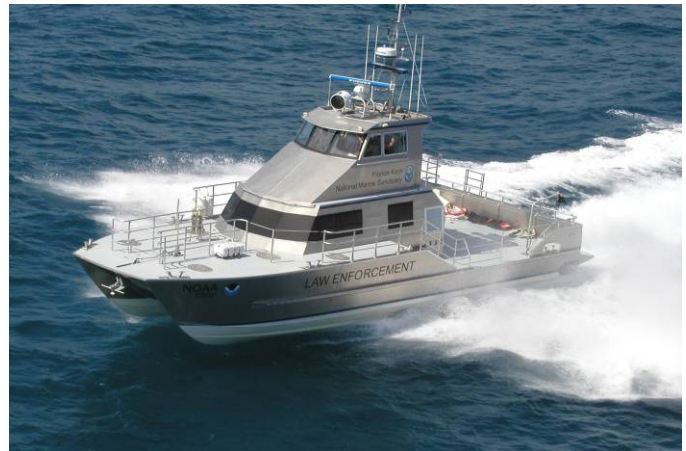
a. Vessel Information

Name: MV Peter Gladding
Year: 2006
Property ID: R5701
Make: Teknicraft
Model: LE Catamaran
Built in: New Zealand
Length: 53 feet
Beam: 20 feet 6 inches
Hull Type: Twin Hull Design
Hull Number: TD 17-18AA
Propulsion: Twin Engine Jet-drive
