SIXTH ENDORSEMENT on COMCARDIV THREE investigative report Ser 023 of
18 Jul 1972

Subj: Damage (possible sabotage) in engineering spaces of USS RANGER
(CVA 61) on 7 July 1972

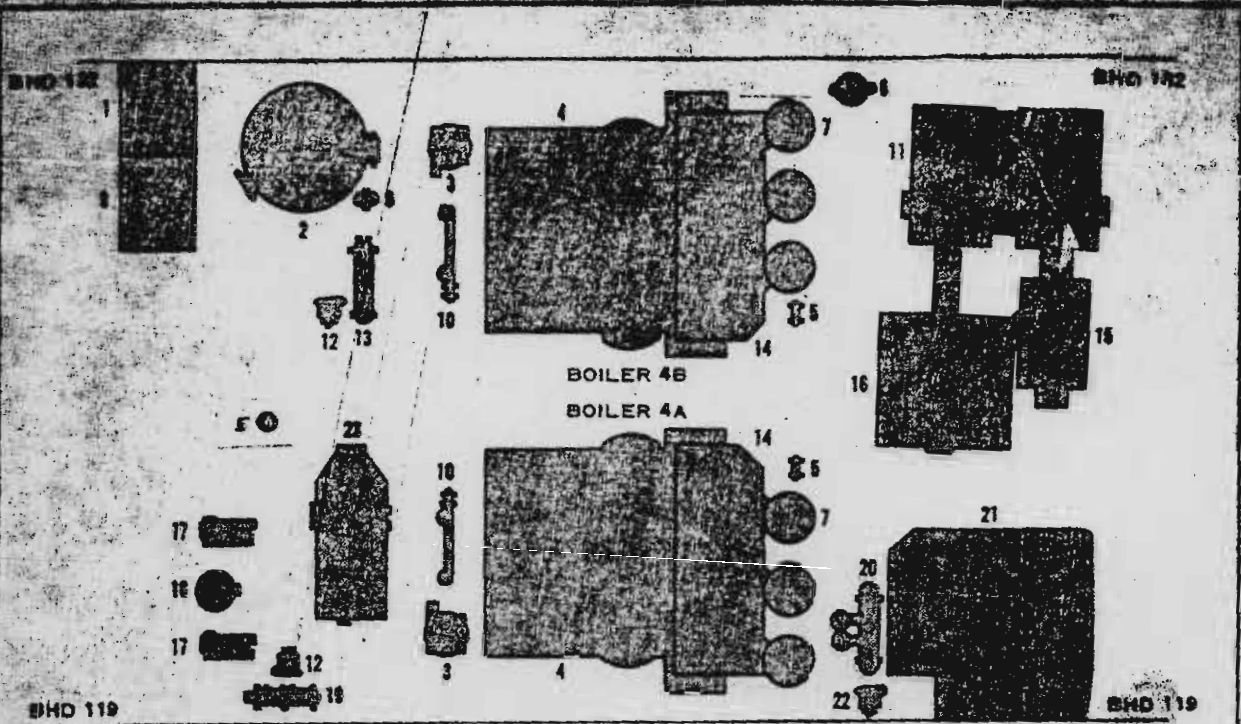
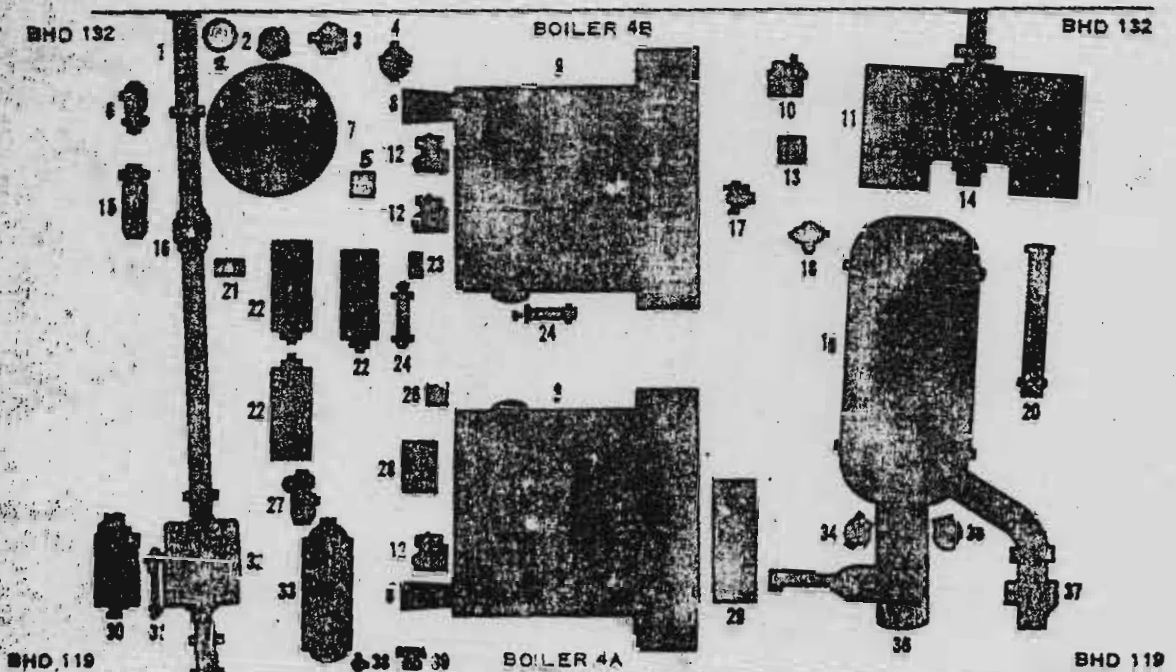
1213 MAIN MACHINERY ROOM NO. 4
FIGURE 2-4

MAIN MACHINERY ROOM NO. 4 - LOWER LEVEL (CONT'D)

Quantity
19. Main condenser	1
20. Lubricating oil cooler	1
21. Feed water recirculating control panel	1
22. Main feed pump (turbine)	3
23. Feed water control panel	1
24. Fuel oil coolers	2
26. Port use fuel oil service pump (motor)	1
27. Ship's service turbo-generator condenser circulating water pump	1
28. Fresh water drain collecting tank and pumps	1 tank, 2 pumps
29. Contaminated drain tank	1
30. Fire pump (turbine)	1
31. Lubricating oil cooler (main thrust bearing)	1
32. Main thrust bearing	1
33. Ship's service turbo-generator condenser	1
34. Main condenser condensate pump (motor)	1
35. Main condenser condensate pump (turbine)	1
36. Main ejection scoop	1
37. Main condenser circulation water pump	1
38. Ship's service turbo-generator condenser condensate pump	1
39. Bilge and fuel oil stripping pump	1

PLAN, UPPER LEVEL

PLAN, LOWER LEVEL

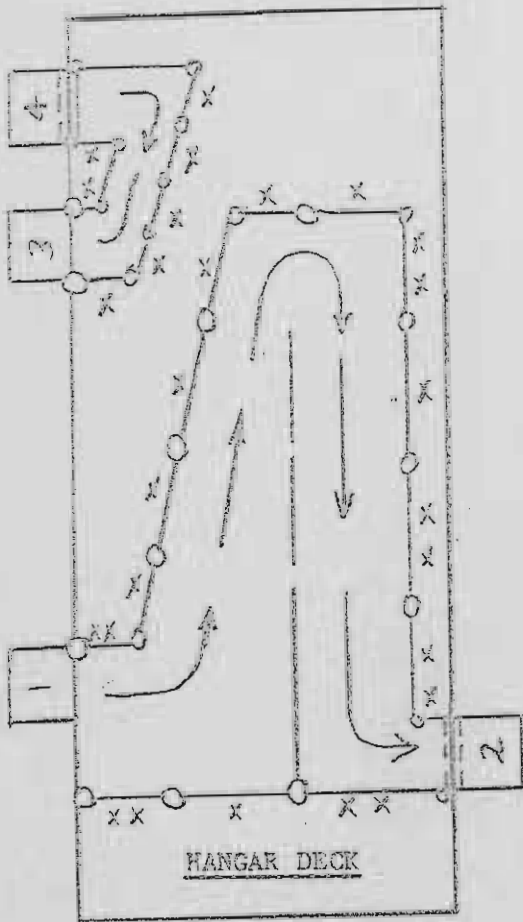
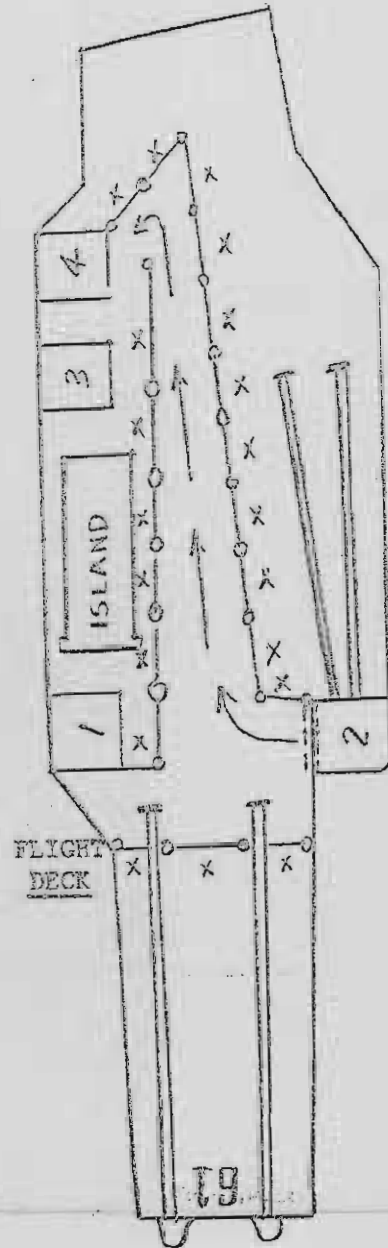
- Permanent Guide Lines
- Temporary Guide Lines
- X Sentries
- Direction of Traffic

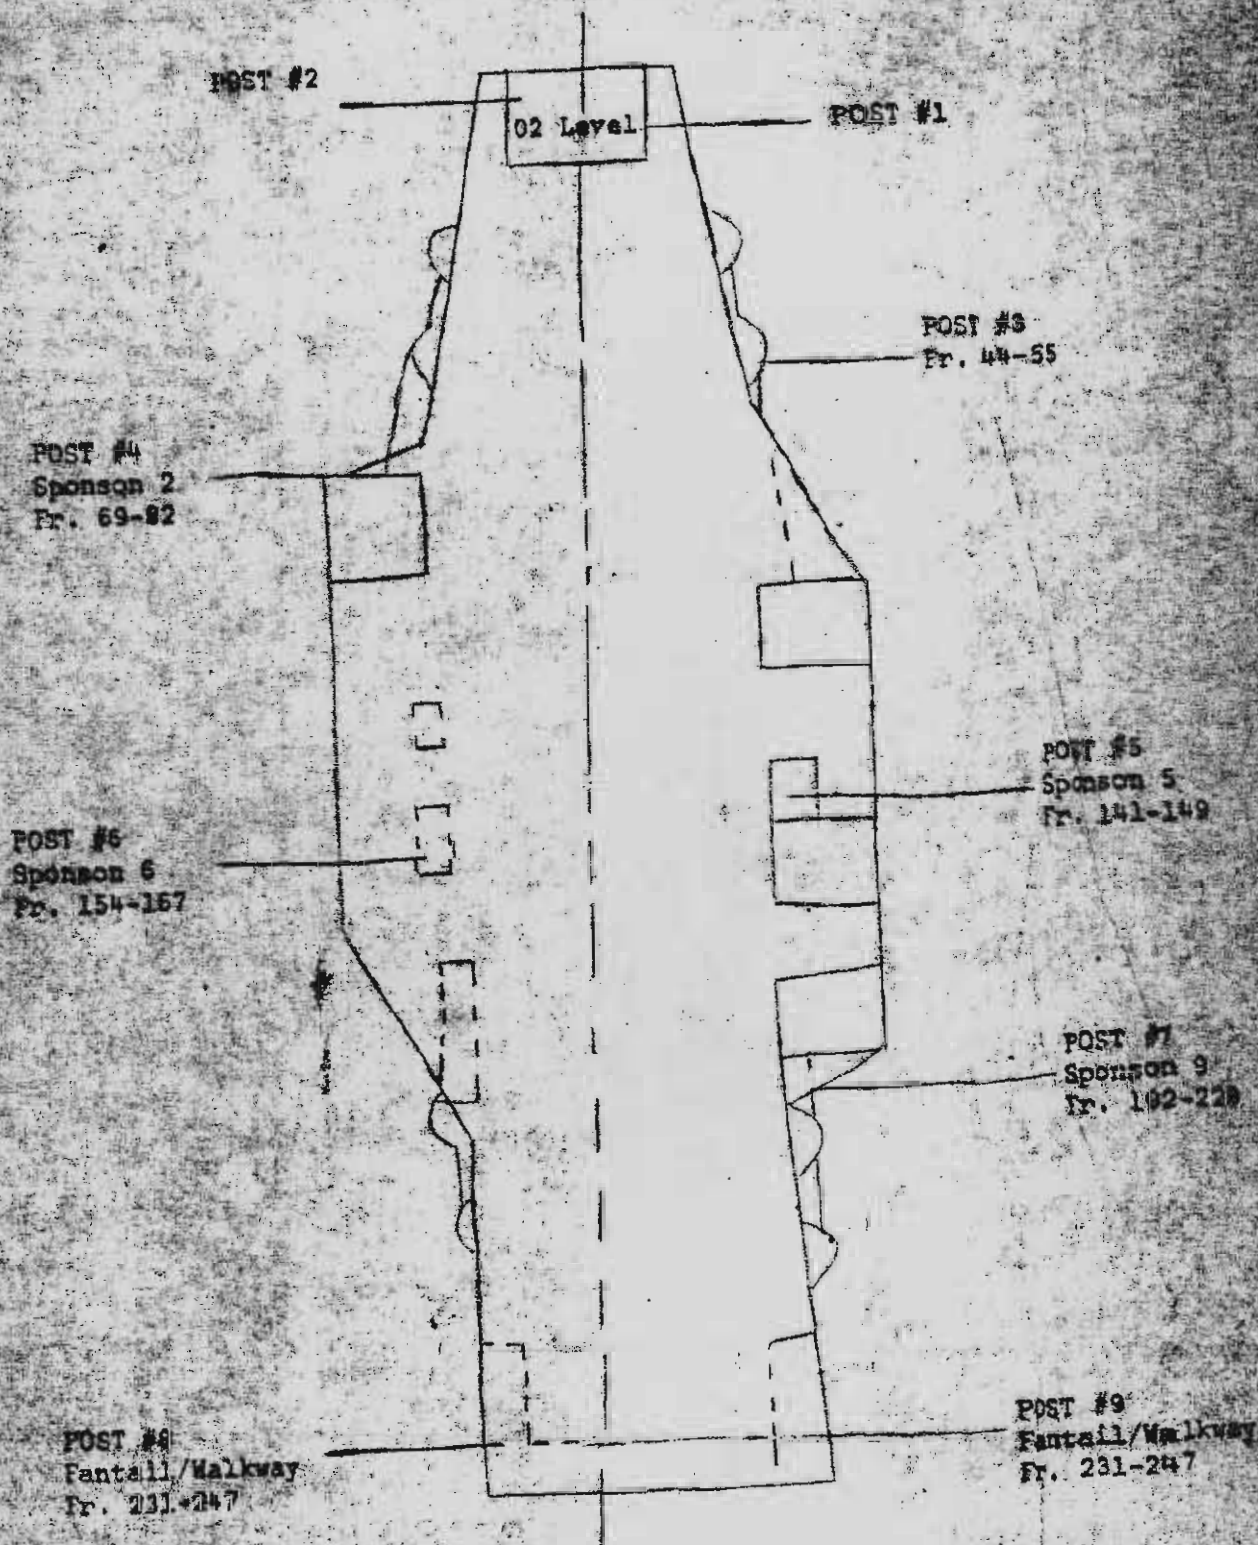
Enclosure (1)

DIAGRAM OF EXTERNAL SECURITY POSTS

EXTERNAL SECURITY POSTS MANNED WHILE VISITING A NAVAL ACTIVITY OR
CIVILIAN PORT CONUS
