U.S. Department  
of Transportation  
**Federal Highway  
Administration**

Thank you for your letter of June 4 requesting an official interpretation regarding the flashing pattern for the Rectangular Rapid Flashing Beacon (RRFB).

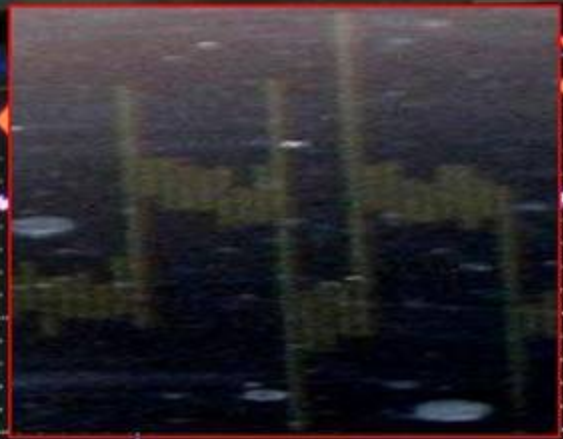
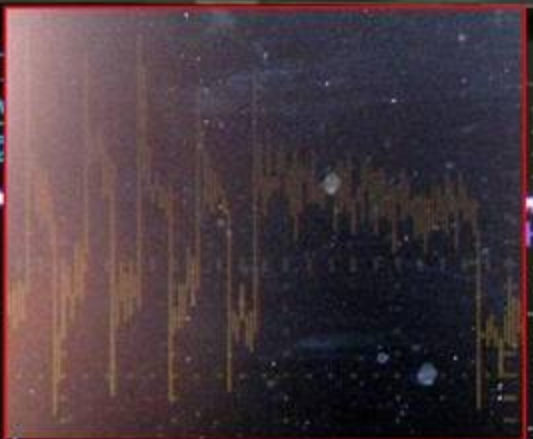
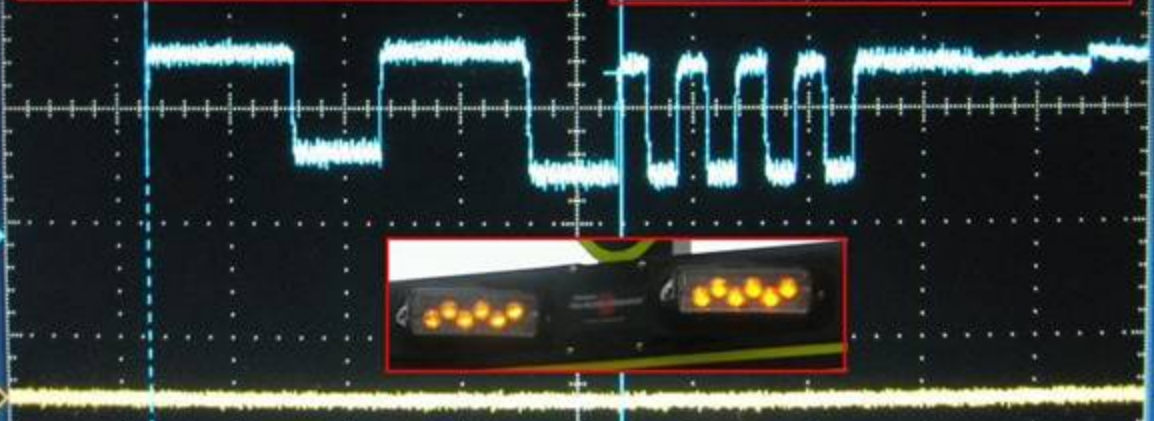
Ch1 5.00 V  $\overline{m}$  Ch2 500mV M 100ms A Ch3  $\sim$  5.20 V  
Ch3 20.0 V  
778.000ms

Cursor  
Function  
Off  
H Bar  
V Bar  
Bring  
Selected  
Cursor  
Center Sc  
Bring Bo  
Cursors  
Screen

We subsequently received a request for an official interpretation of the RRFB flashing pattern in an e-mail message from Ron Van Houten on July 15, 2010. Mr. Van Houten was one of the researchers who participated in some of the experiments in Florida that led to the interim approval. In his e-mail message (see copy attached to this letter), Mr. Van Houten informed us that Mr. Carl Morse, who manages the Florida DOT's traffic control device testing laboratory in Tallahassee, had used an oscilloscope to analyze the actual on/off pattern for the two lights of the type of RRFB that was used in the actual field experimentations and found that the flashing pattern was something other than a 2/3 flashing pattern. Mr. Van Houten's message included an photograph of Mr. Morse's oscilloscope output.

Scott: I have recently learned that the flash pattern we evaluated actually is two slow followed by four rapid flashes. Carl Morse has looked on a scope and the following is what has been determined: Each side of the LED flasher illuminated in a wig-wag sequence (left and then right). The left LED flashed two times in a slow volley each time it was energized (124 ms on and 76 ms off per flash) followed by the right LED, which flashed four times in a rapid volley when energized (25 ms on and 25 ms off per flash) and then a longer 200 ms flash. The total cycle length is 800 ms. The e-mail below from Rick Jones states that the units submitted to FDOT for testing had the same flash pattern as those evaluated in our research.

I have attached the scope tracing, and slow motion video of the flash pattern. Even in slow motion it appears like two slow flashes followed by three fast flashes but the eyes is deceived. This flash pattern is likely an SAE standard. Carl noted another LED flasher manufacture used the same pattern on flashers made for a different application. Since the 2/4 pattern is what we evaluated, and is what is manufactured, it is my recommendation that the standard be changed to reflect this. Thanks, Ron
