NTSB National Transportation Safety Board

Back to basics: Why investigate accidents?

Robert L. Sumwalt
NTSB Board Member
September 17, 2009

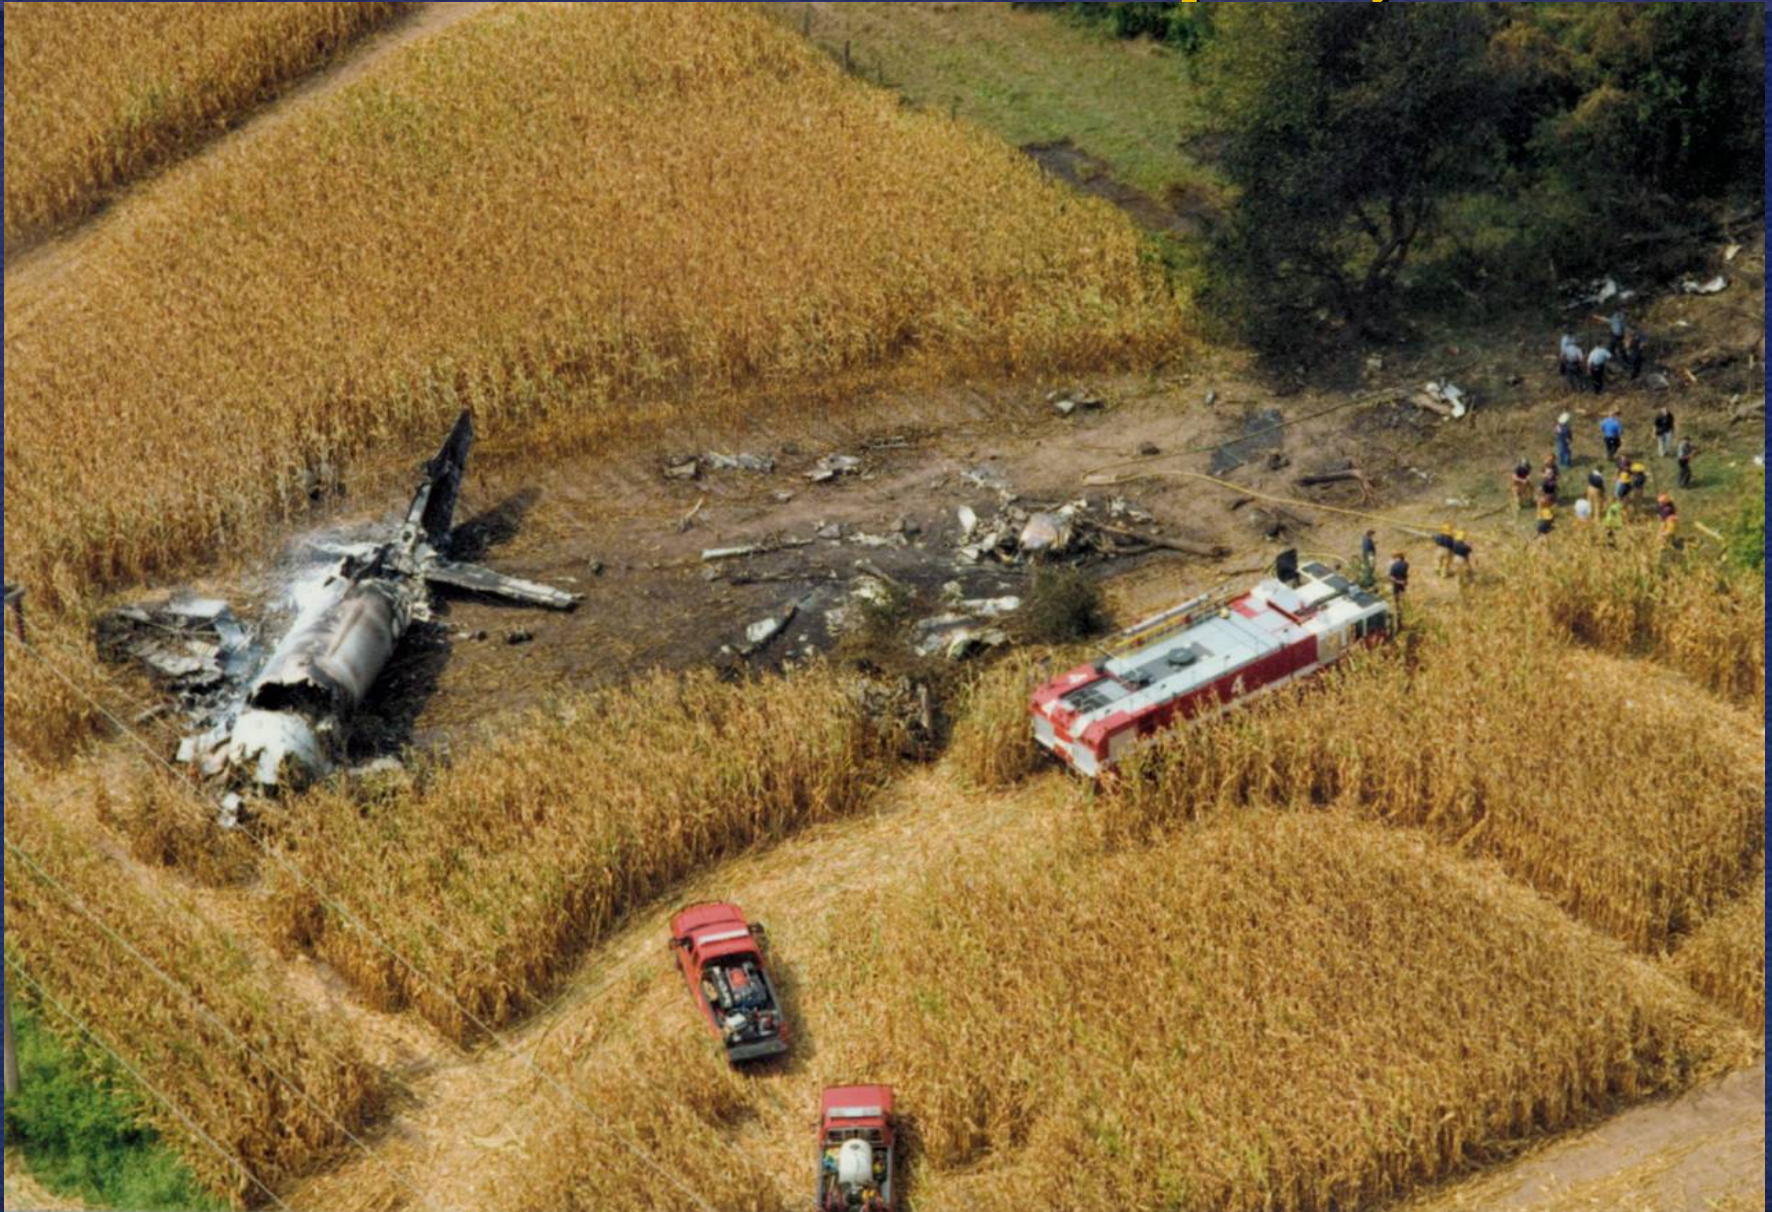
Air Tahoma

Sept 1, 2008

- Elevator trim cables were rigged improperly, resulting in the trim cables being reversed.
 - When pilot applied nose-up trim, the elevator trim system actually applied nose-down trim.
- Inspector's block on maintenance work cards were not signed off by the Required Inspection Item (RII) inspector.
