Capillary Electrophoresis in DNA Analysis

Troubleshooting the ABI 310

NEAFS Workshop
Mystic, CT
September 29-30, 2004
Dr. John M. Butler
Dr. Bruce R. McCord

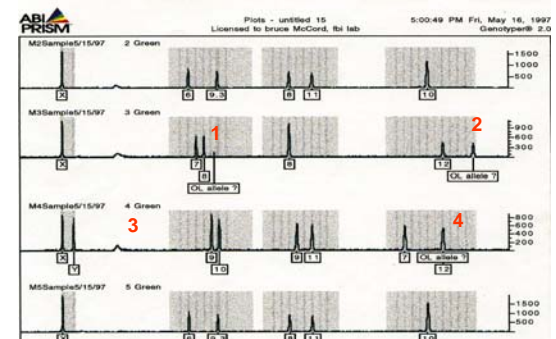
Off-ladder alleles Four types

1. Spike
2. OL Allele
3. Free Dye
4. Noise

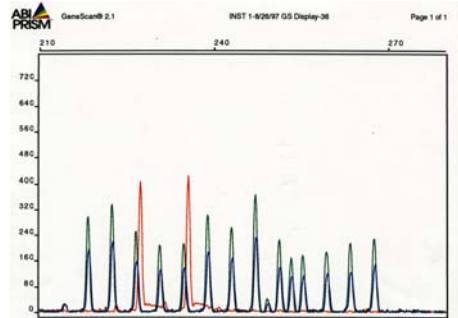
Band shift in CE Analysis of the FGA locus

Likely the result of temperature or viscosity induced mobility change

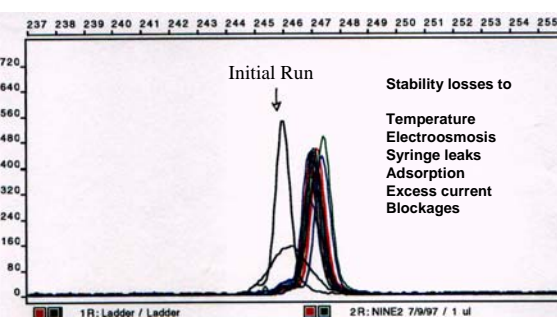
Due to its structure and its non-calibration, the "250" peak can be used to indicate stability

Initial Run

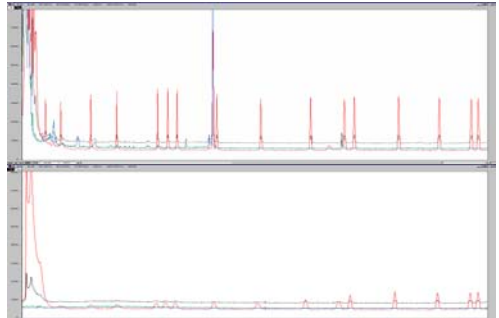
CE: Effect of pH 7 vs. 8.3

1 μl TH01 added to 10 μl of 3.0 mM NiCl₂ in 10 mM Tris, pH 7 or pH 8.3. Sample allowed to interact for 1 hr and then 1 μl added to ROX/formamide.

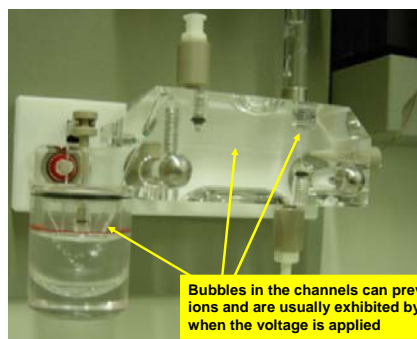
Remove all bubbles from the channels

Bubbles in the channels can prevent flow of ions and are usually exhibited by zero current when the voltage is applied
