**APPENDIX A
HYDRAULIC DESIGN
EMERGENCY BANK STABILIZATION
DILLINGHAM, ALASKA**

APPENDIX A HYDRAULIC DESIGN

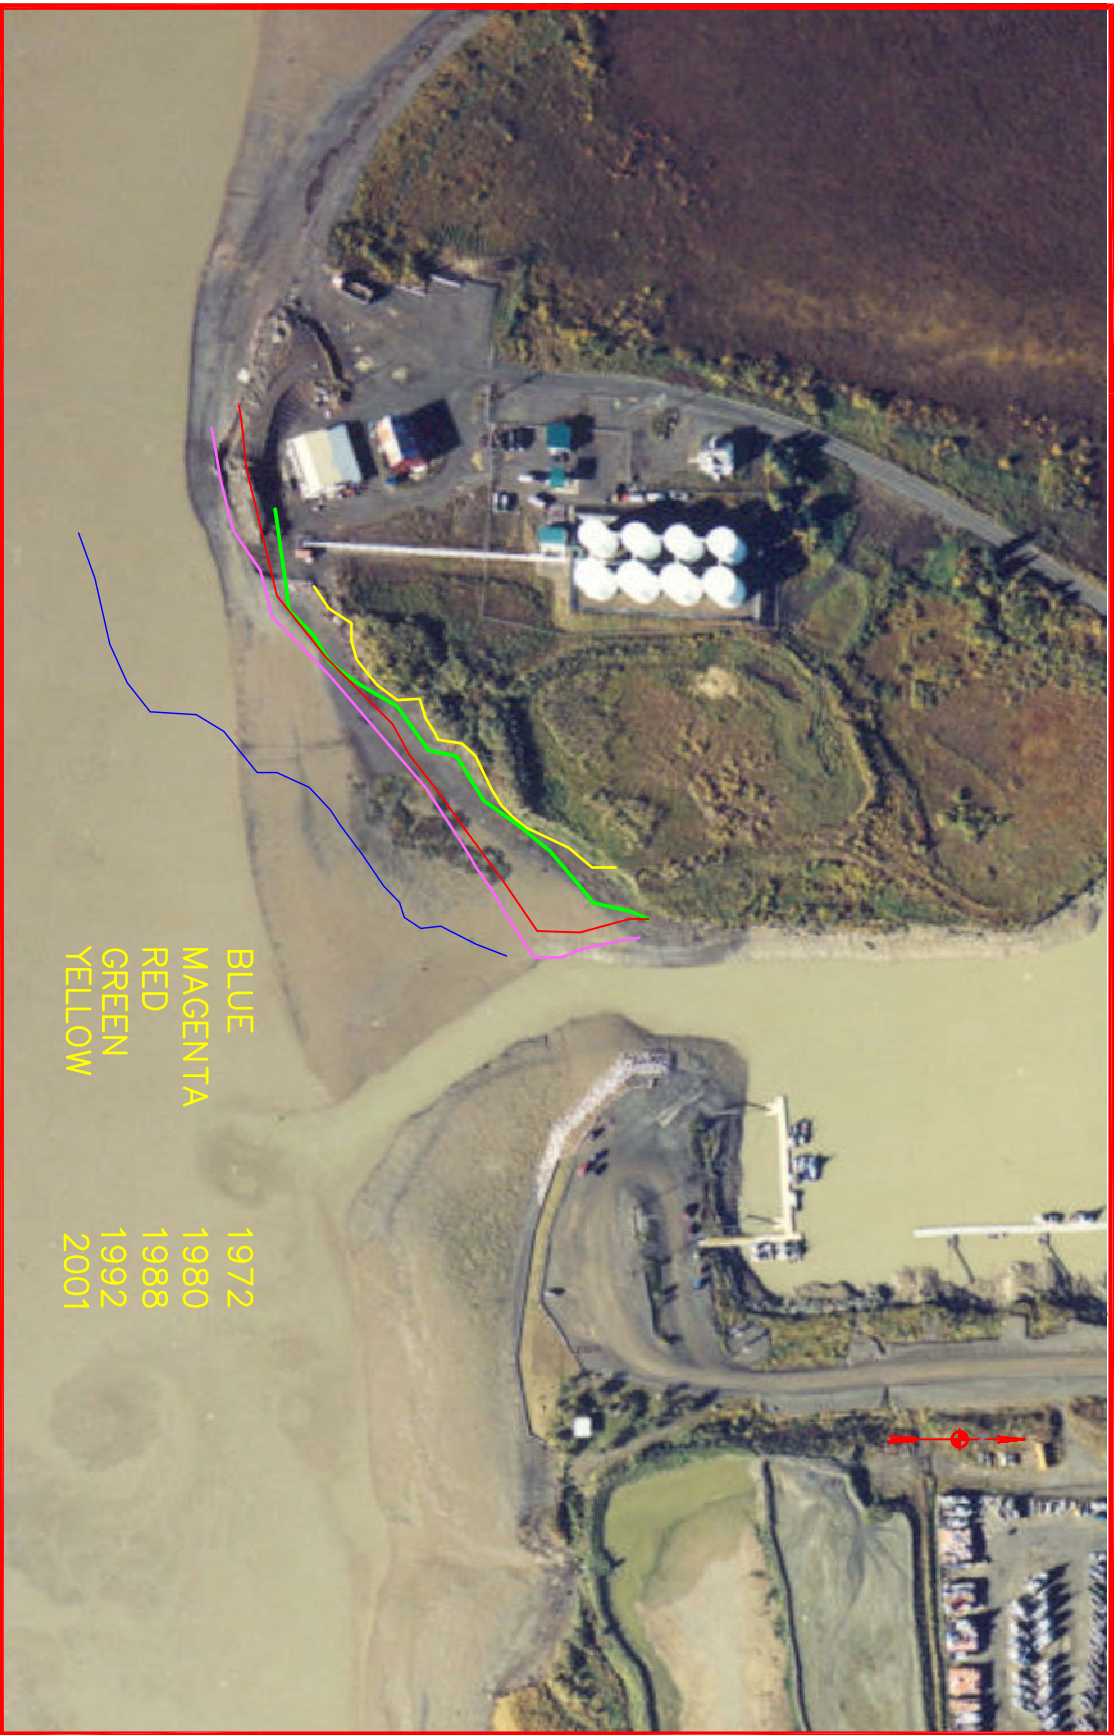
A--5

EROSION RATES – 2001 AERIAL PHOTO
DILLINGHAM EMERGENCY EROSION PROTECTION

Tetra Tech, as part of the current design, conducted a historical erosion analysis of the proposed project area. Five aerial photographs of the study area spanning the years from 1972 to 2001 were obtained and digitally adjusted to the NAD 83, Zone 6, State Plane coordinate system. The visible vegetation line in each aerial photograph was plotted and the area lost to erosion between each set of photographs was measured using GIS software.
