February 10, 2007

Analysis of the London Avenue Canal Load Test - Section 1

Seepage and Stability Analysis

Thomas L. Brandon

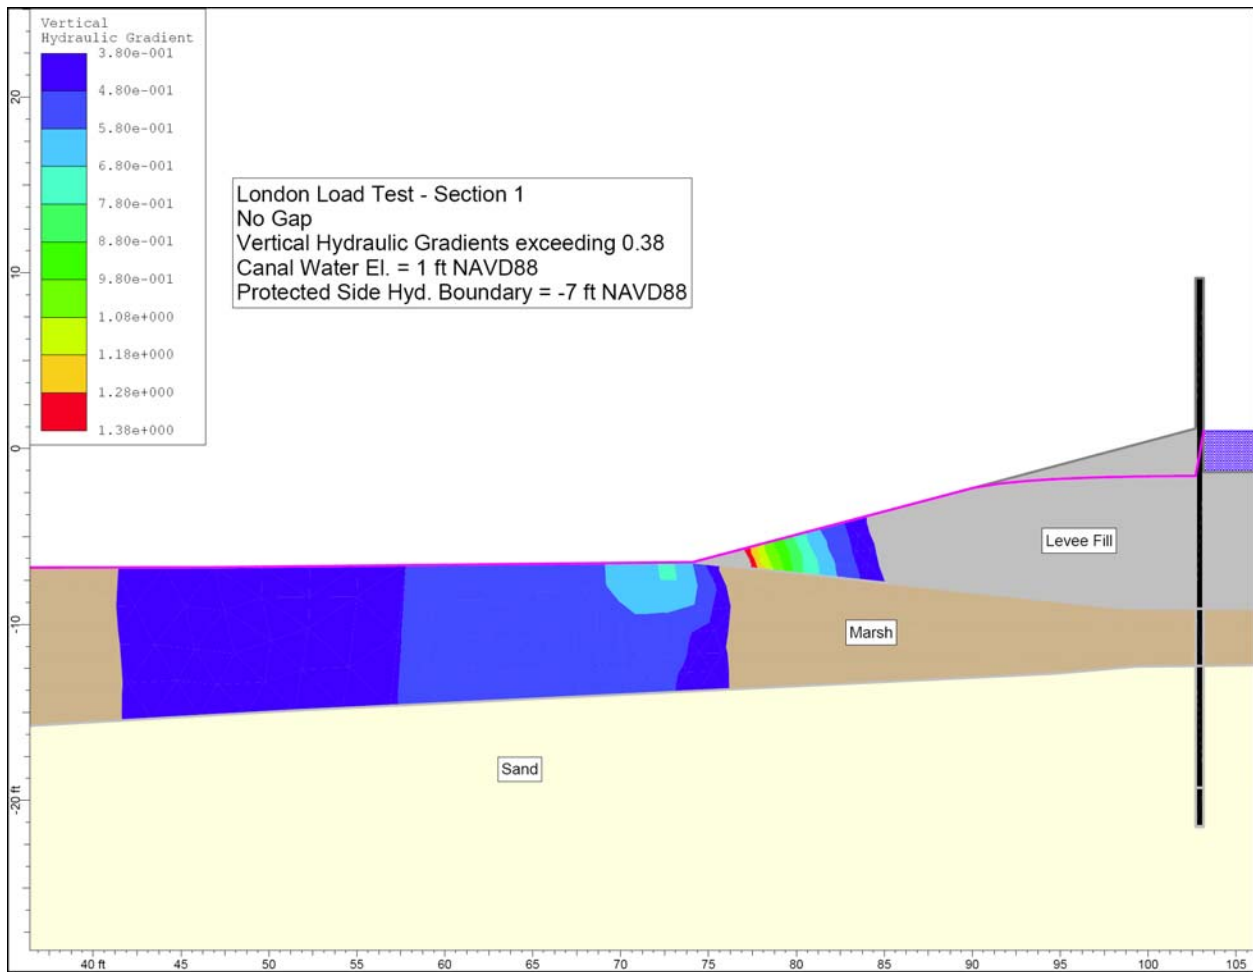
Figure 3 Contours of vertical hydraulic gradient showing gradients exceeding 0.38. The canal water level is 1.0 ft NAVD88, and no gap is present.

Shown in Figure 3 are locations where the vertical hydraulic gradient exceeds the critical hydraulic gradient of 0.38 for a canal water level of 1 ft NAVD88, and no gap exists between the I-wall and the protected side soil. As shown by the figure, there are substantial areas where the gradient exceeds the critical gradient. Figure 4 shows the results of an identical analysis, except that a gap is now present between the I-wall and the canal side embankment down to the marsh/sand interface. The presence of the gap only slightly increases the zone where the hydraulic gradient exceeds the critical hydraulic gradient. The maximum hydraulic gradient for canal water elevation of 1 ft is 0.71 for the “no gap” case and 0.74 for the “gap” case.

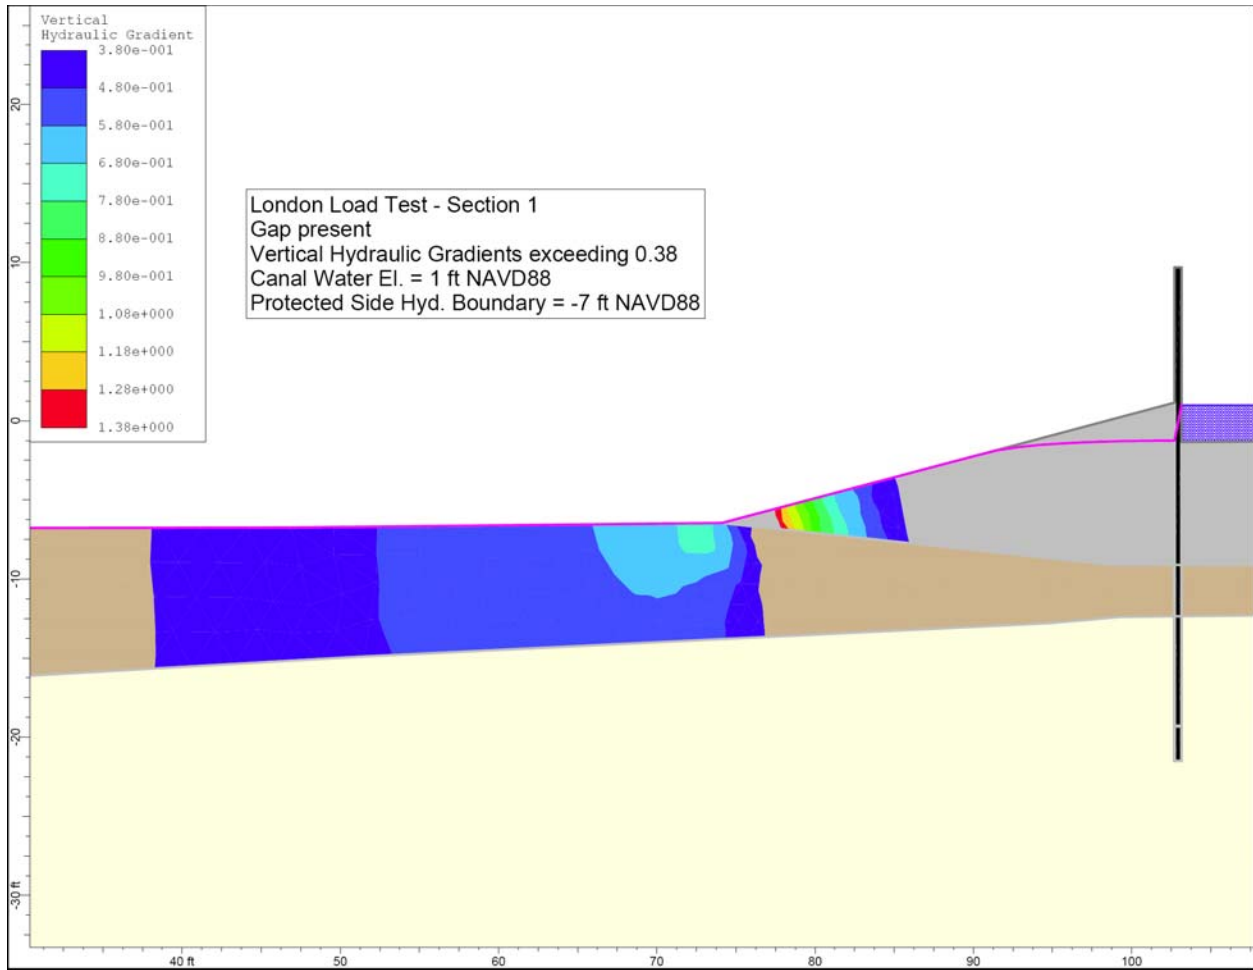
Figure 4 Contours of vertical hydraulic gradient showing gradients exceeding 0.38. The canal water level is 1.0 ft NAVD88, and a gap is present.

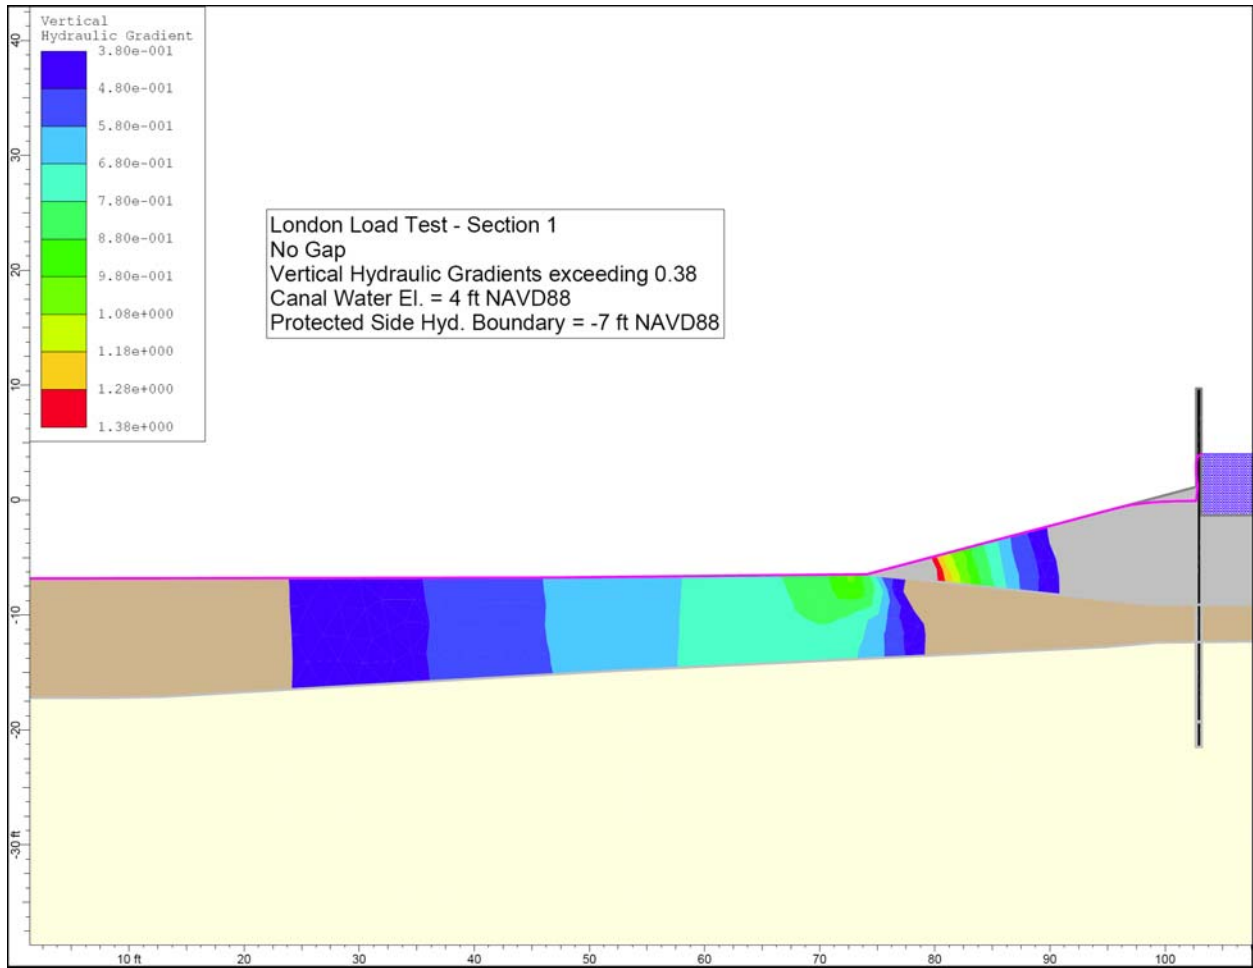
Figure 5 Contours of vertical hydraulic gradient showing gradients exceeding 0.38. The canal water level is 4.0 ft NAVD88, and a gap is not present.

Figures 5 and 6 show similar results for a canal water level of 4 ft NAVD88, for the “no gap” and the “gap” case. Similar to the previous results, the presence of the gap only slightly increases the zone where the hydraulic gradient exceeds 0.38. The maximum hydraulic gradient for canal water elevation of 4 ft is 1.00 for the “no gap” case and 1.07 for the “gap” case.

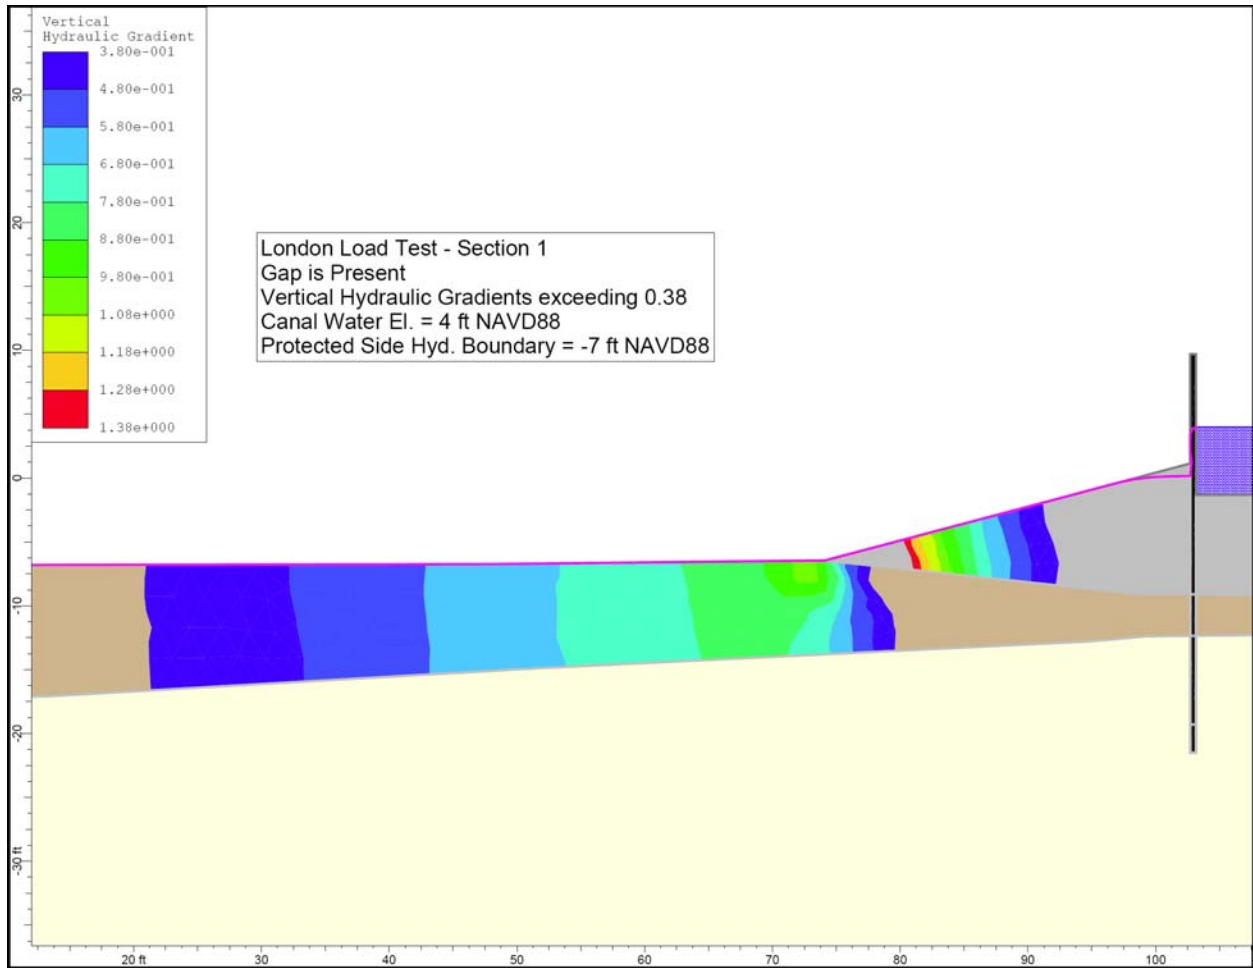
Figure 6 Contours of vertical hydraulic gradient showing gradients exceeding 0.38. The canal water level is 4.0 ft NAVD88, and a gap is present.

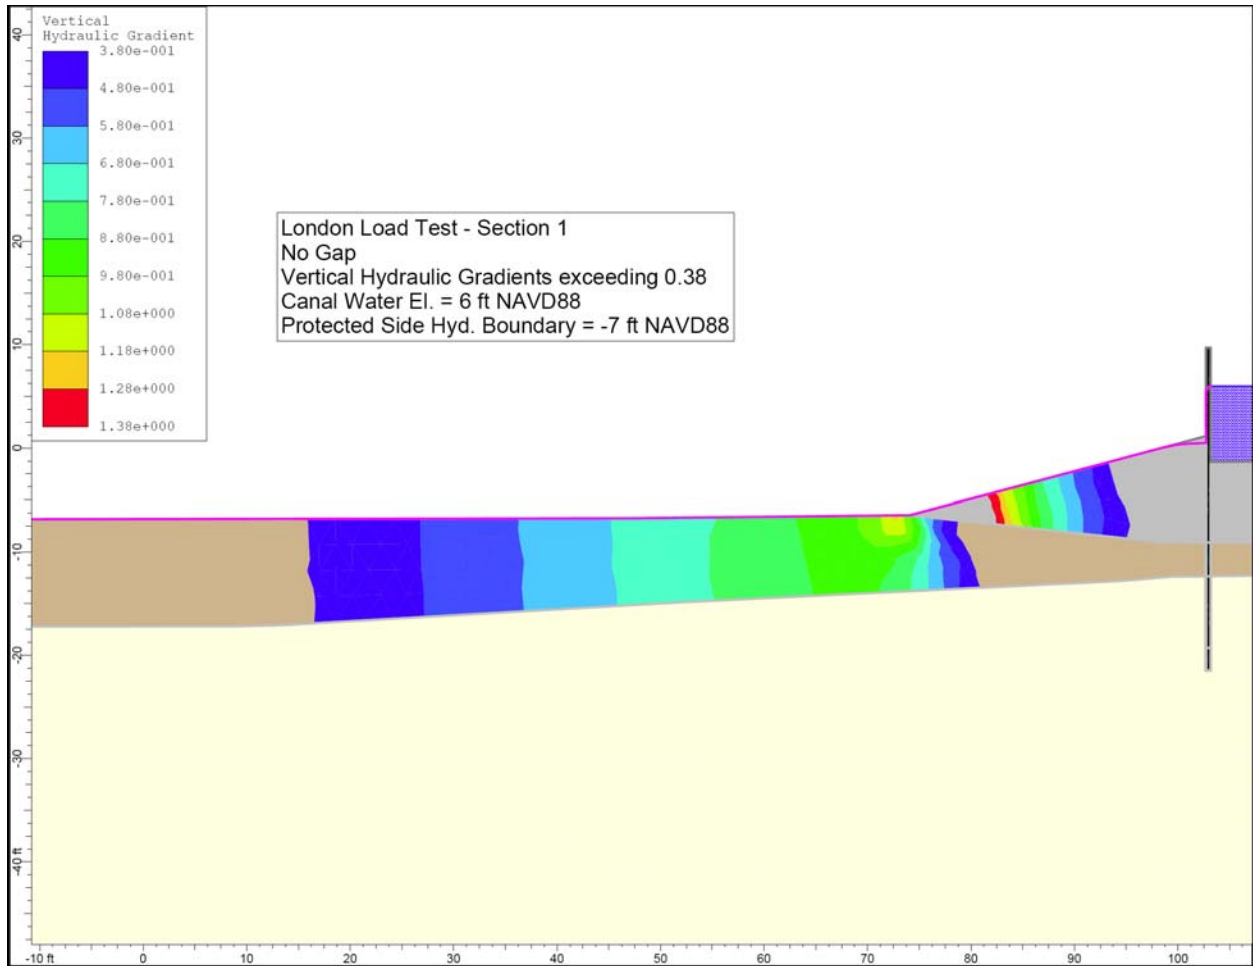
Figure 7 Contours of vertical hydraulic gradient showing gradients exceeding 0.38. The canal water level is 6.0 ft NAVD88, and a gap is not present.

Figures 7 and 8 show the results for a canal water level of 6 ft NAVD88, for the “no gap” and the “gap” case. The maximum hydraulic gradient for canal water elevation of 6 ft is 1.19 for the “no gap” case and 1.26 for the “gap” case.

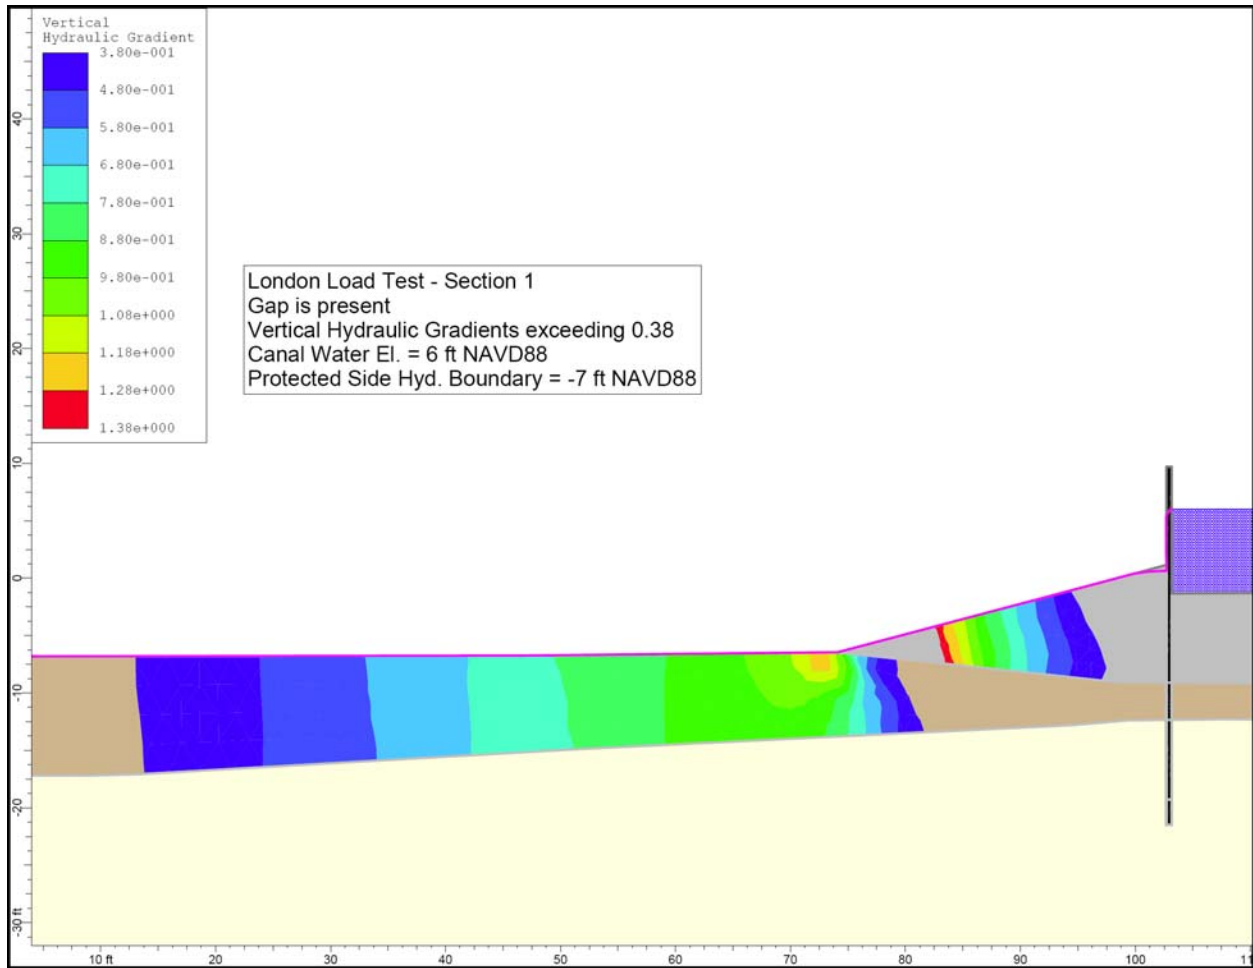
Figure 8 Contours of vertical hydraulic gradient showing gradients exceeding 0.38. The canal water level is 6.0 ft NAVD88, and a gap is present.

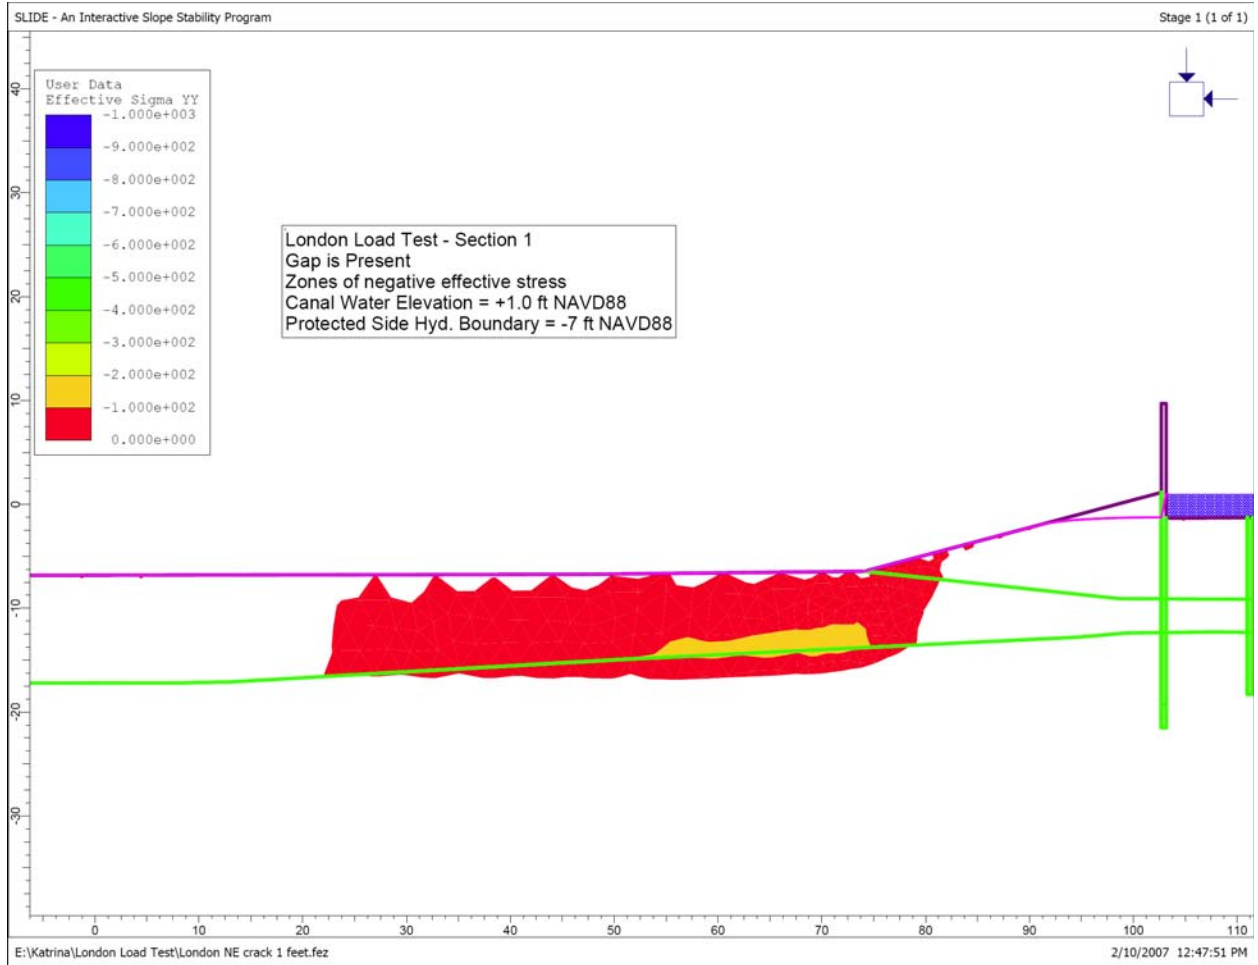
Figure 10 Areas of negative effect stress, indicating potential heave. The canal water level is 1.0 ft NAVD88, and a gap is present.

The computer program PHASE2² was coupled with SLIDE to calculate the effective stresses existing at the marsh/sand interface. Total stresses at the interface were calculated using the finite element method with PHASE2 assuming linear elastic behavior of the soils, and pore pressures were calculated using the results of the finite element seepage analysis. Shown in Figure 9 is the zone where the pore pressures exceed the total stress for a canal water elevation of 1 ft for the “no gap” condition. Figure 10 shows the results of an identical analysis, but includes

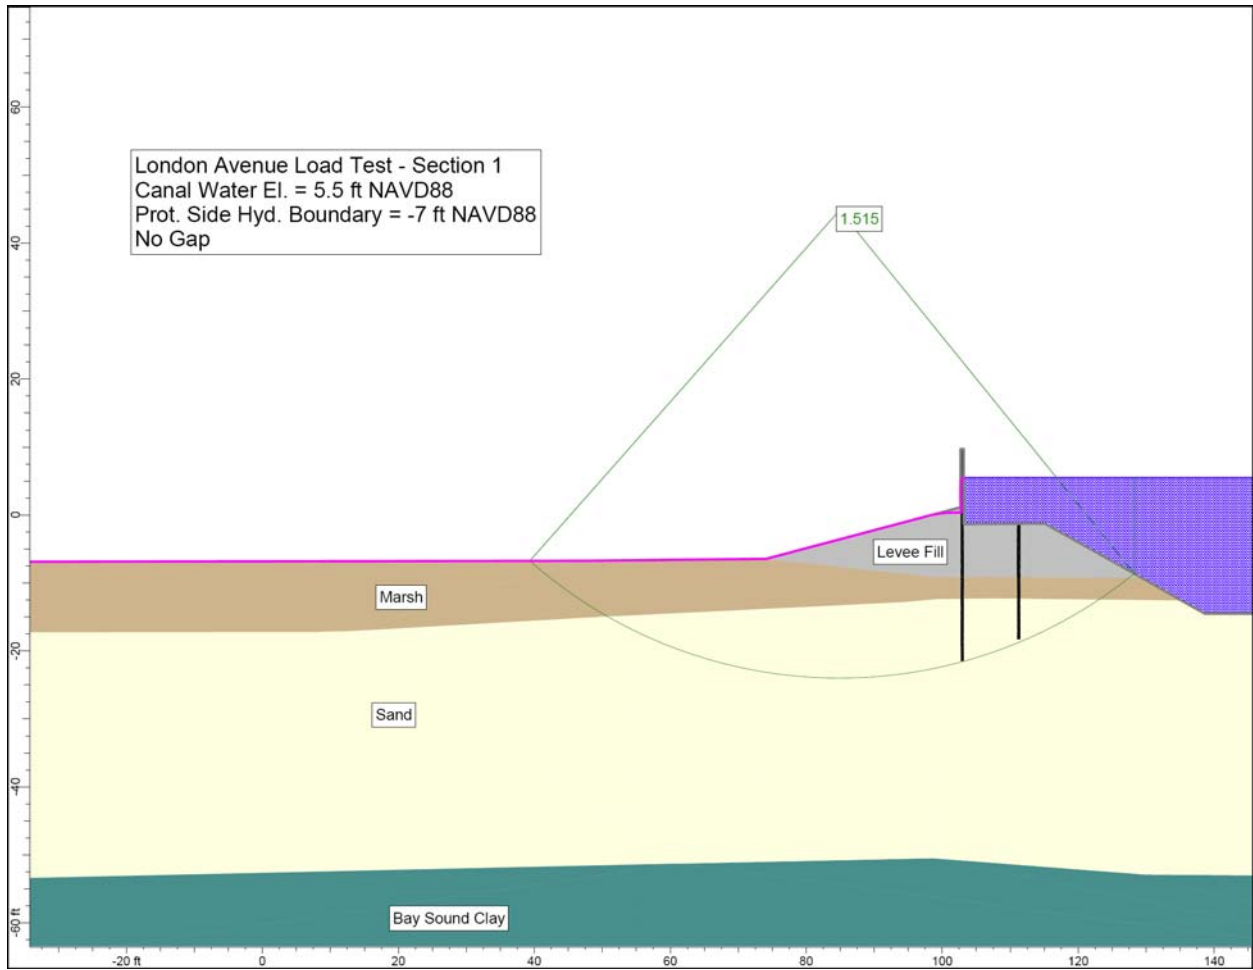
Figure 13 Critical failure surface for canal water level of 5.5 ft NAVD88, for the condition of “no gap.”

Figures 13, 14, and 15 show the critical failure surfaces for the “no gap” condition for canal water elevations of 5.5, 7.5, and 9.5 ft, respectively. Figures 16, 17, and 18 show the critical failure surfaces for the “gap” condition for canal water elevations of 3.5, 5.5, and 7.5 ft, respectively.. The factors of safety calculated for these analyses are also shown plotted in Figure 19. As shown by Figure 19, a canal water level of about 9.2 ft produces a factor of safety of unity for the “no gap” condition. For the “gap” condition, the canal water level that results in a factory of safety of unity is about 6.2 ft. This demonstrates the considerable effect that the presence of the gap has on shear stability, and this effect is much greater than the influence of the gap on erosion and heave.

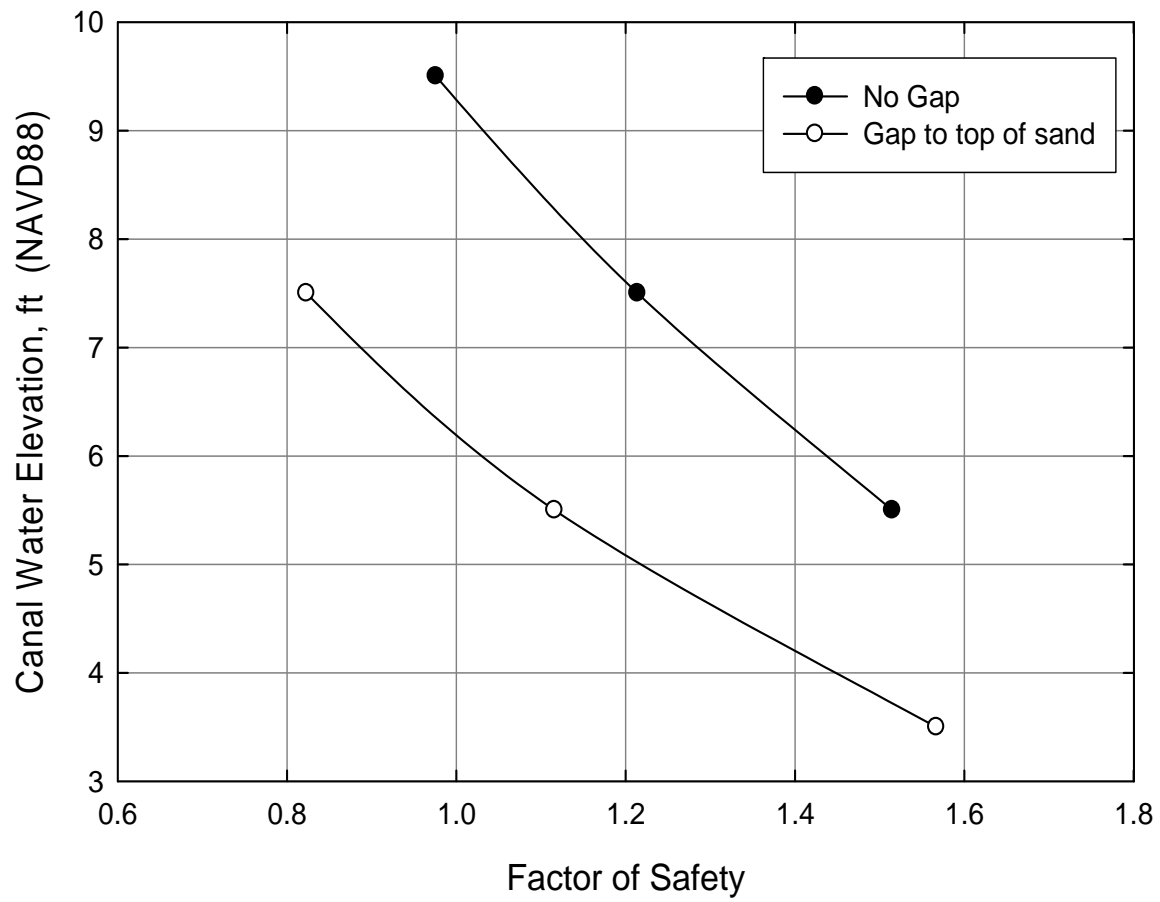
Figure 19 Factors of safety for the “gap” and “no gap” conditions as a function of canal water level.
