Office of Health, Safety and Security

Electrical Safety Report

April 2011

Electrical Safety Occurrences

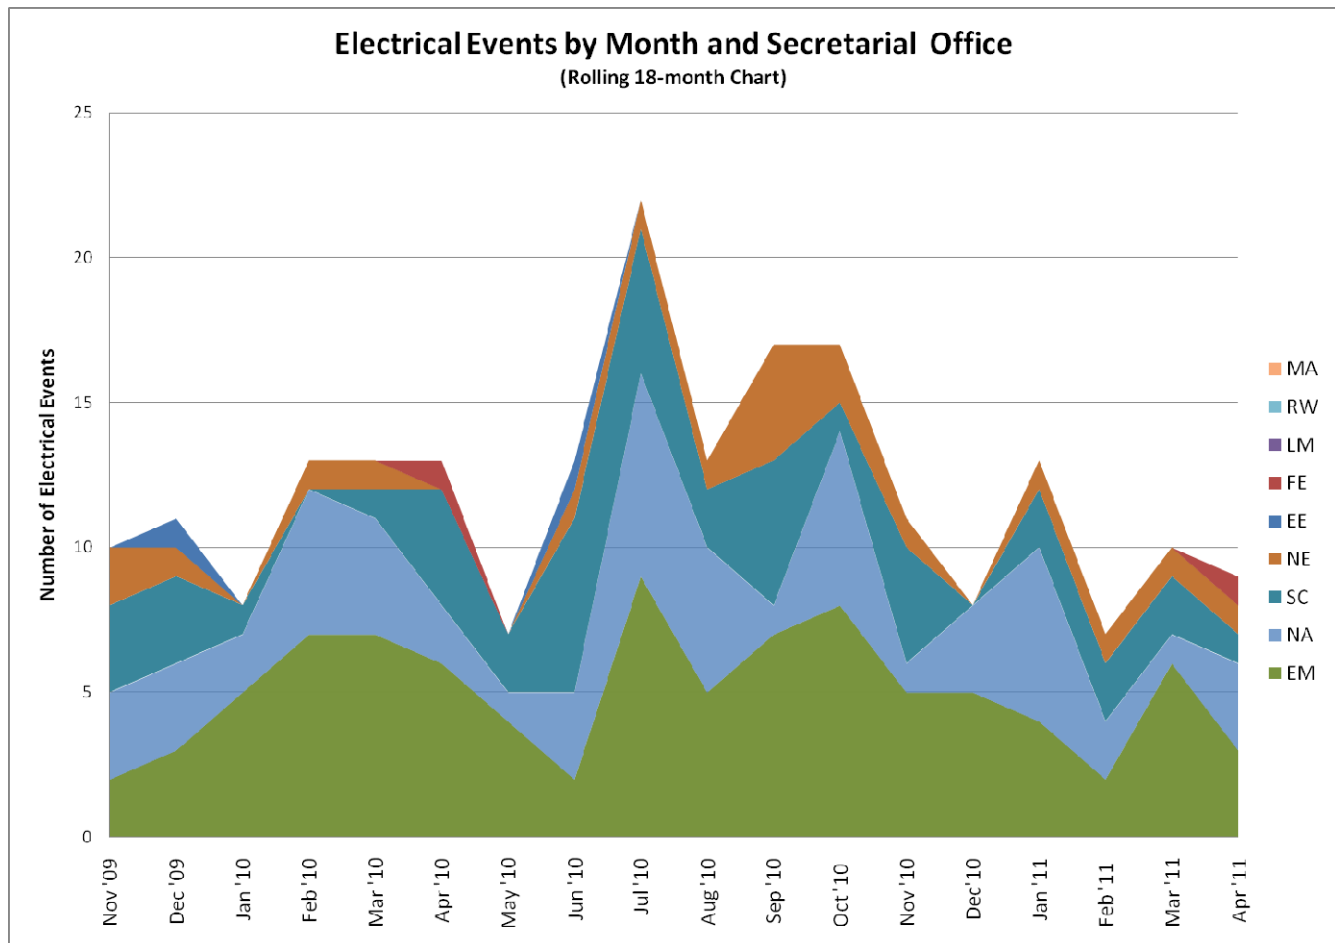
The monthly average for 2011 is lower than the monthly average in calendar years 2009 and 2010.

Period	Electrical Safety Occurrences	Shocks	Burns	Fatalities
April	9	1	0	0
March	10	1	0	0
February	7	3	0	0
January	13	3	1	0
2011 total	39 (avg. 9.8/month)	8	1	0
2010 total	155 (avg. 12.9/month)	28	2	0
2009 total	128 (avg. 10.7/month)	25	3	0
2008 total	113 (avg. 9.4/month)	26	1	0
2007 total	140 (avg. 11.7/month)	25	2	0
2006 total	166 (avg. 13.8/month)	26	3	0
2005 total	165 (avg. 13.8/month)	39	5	0
2004 total	149 (avg. 12.4/month)	25	3	1

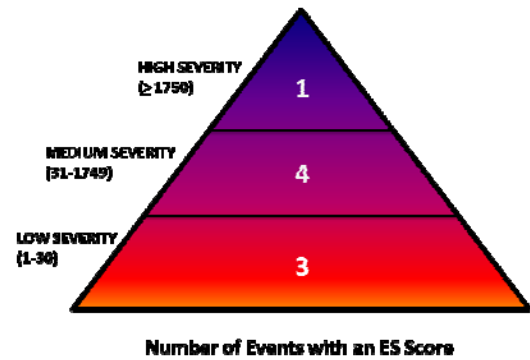
Electrical Severity Scores

The electrical severity scores are calculated using Revision 2 of the Electrical Severity Measurement Tool. One of the electrical events this month did not have an Electrical Severity (ES) score. The other eight events are distributed as shown in the triangle, with the highest ES score being 2,100. The actual score for each event is provided in the event tables.

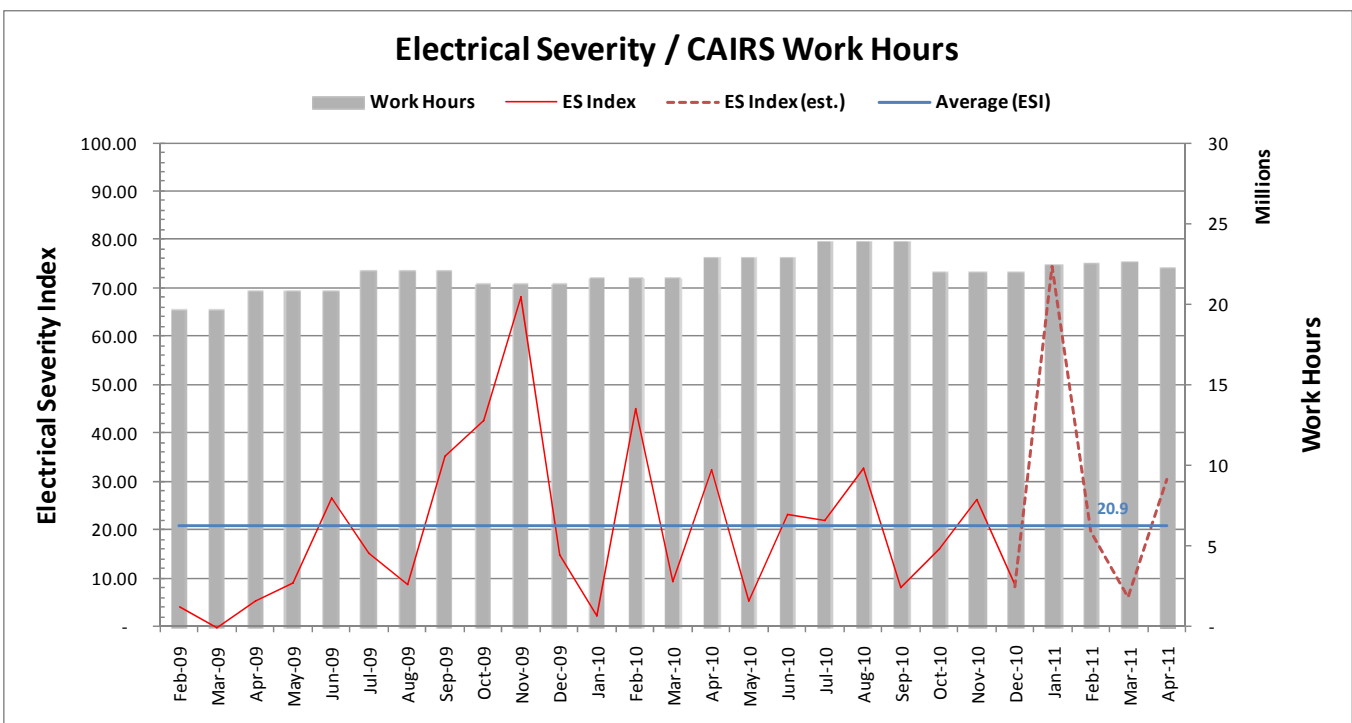
The following chart shows a calculated Electrical Severity Index (ESI) for the DOE complex.

Note: An estimated ESI is calculated until accurate CAIRS man-hours are available. The chart will be updated monthly.

Category	March	April	Δ
Total Occurrences	10	9	-1
Total Electrical Severity	670	3,375	+2,705
Estimated Work Hours	22,615,034* (22,615,034)	22,256,450	-358,585
ES Index	5.93* (5.93)	30.33	+24.4
Average ESI	20.6	20.9	+0.3

$$\text{Electrical Severity Index} = (\Sigma \text{Electrical Severity} / \Sigma \text{Work Hours}) 200,000$$

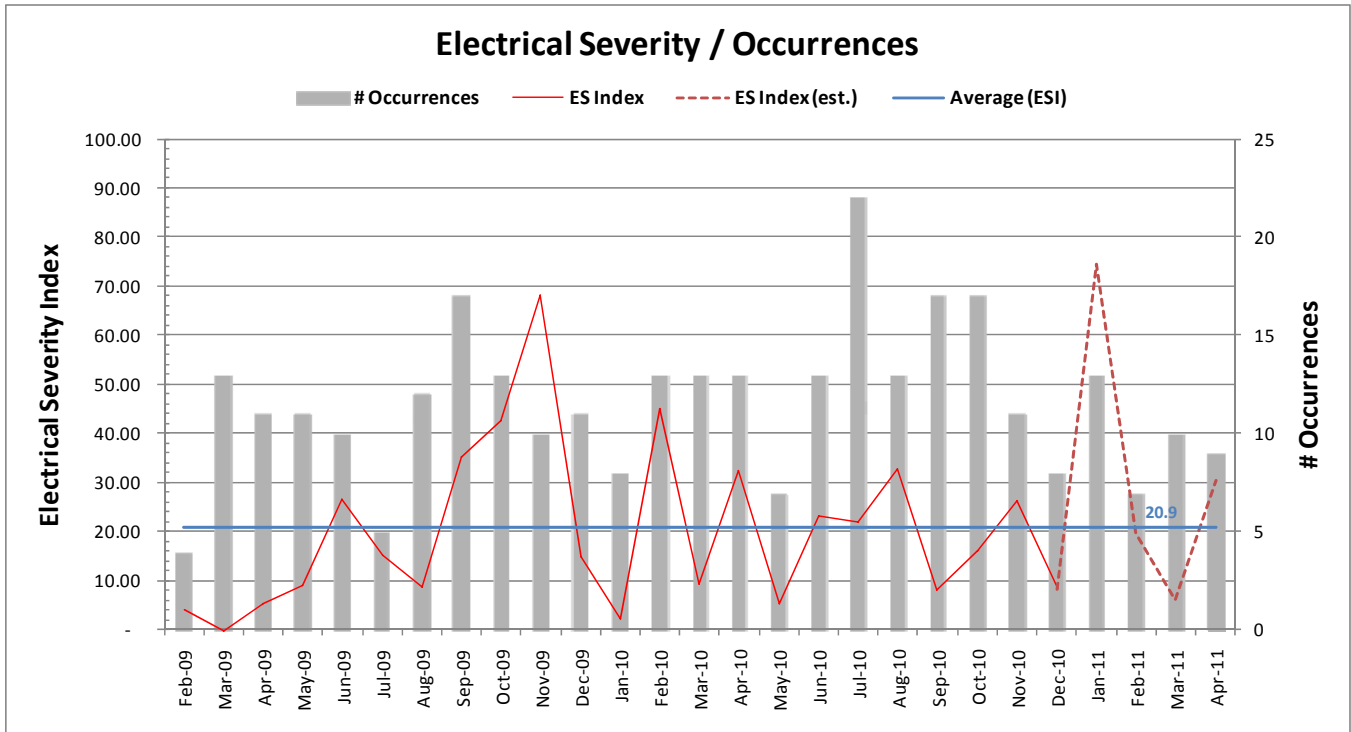
The following chart shows ESI with the number of Occurrences instead of work hours.

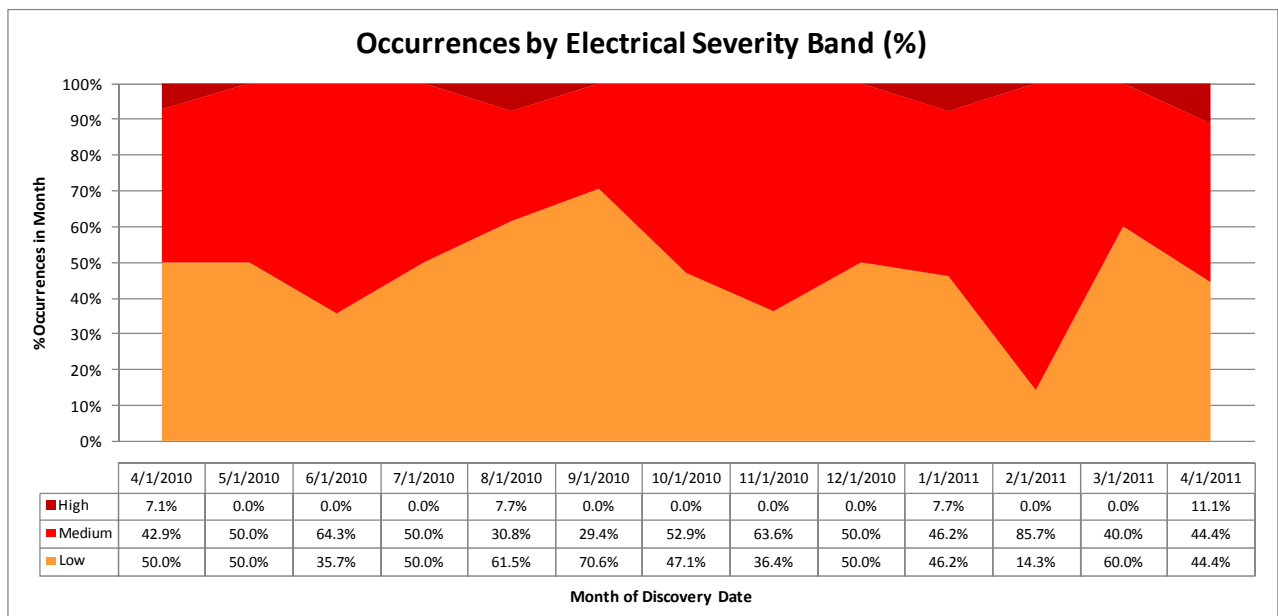
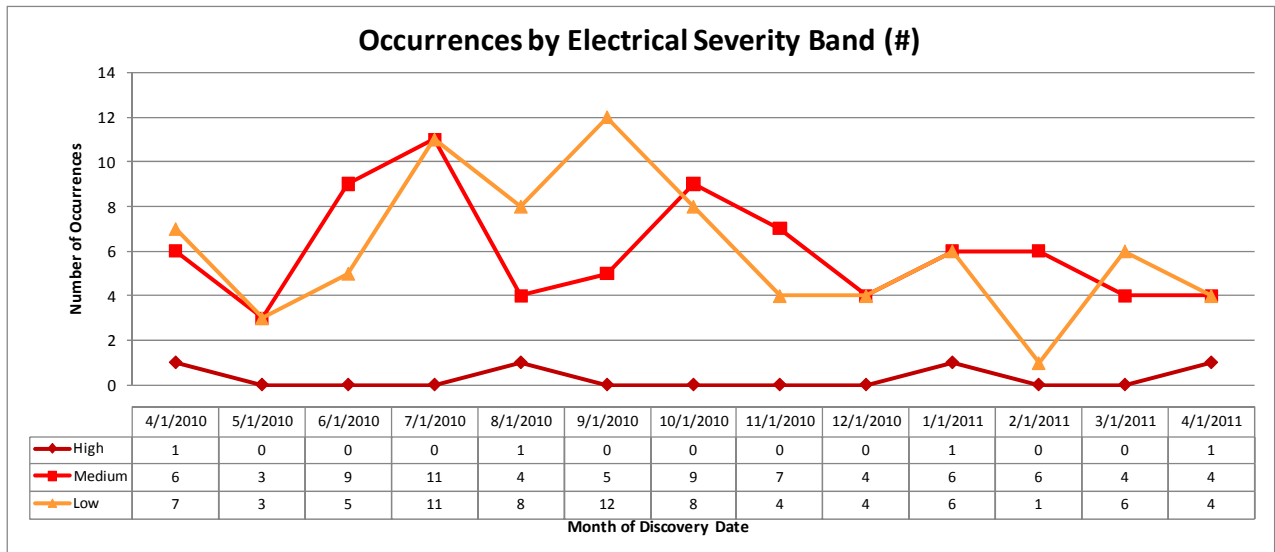
Summary of Occurrences by Severity Band

For the interval April 2010 through April 2011 (current month and the past 12), the next two charts summarize occurrences by severity band and month of discovery date:

- By percentage of total occurrences in month
- By number of occurrences in month

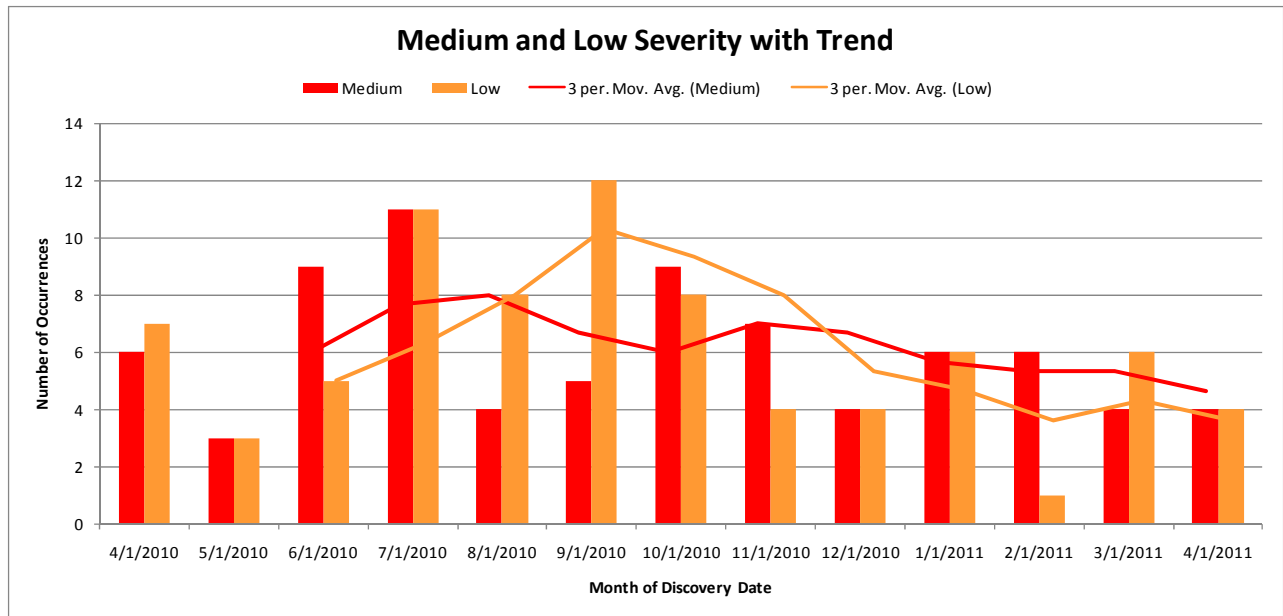
Medium and Low Severity with Trend

The following chart focuses on the Medium and Low severity data series for April 2010 through April 2011. Trend lines are included for each, using a 3-month moving average.
