## Electrical Safety Occurrences

## Electrical Safety Occurrences – August 2010

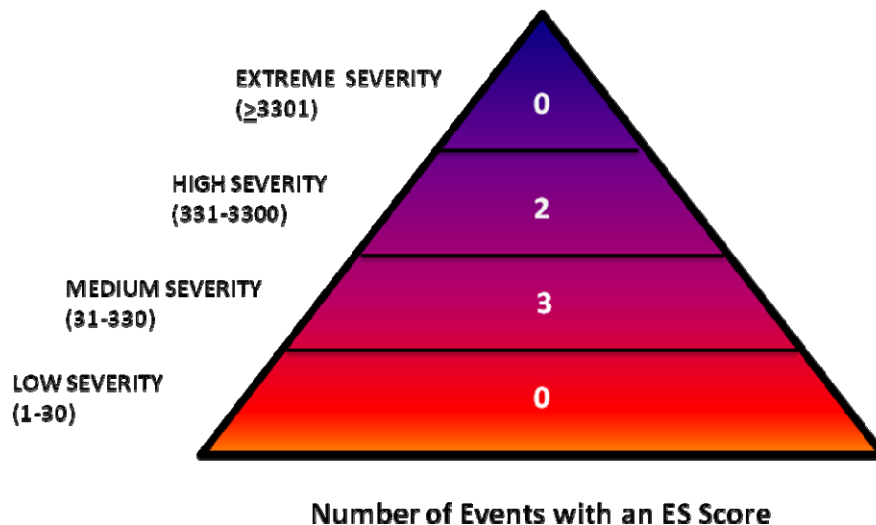
Continue to evaluate electrical events using the Electrical Severity Measurement Tool. Eight of the electrical events were determined to have no Electrical Severity (ES) score. The other five events were distributed as shown below, with the highest ES score being 2400.

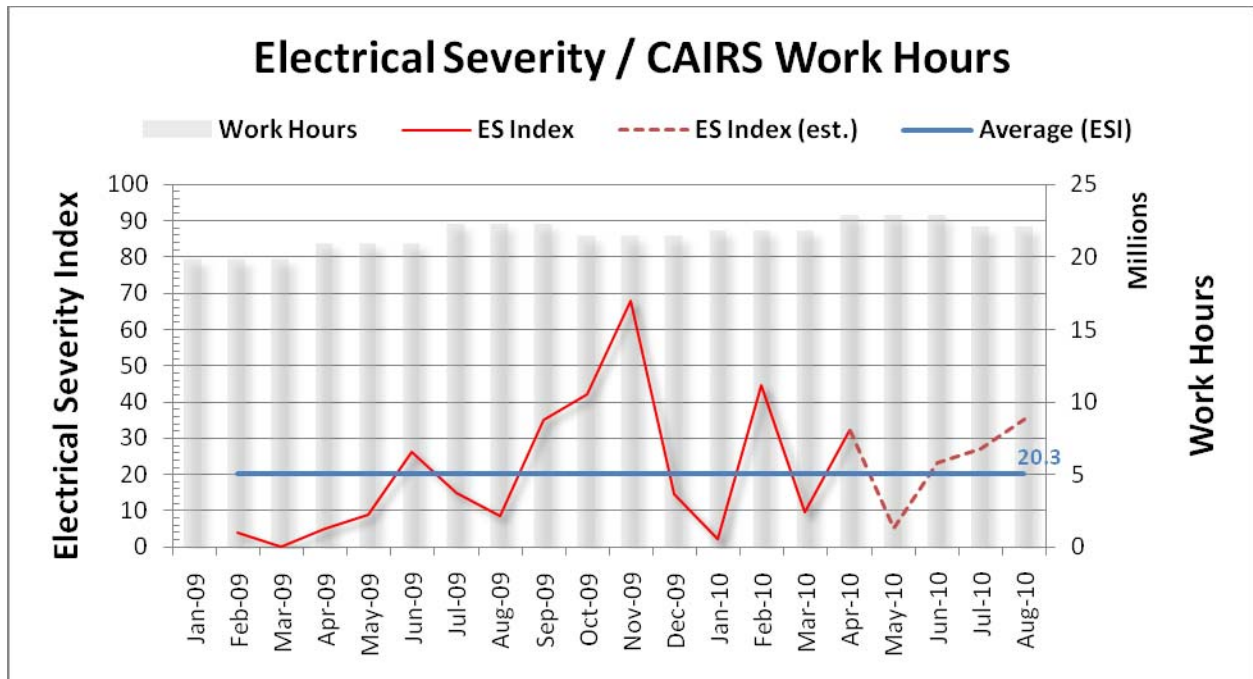
## Electrical Severity Index

The following chart shows a calculated Electrical Severity Index (ESI) for the DOE complex.

Note: An estimated ESI is calculated until accurate CAIRS man-hours are available. The chart will be updated monthly.

Category	July	August	Δ
<b>Total Occurrences</b>	22	13	-9
<b>Total Electrical Severity</b>	2,990	3,870	+880
<b>Estimated Work Hours</b>	21,737,519	21,958,613	-7,449
<b>ES Index</b>	27.22* (27.51)	35.25	+8.03
<b>Average ESI</b>	19.6	20.3	+0.7

\* These are actual CAIRS work hours for July and ES Index based on the actual hours. The estimated hours and ES Index based on the estimated hours (as reported in July) are shown in parentheses.

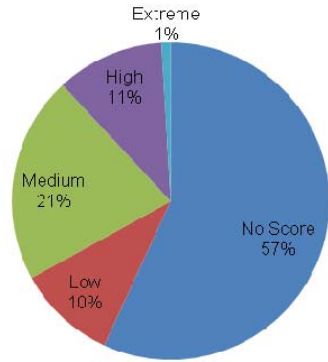
Distribution of Electrical Severity for Events Involving Electrical Work

A review of electrical severity categories from January 2009 to August 2010, for events involving electrical work (109) and non-electrical work (120), shows that workers performing non-electrical work have a greater exposure to medium and high severity events. Much of this can be attributed to the higher number of non-electrical workers who come in contact with electrical energy.

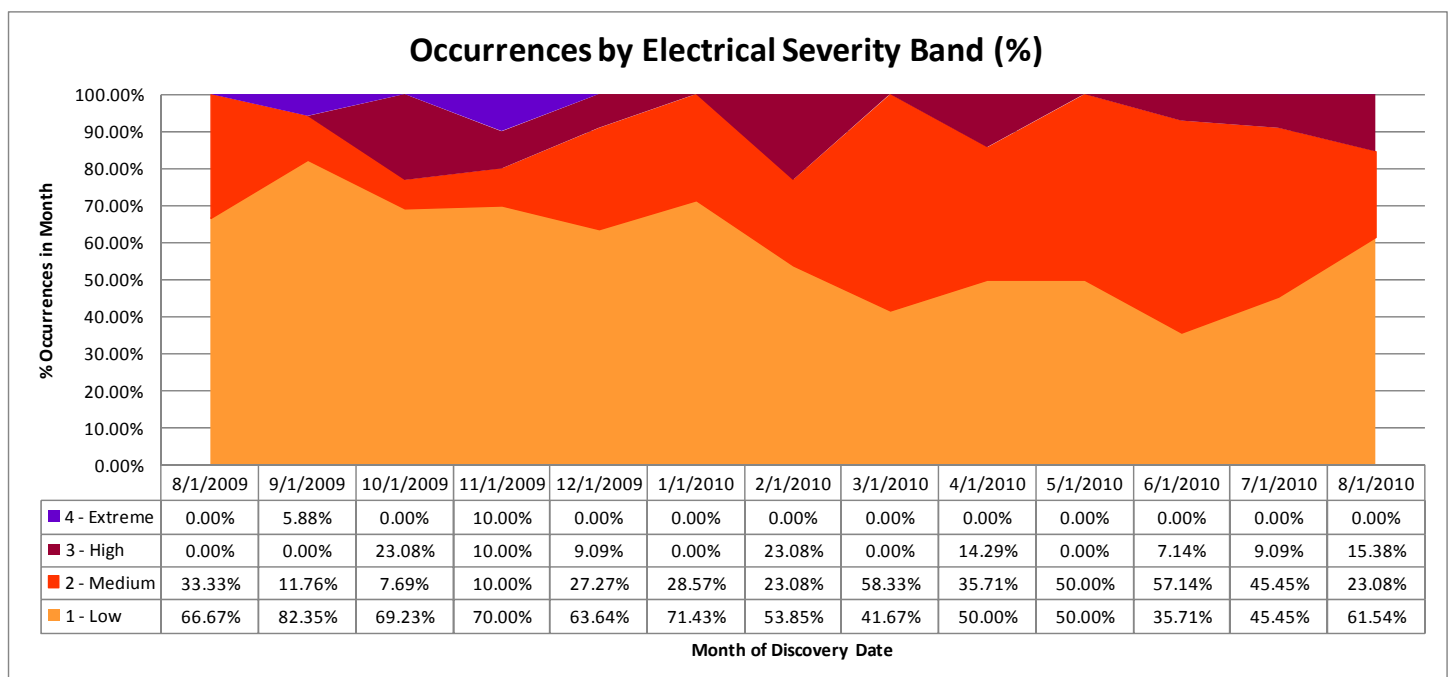
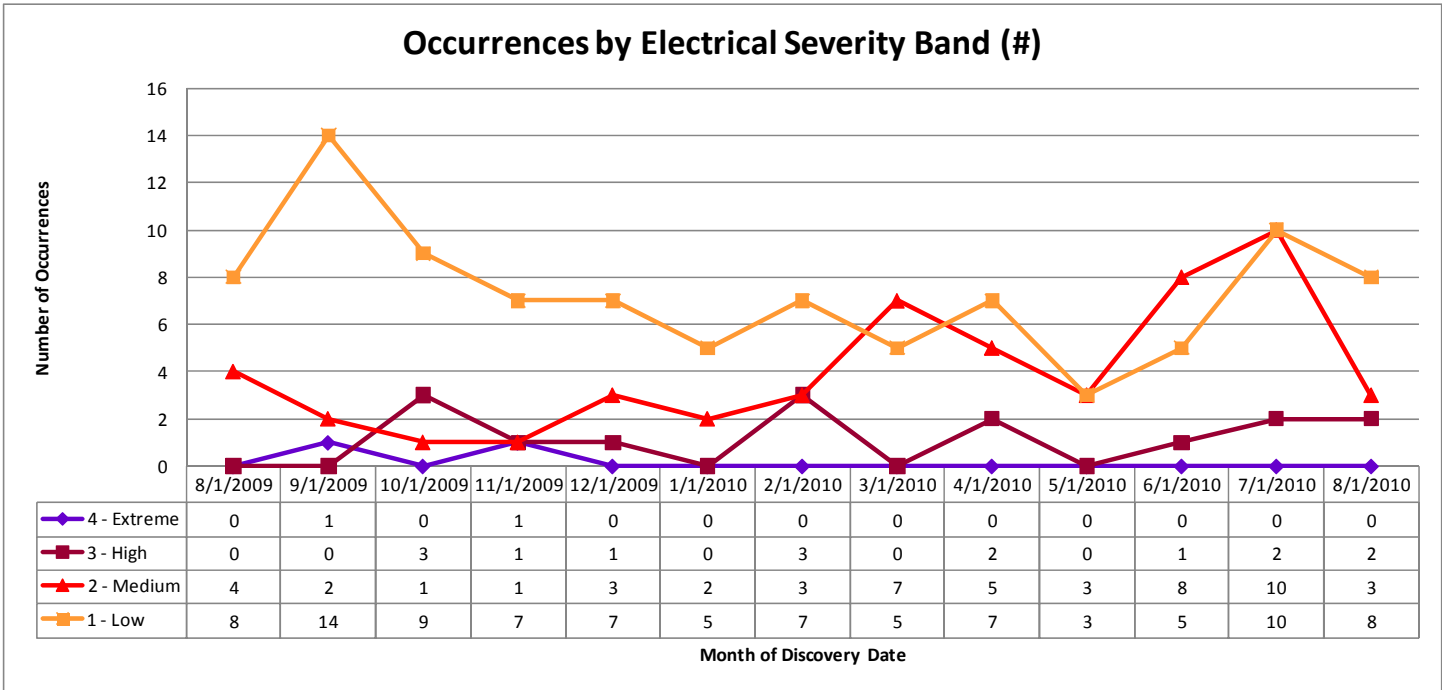
## Summary of Occurrences by Severity Band

For the interval August 2009 through August 2010 (current month and the past 12), the two charts below summarize occurrences by severity band and month of discovery date:

- By percentage of total occurrences in month
- By number of occurrences in month

The key observation is that Medium severity occurrences as a group are increasing in CY2010.

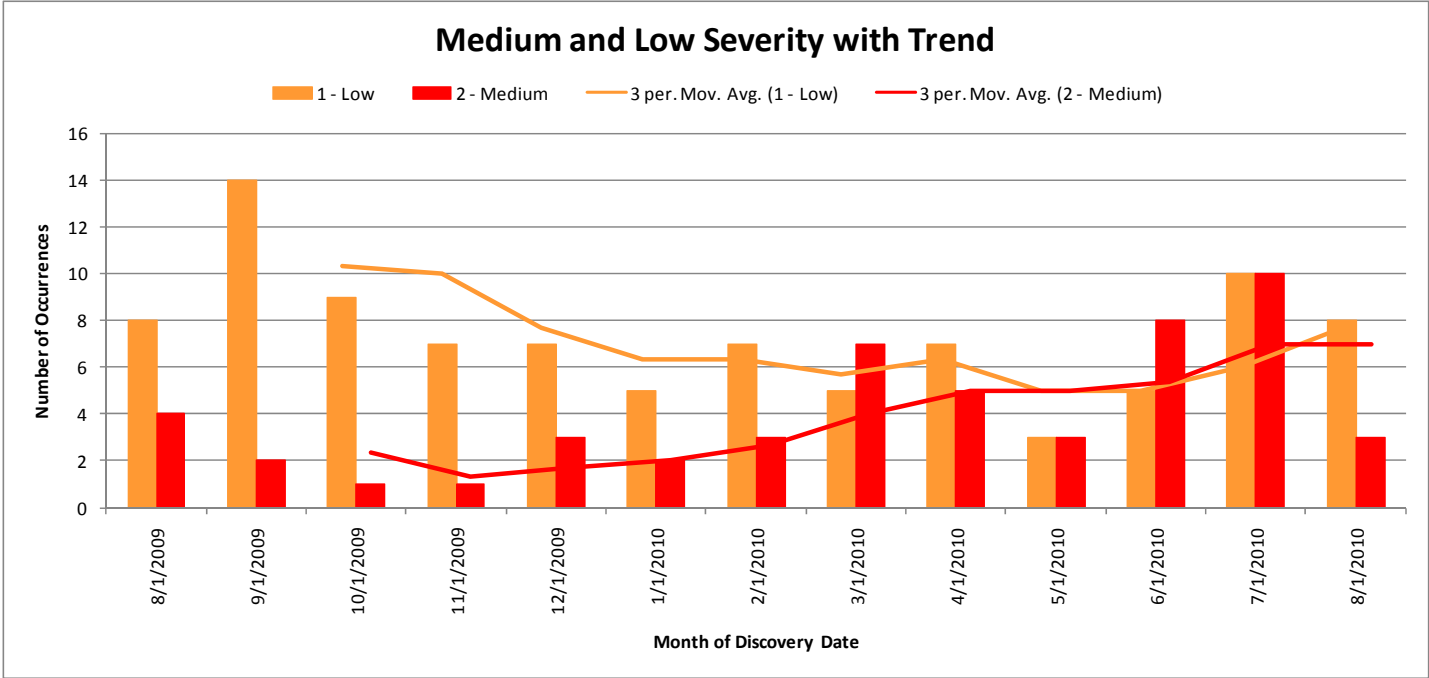
### Medium and Low Severity with Trend

The following chart focuses on the Medium and Low severity data series for August 2009 through August 2010. Trend lines are included for each, using a 3-month moving average.

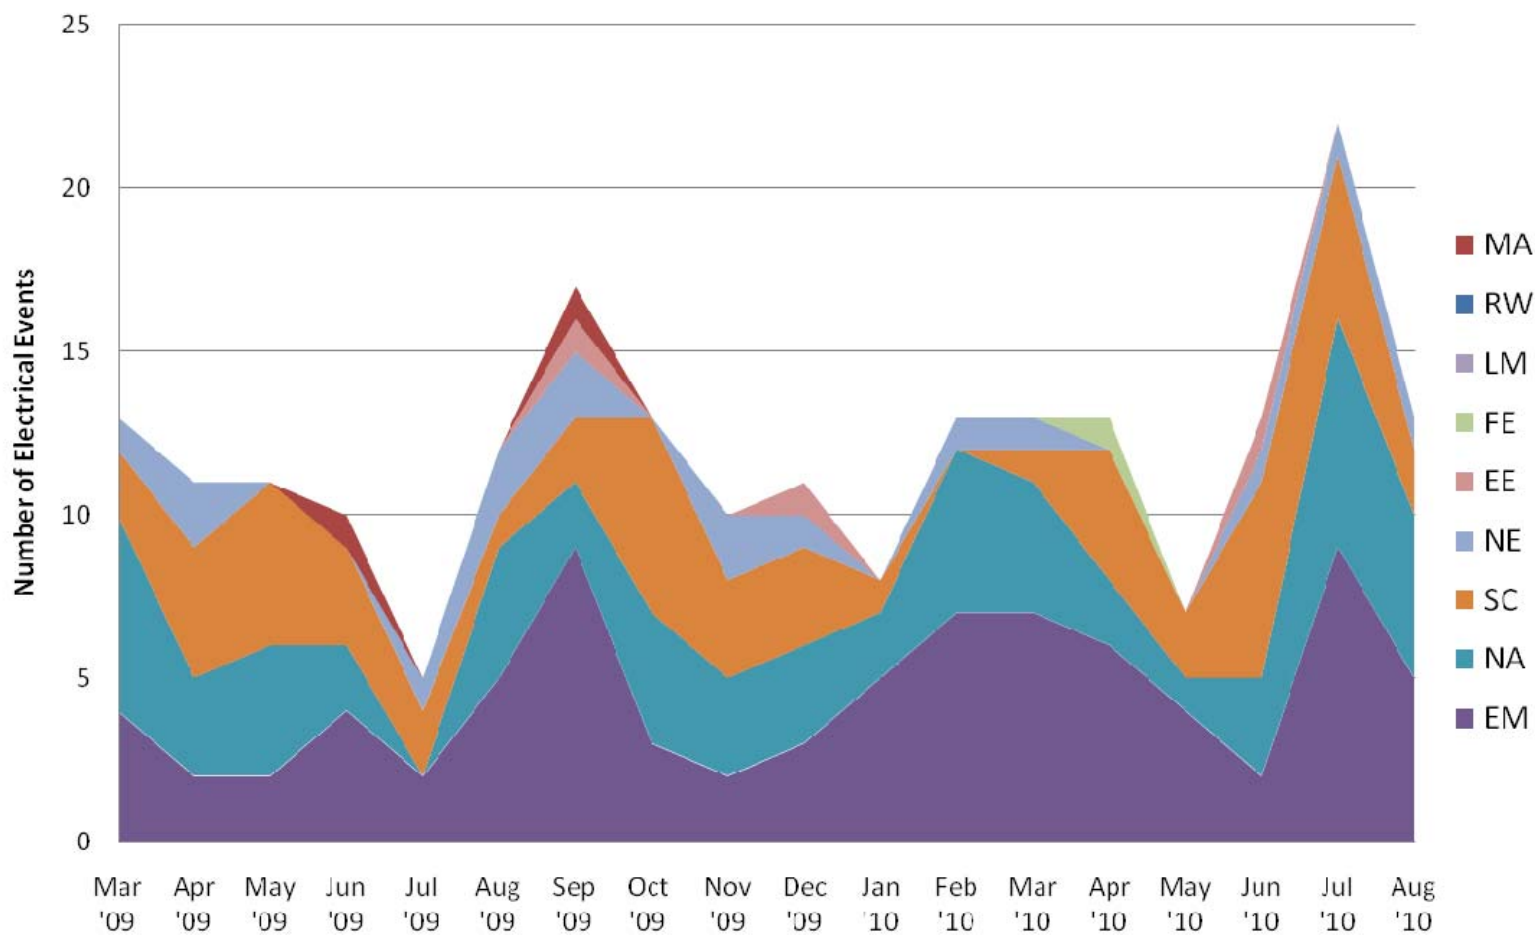
# Electrical Events by Month and Secretarial Office

(Rolling 18-Month Chart)

EE - Energy Efficiency and Renewable Energy, EM - Environmental Management, FE - Fossil Energy, LM - Legacy Management, MA - Management, NA - National Nuclear Security Administration, NE - Nuclear Energy, RW - Civilian Radioactive Waste Management, SC - Science
