December 2010

Electrical Safety Occurrences

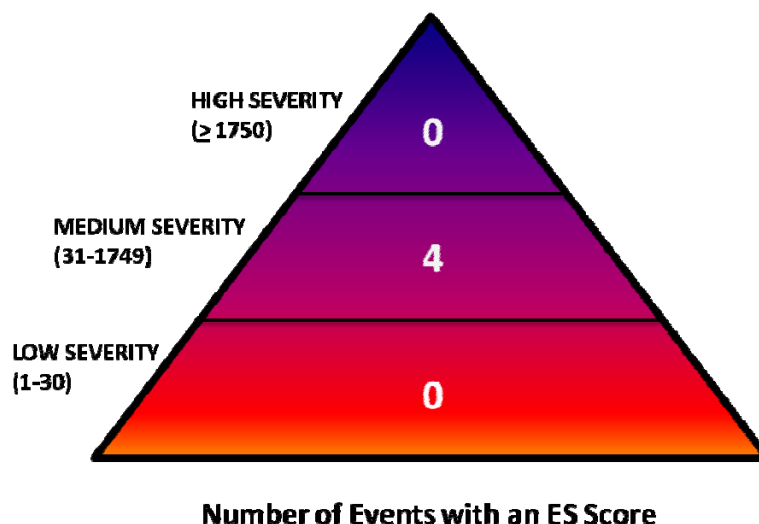
Four of the electrical events were determined to have no Electrical Severity (ES) score. The other four events were distributed as shown below, with the highest ES score being 550.

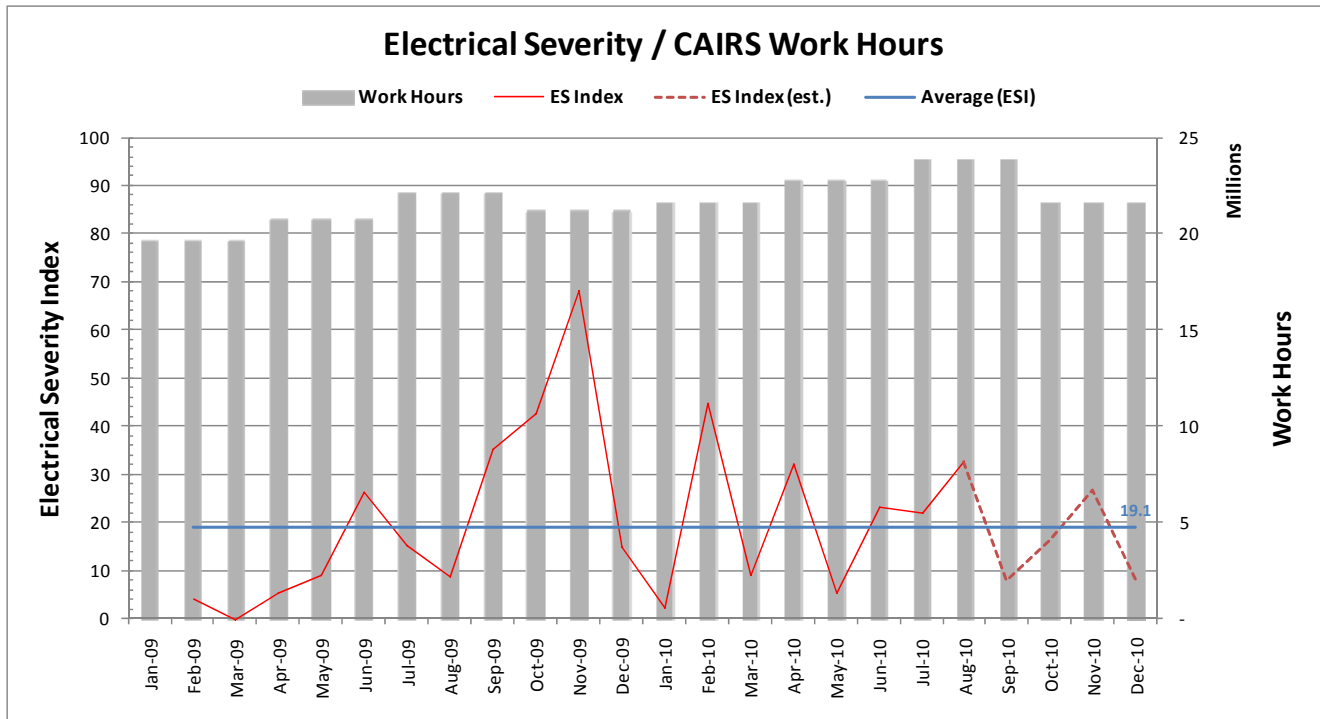
The following chart shows a calculated Electrical Severity Index (ESI) for the DOE complex.

Note: An estimated ESI is calculated until accurate CAIRS man-hours are available. The chart will be updated monthly.

Category	November	December	Δ
Total Occurrences	11	8	-3
Total Electrical Severity	2,870	890	-1500
Estimated Work Hours	21,581,355* (22,449,113)	21,578,874	-2,481
ES Index	26.60* (25.57)	8.25	-18.35
Average ESI	19.4	19.1	-0.3

$$\text{Electrical Severity Index} = (\sum \text{Electrical Severity} / \sum \text{Work Hours}) 200,000$$

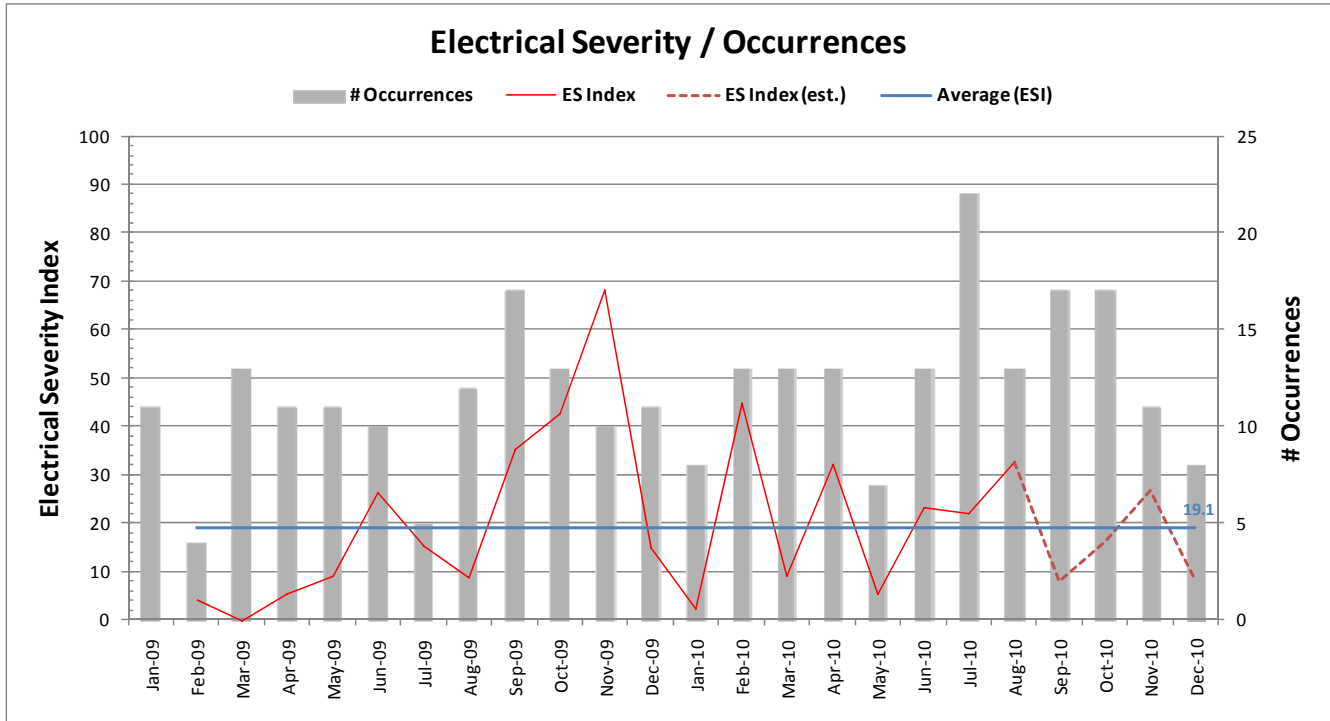
The following chart shows ESI with the number of Occurrences instead of work hours.

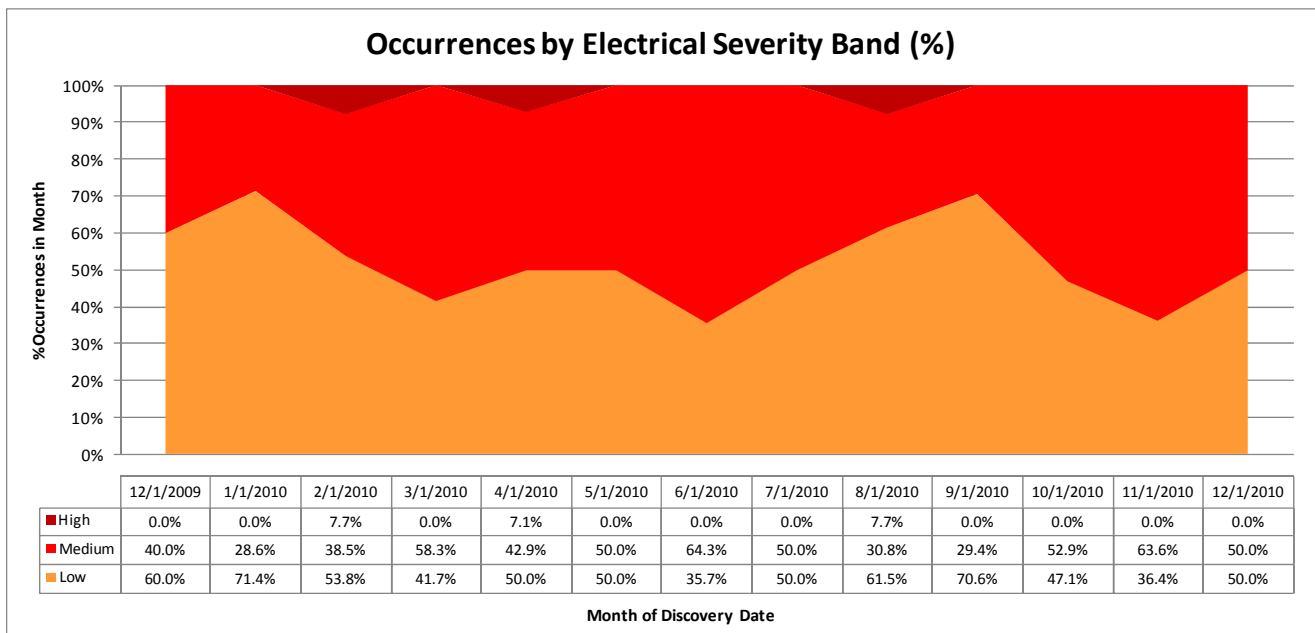
For the interval December 2009 through December 2010 (current month and the past 12), the two charts below summarize occurrences by severity band and month of discovery date:

- By percentage of total occurrences in month
- By number of occurrences in month

The key observation is that Medium severity occurrences as a group increased in CY2010.

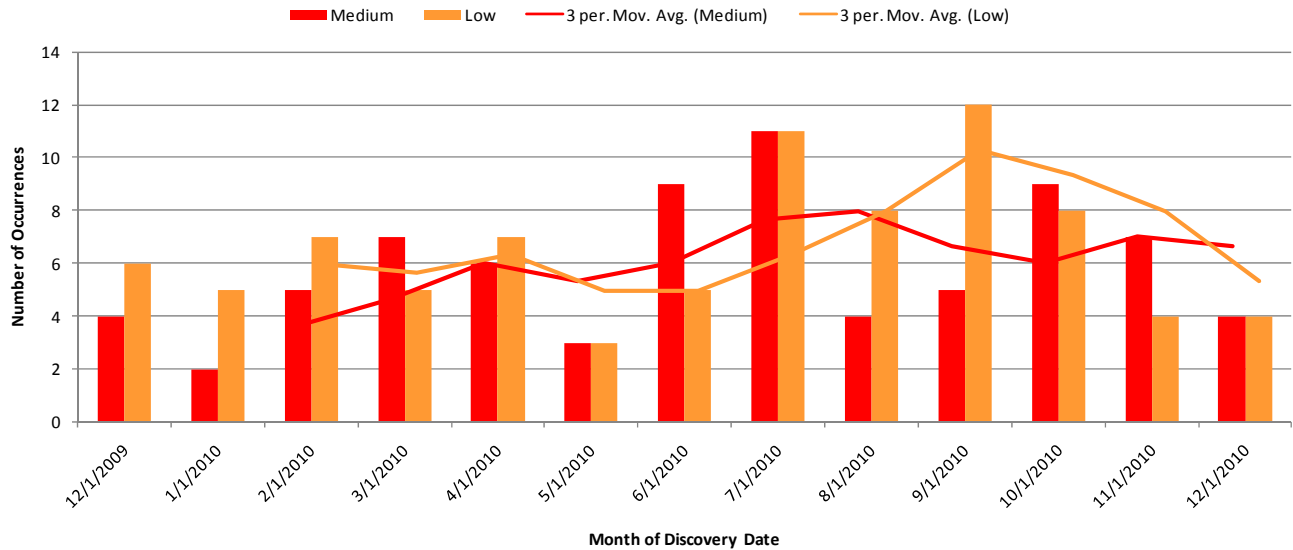
Medium and Low Severity with Trend

The following chart focuses on the Medium and Low severity data series for December 2009 through December 2010. Trend lines are included for each, using a 3-month moving average.

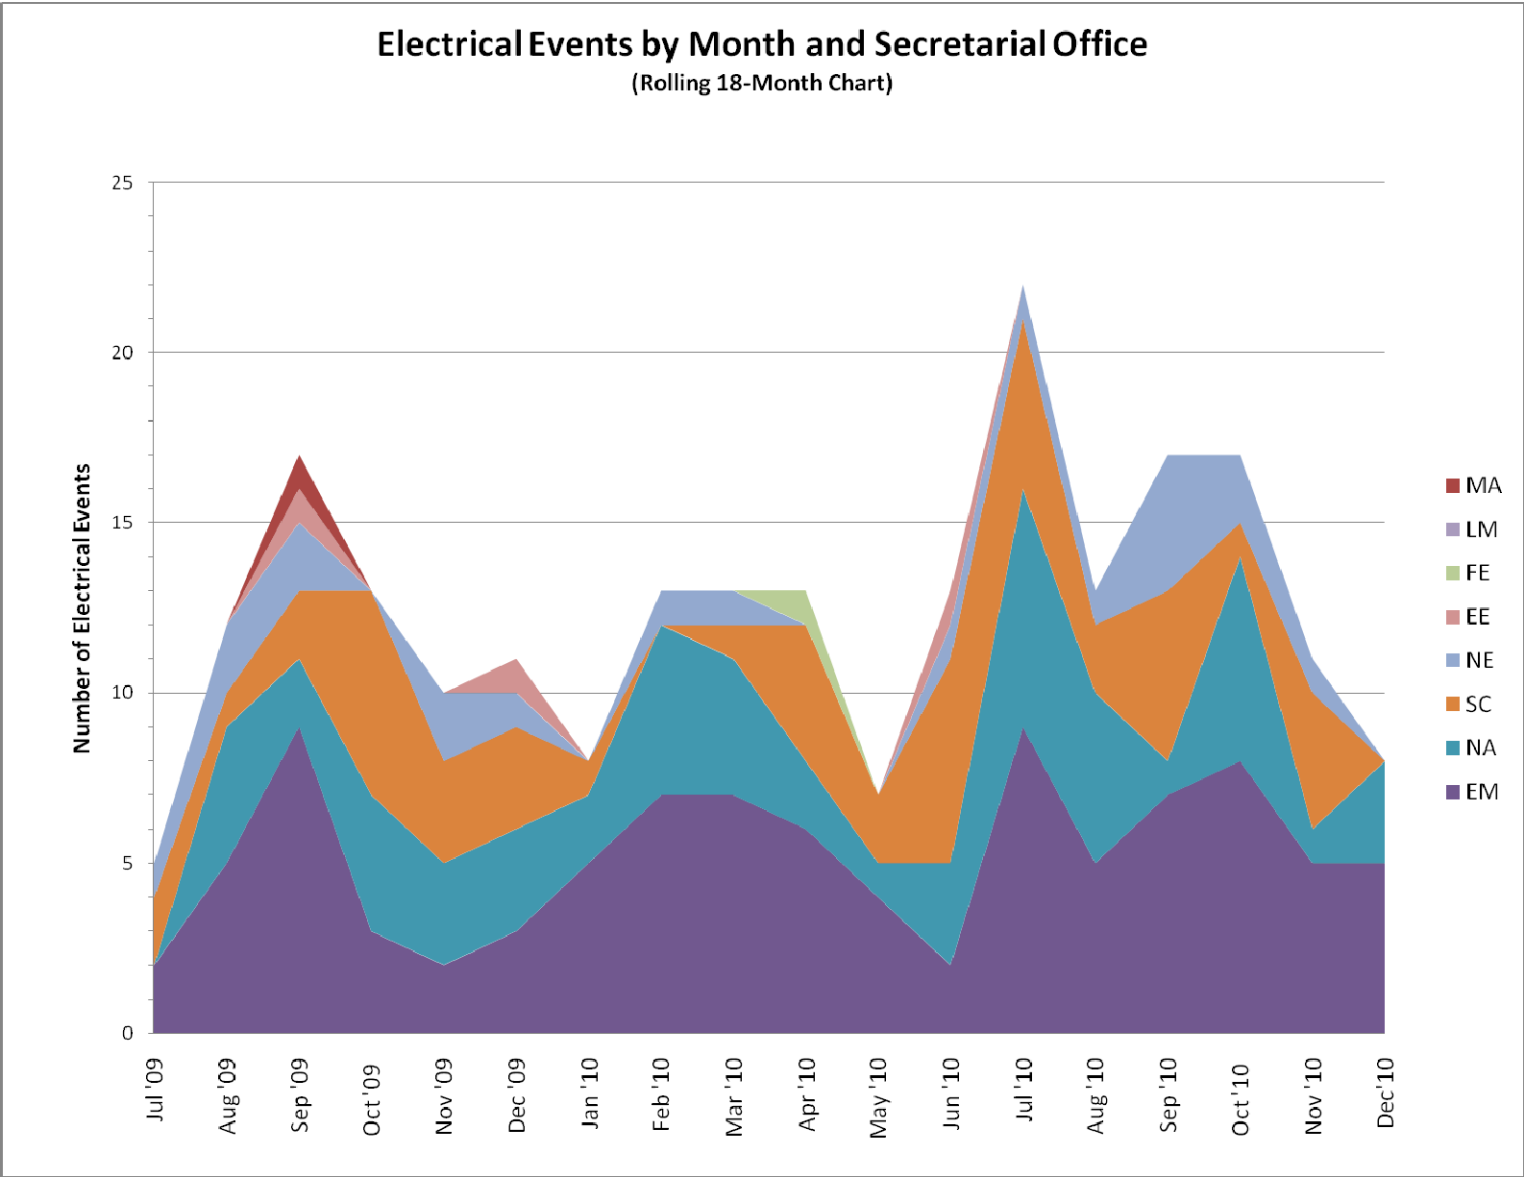
Electrical Events by Month and Secretarial Office

(Rolling 18-Month Chart)

EE - Energy Efficiency and Renewable Energy, EM - Environmental Management, FE - Fossil Energy, LM - Legacy Management, MA - Management, NA - National Nuclear Security Administration, NE - Nuclear Energy, SC - Science
