January 2011

Electrical Safety Occurrences

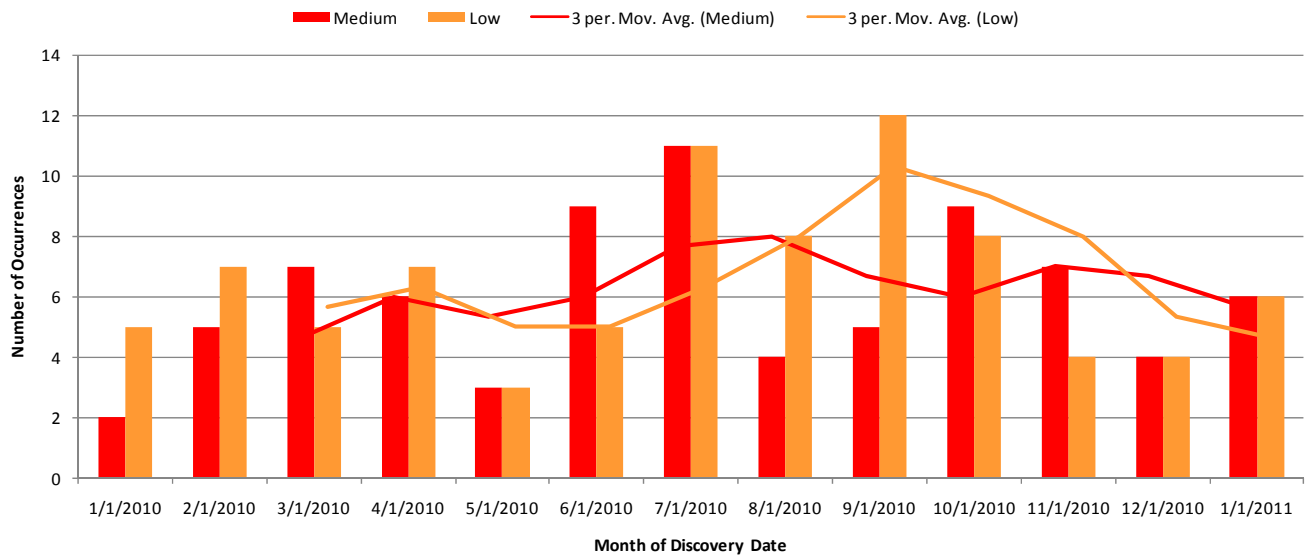
Medium and Low Severity with Trend

The following chart focuses on the Medium and Low severity data series for January 2010 through January 2011. Trend lines are included for each, using a 3-month moving average.
