# Electrical Safety Report

July 2010

## Electrical Safety Occurrences

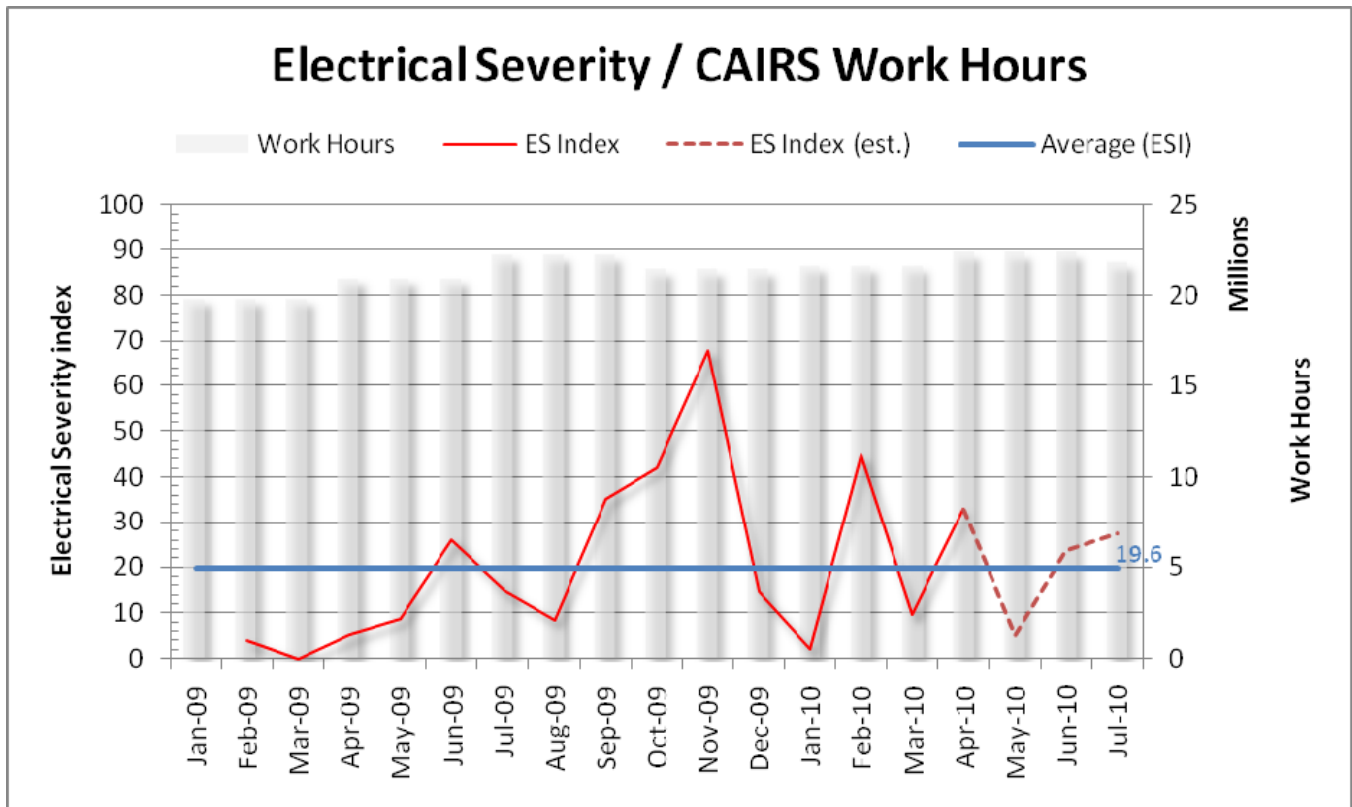
The following chart shows a calculated Electrical Severity Index (ESI) for the DOE complex.

Note: An estimated ESI is calculated until accurate CAIRS man-hours are available. The chart will be updated monthly.

Category	June	July	Δ
<b>Total Electrical Severity</b>	2,630	2,990	+360
<b>Estimated Work Hours</b>	22,305,596	21,737,519	-568,077
<b>ES Index</b>	23.58	27.51	+3.93
<b>Average ESI</b>	19.2	19.6	+0.4

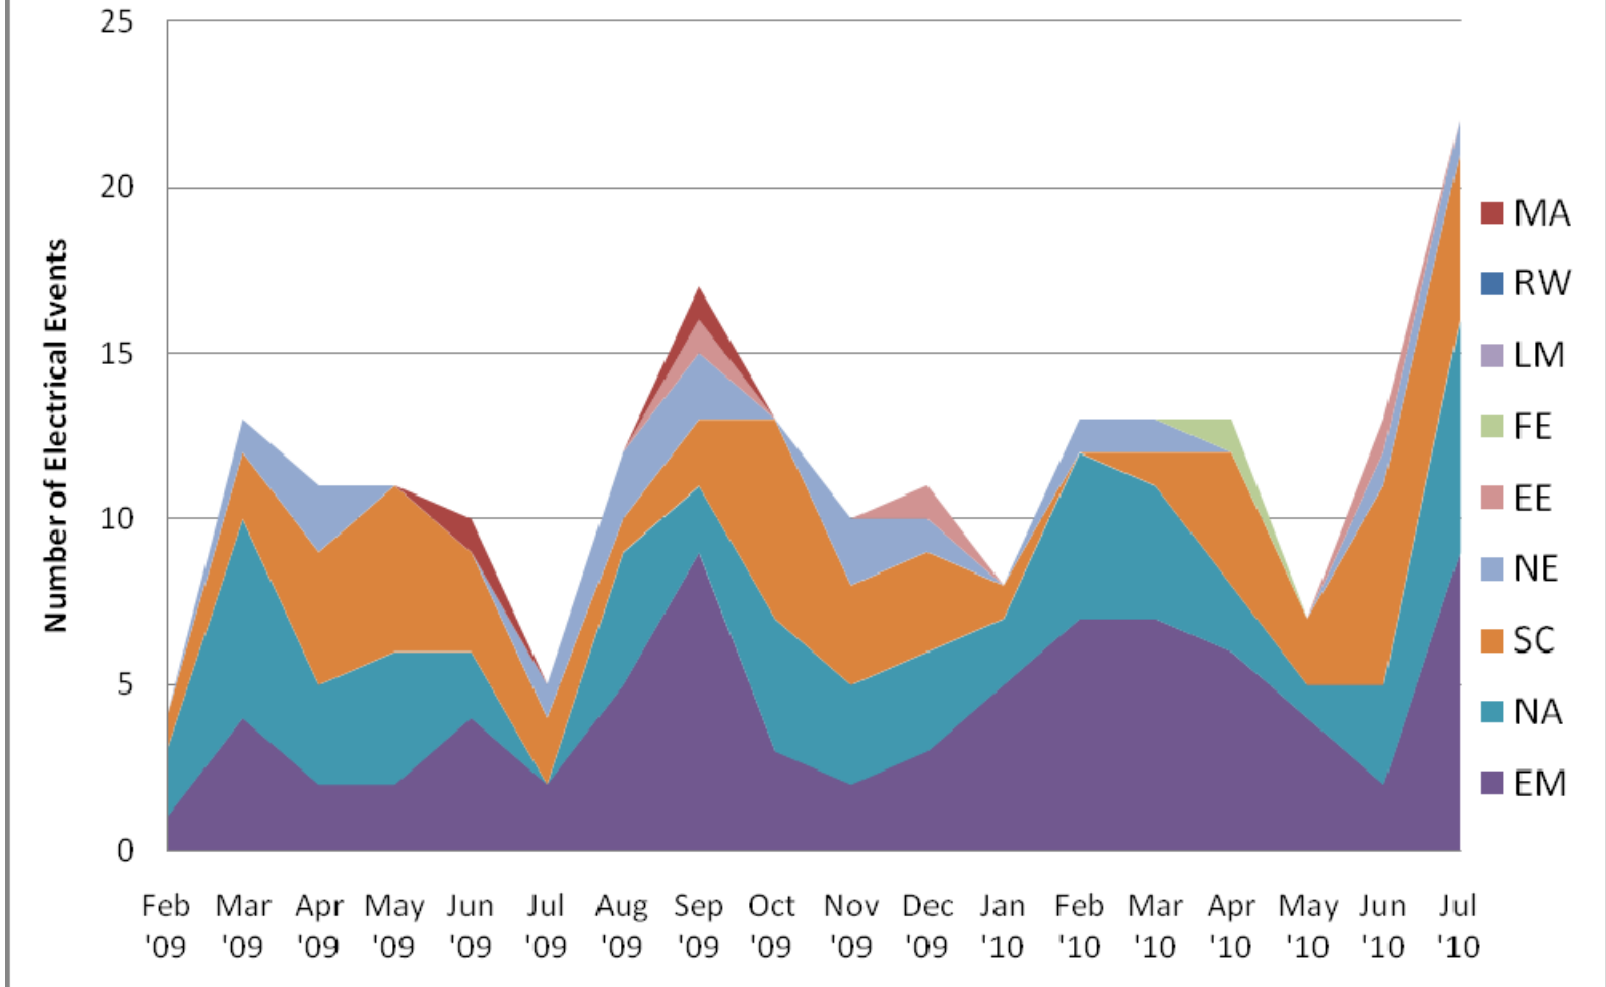
# Electrical Events by Month and Secretarial Office

(Rolling 18-Month Chart)

EE - Energy Efficiency and Renewable Energy, EM - Environmental Management, FE - Fossil Energy, LM - Legacy Management, MA - Management, NA - National Nuclear Security Administration, NE - Nuclear Energy, RW - Civilian Radioactive Waste Management, SC - Science
