June 2010 Electrical Safety Occurrences

Electrical Safety Occurrences – June 2010

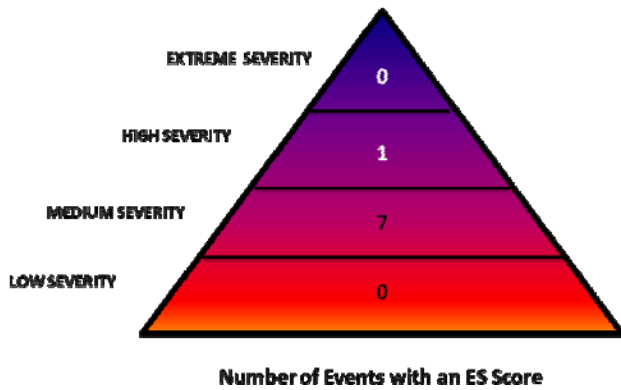
Please continue to evaluate electrical events using the Electrical Severity Measurement Tool. During the month of June, five of the thirteen electrical events were determined to have no Electrical Severity (ES) score. The other eight events were distributed as shown below, with the highest ES score being 1600.

Electrical Severity	Numerical Score
Low	1 to 30
Medium	31 to 330
High	331 to 3300
Extreme	>3300

ES Scores: Extreme is >3301, High is 331-3300, Medium is 31-330, and Low is 1-30

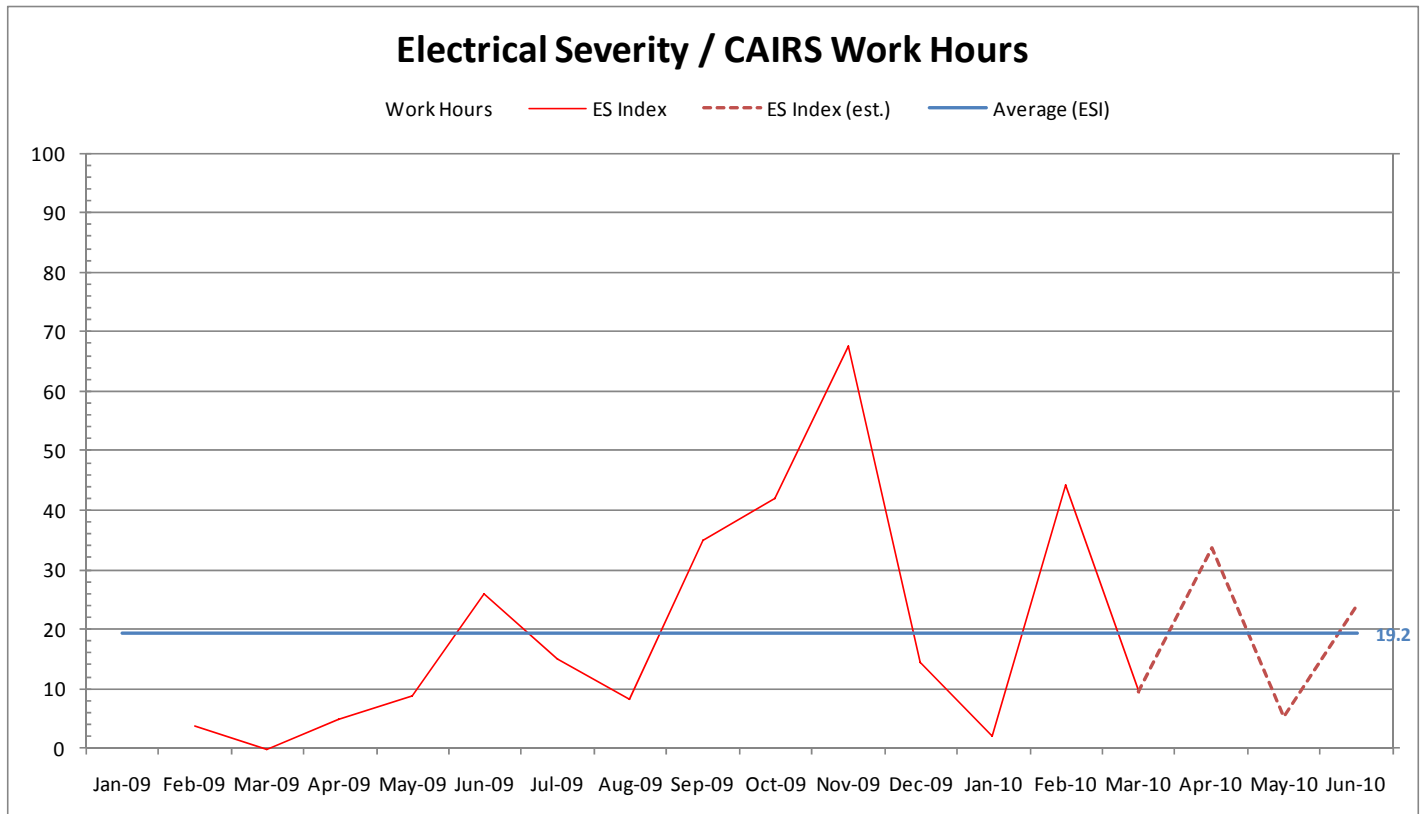
The following chart shows a calculated Electrical Severity Index (ESI) for the DOE complex. Since February 2009, the average ESI has been 19.2. As seen on the chart, the ESI has been moving in a favorable direction since November 2009.

Note: An estimated ESI is calculated until accurate CAIRS man-hours are available. The chart will be updated monthly.

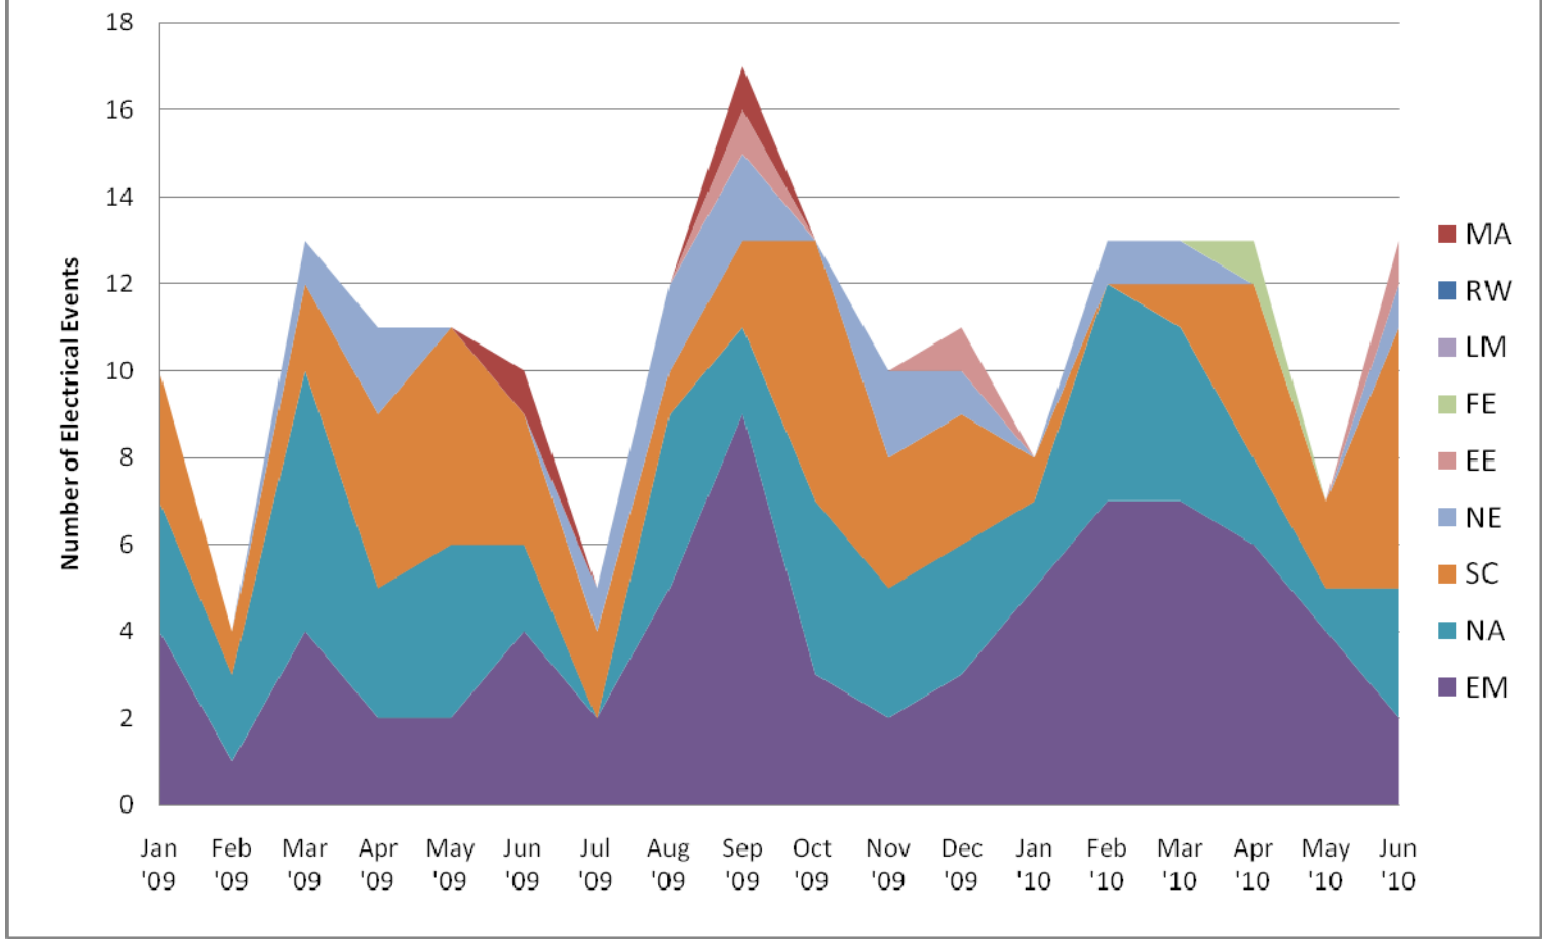
Electrical Events by Month and Secretarial Office

(Rolling 18-Month Chart)

EE - Energy Efficiency and Renewable Energy, EM - Environmental Management, FE - Fossil Energy, LM - Legacy Management, MA - Management, NA - National Nuclear Security Administration, NE - Nuclear Energy, RW - Civilian Radioactive Waste Management, SC - Science
