Office of Health, Safety and Security

Electrical Safety Report

March 2011

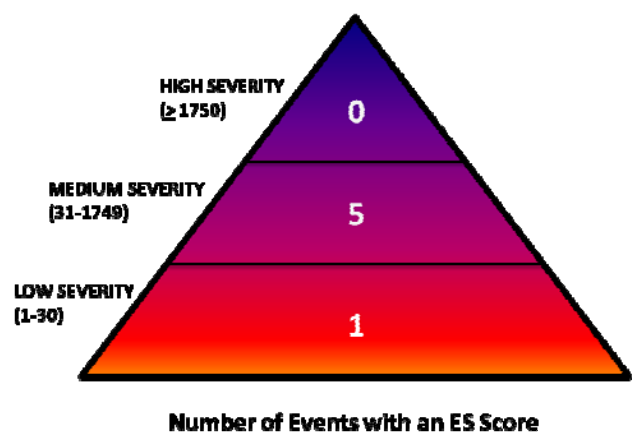
The electrical severity scores are calculated using Revision 2 of the Electrical Severity Measurement Tool, which was released October 20, 2010. Five of the electrical events this month did not have an Electrical Severity (ES) score. The other five events were distributed as shown in the triangle, with the highest ES score being 330. The actual score for each event is provided in the event tables.

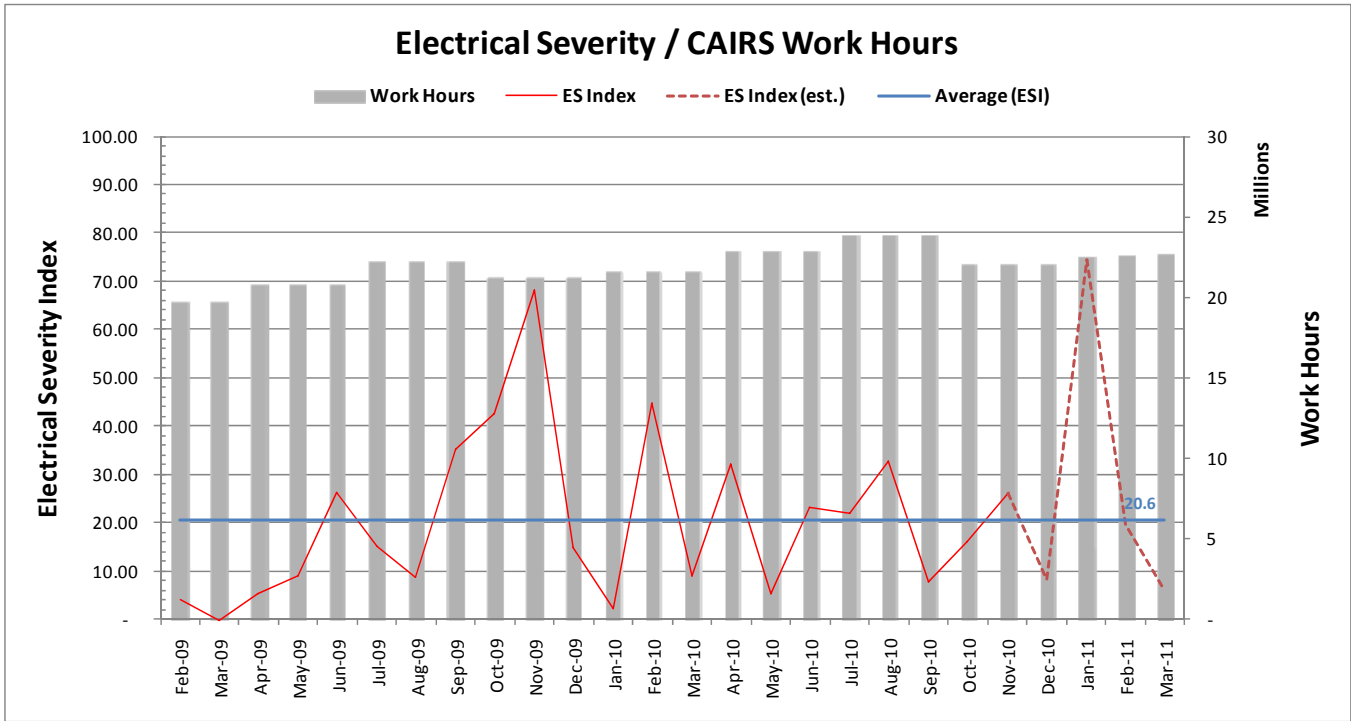
The following chart shows a calculated Electrical Severity Index (ESI) for the DOE complex.

Note: An estimated ESI is calculated until accurate CAIRS man-hours are available. The chart will be updated monthly.

$$\text{Electrical Severity Index} = (\sum \text{Electrical Severity} / \sum \text{Work Hours}) 200,000$$

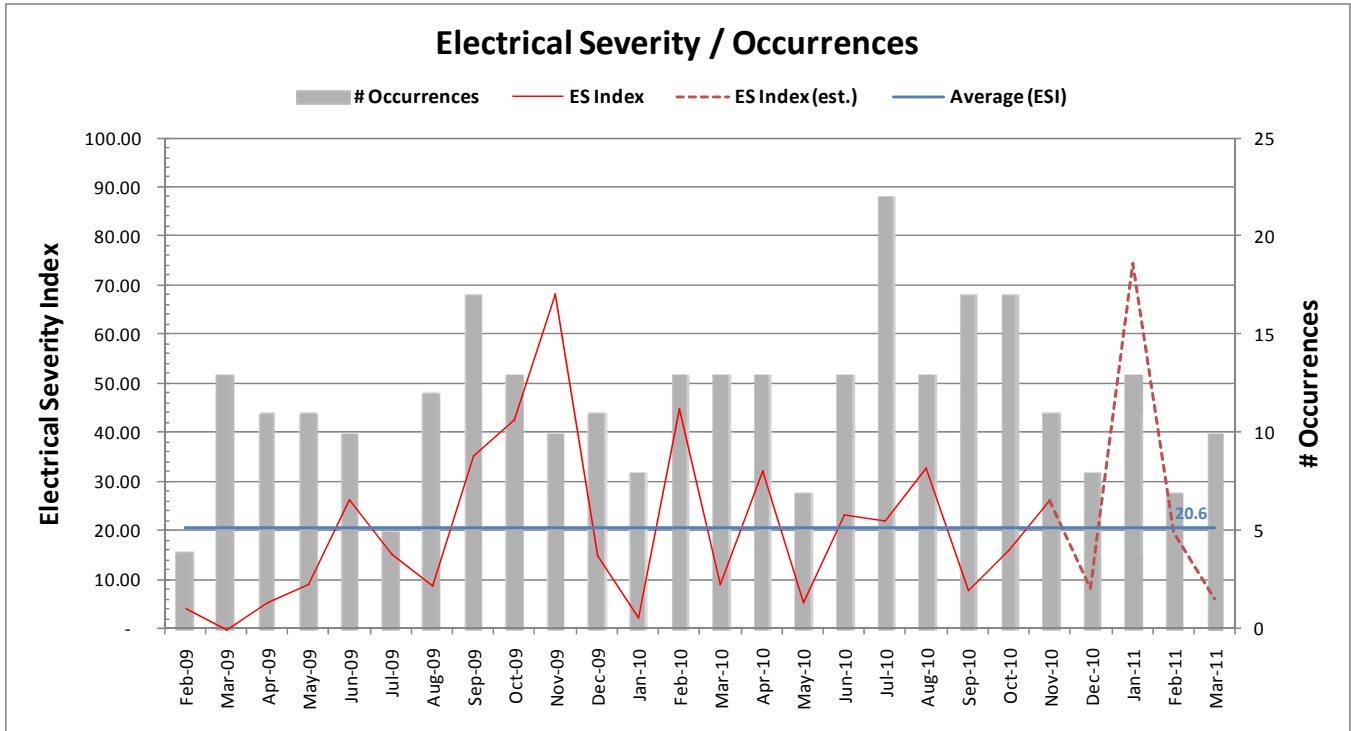
The following chart shows ESI with the number of Occurrences instead of work hours.

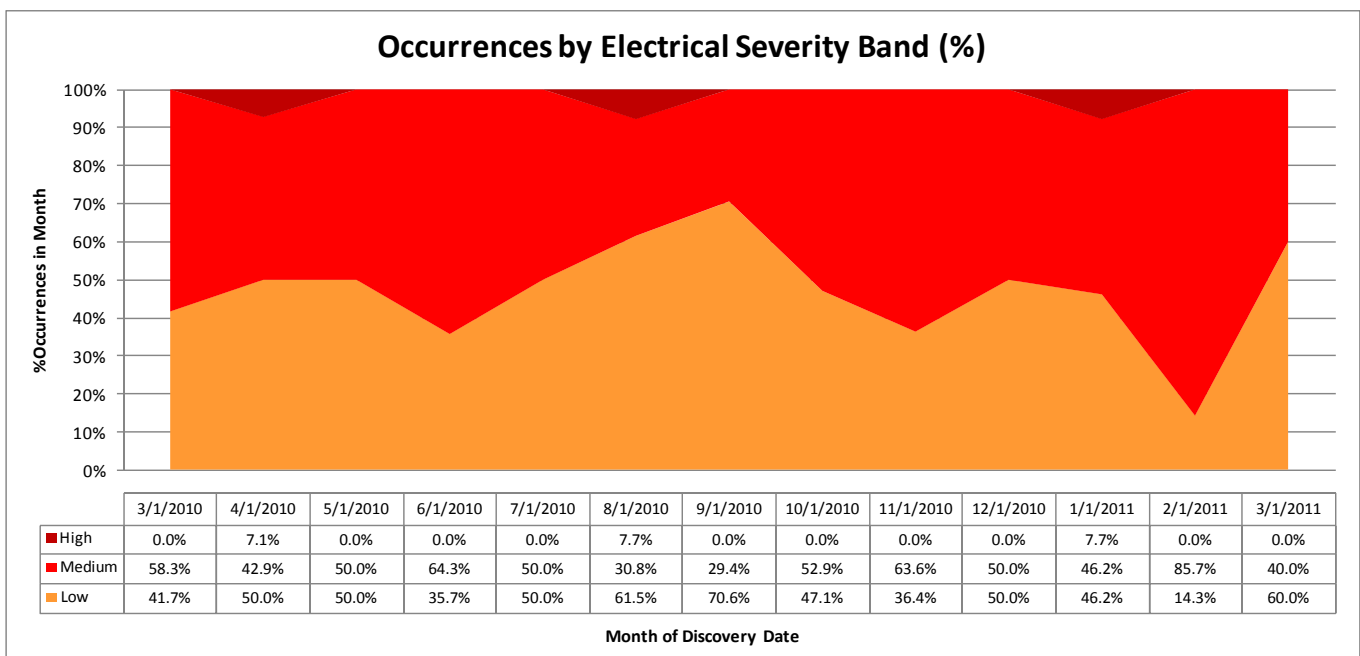
For the interval March 2010 through March 2011 (current month and the past 12), the two charts below summarize occurrences by severity band and month of discovery date:

- By percentage of total occurrences in month
- By number of occurrences in month

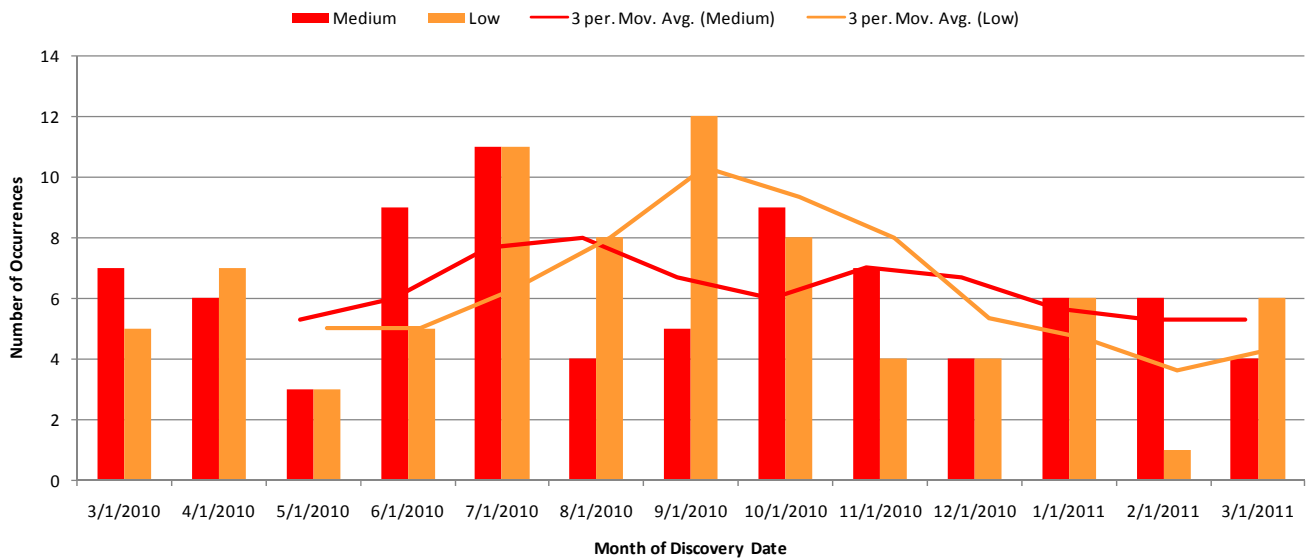
Medium and Low Severity with Trend

The following chart focuses on the Medium and Low severity data series for March 2010 through March 2011. Trend lines are included for each, using a 3-month moving average.

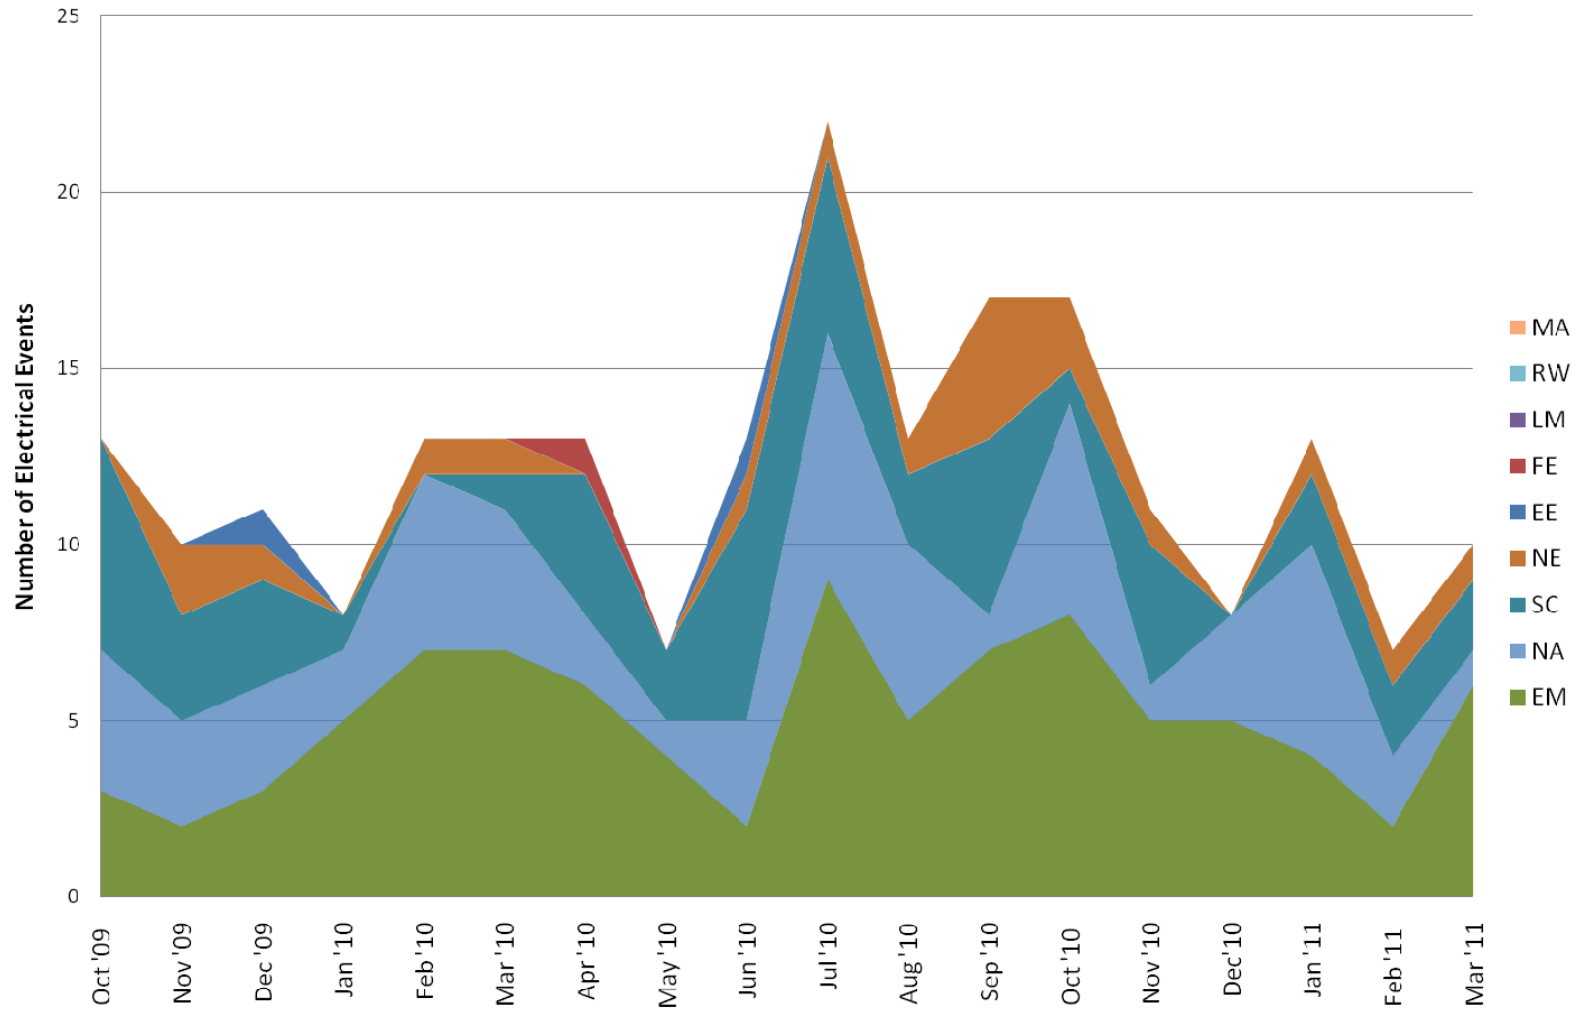
Electrical Events by Month and Secretarial Office

(Rolling 18-month Chart)

EE - Energy Efficiency and Renewable Energy, EM - Environmental Management, FE - Fossil Energy, LM - Legacy Management, MA - Management, NA - National Nuclear Security Administration, NE - Nuclear Energy, SC - Science
