Office of Health, Safety and Security

# Monthly Analysis of Electrical Safety

May 2011

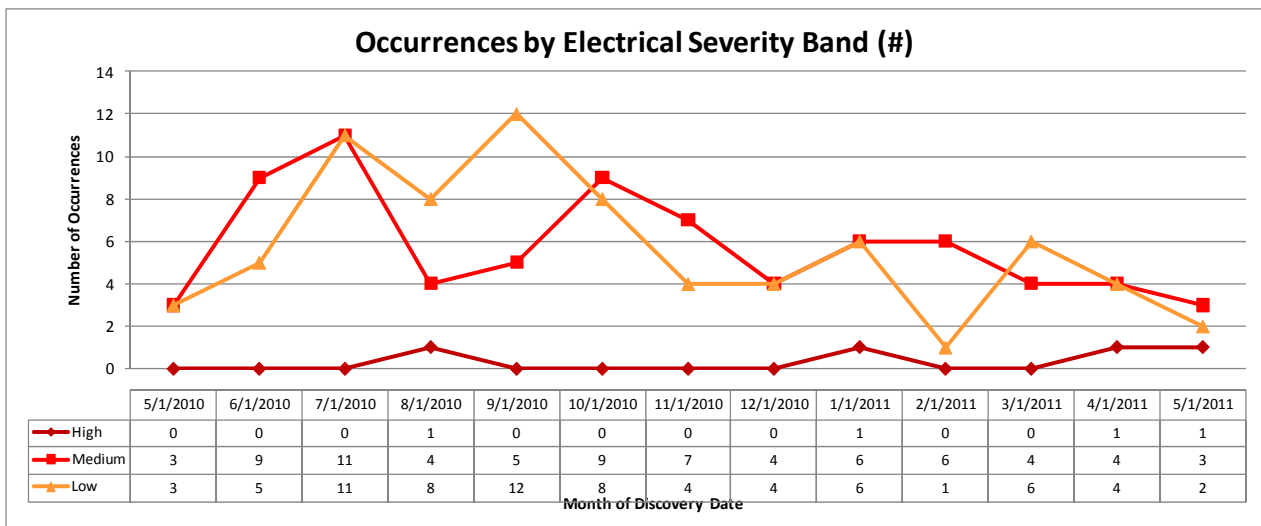
For the interval May 2010 through May 2011 (current month and the past 12), the next two charts summarize occurrences by severity band and month of discovery date:

- By percentage of total occurrences in month
- By number of occurrences in month

What we can see from the previous two charts is an increase in the number of events with High electrical severity scores and a decrease in the number of events with Low electrical severity scores while the number of occurrences with Medium scores remained almost unchanged.
