November 2010

Electrical Safety Occurrences

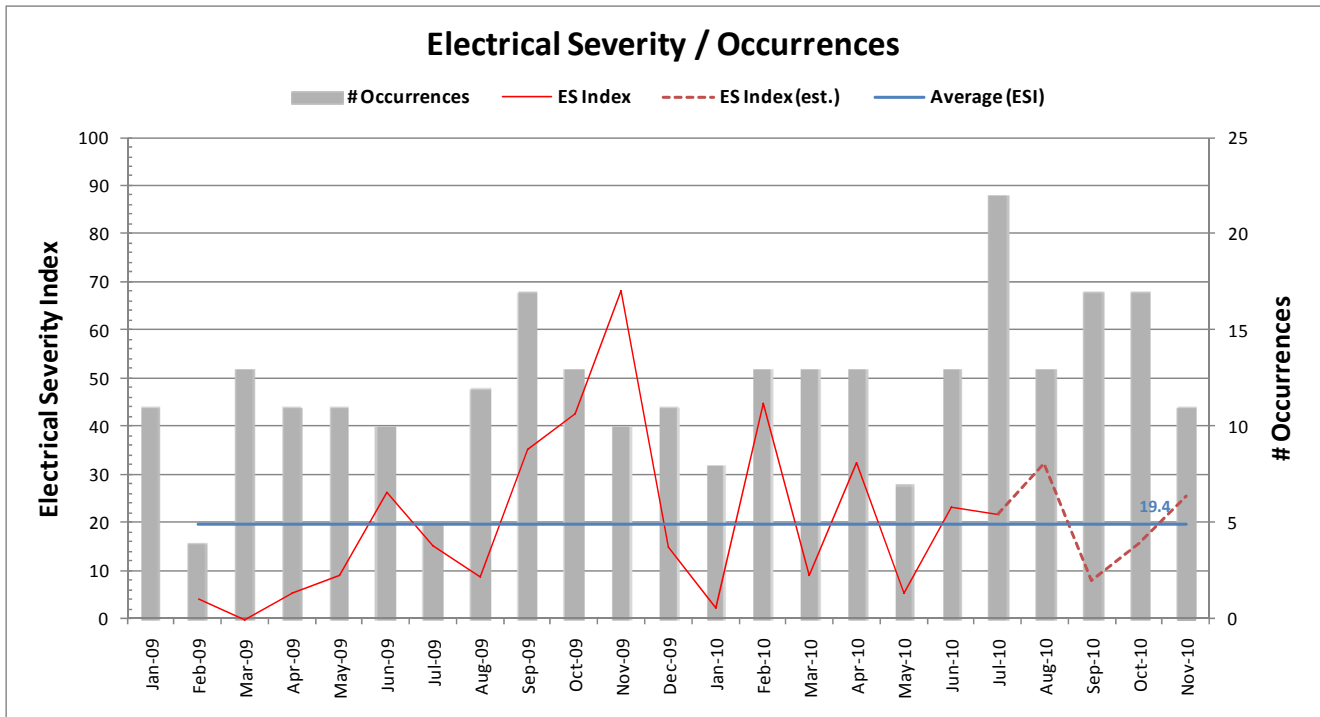
The following chart shows ESI with the number of Occurrences instead of work hours.

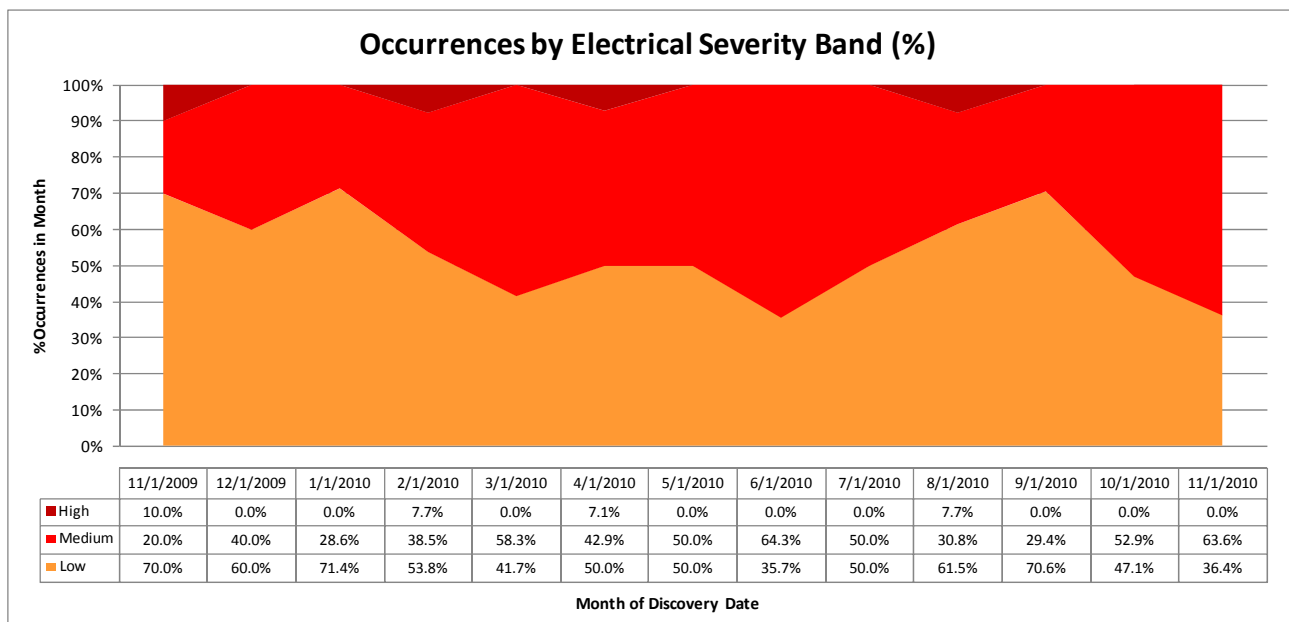
Summary of Occurrences by Severity Band

For the interval November 2009 through November 2010 (current month and the past 12), the two charts below summarize occurrences by severity band and month of discovery date:

- By percentage of total occurrences in month
- By number of occurrences in month

The key observation is that Medium severity occurrences as a group are increasing in CY2010.

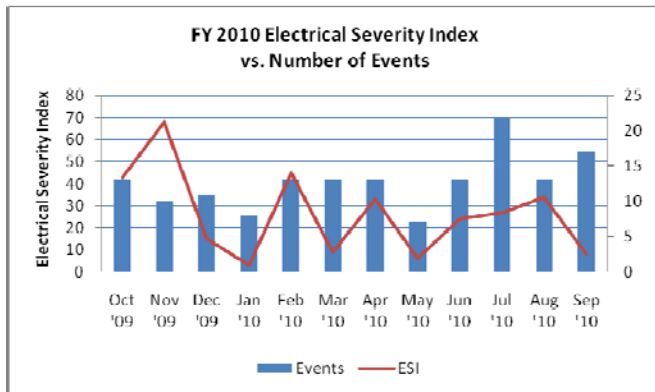
The trend in the number of electrical events increased during the fiscal year but the electrical severity index (ESI) decreased during the same period. The average ESI for FY 2010 was 26.3. The average ESI from June 2009 through November 2010 has decreased to 19.6. Although the trend in electrical shocks involving electrical workers decreased slight during the fiscal year, the trend for non-electrical workers continued to increase.
