October 2010

Electrical Safety Occurrences

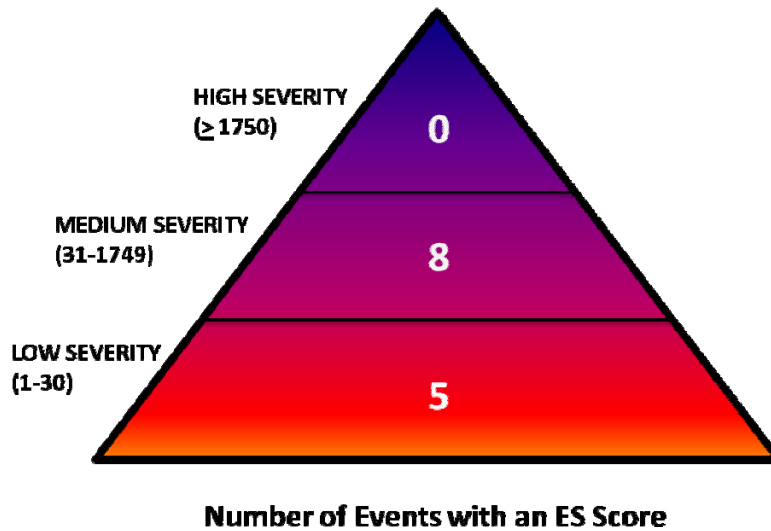
Four of the electrical events were determined to have no Electrical Severity (ES) score. The other thirteen events were distributed as shown below, with the highest ES score being 700.

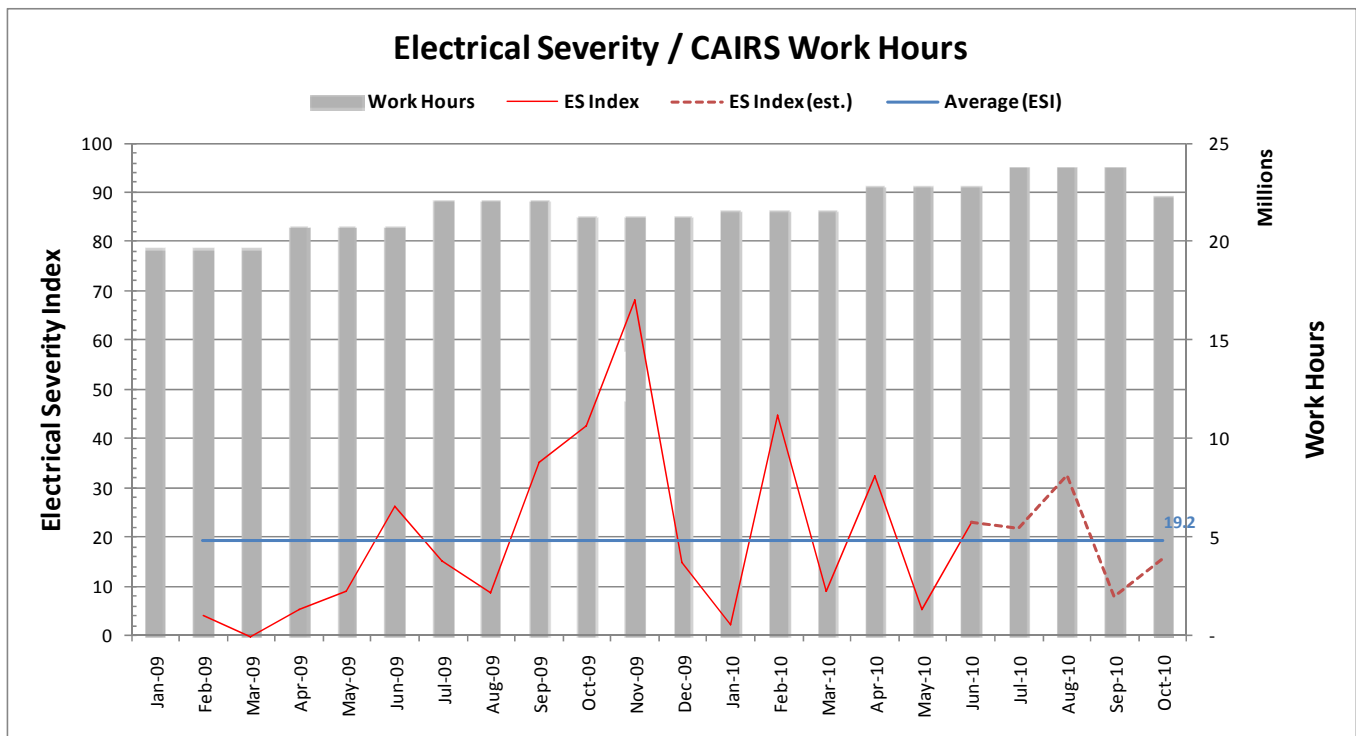
The following chart shows a calculated Electrical Severity Index (ESI) for the DOE complex.

Note: An estimated ESI is calculated until accurate CAIRS man-hours are available. The chart will be updated monthly.

Category	September	October	Δ
Total Occurrences	17	17	0
Total Electrical Severity	930	1,750	+820
Estimated Work Hours	23,741,160* (21,958,613)	22,311,575	-1,429,585
ES Index	7.83* (8.24)	15.69	+7.86
Average ESI	19.4	19.2	-0.2

$$\text{Electrical Severity Index} = (\sum \text{Electrical Severity} / \sum \text{Work Hours}) 200,000$$

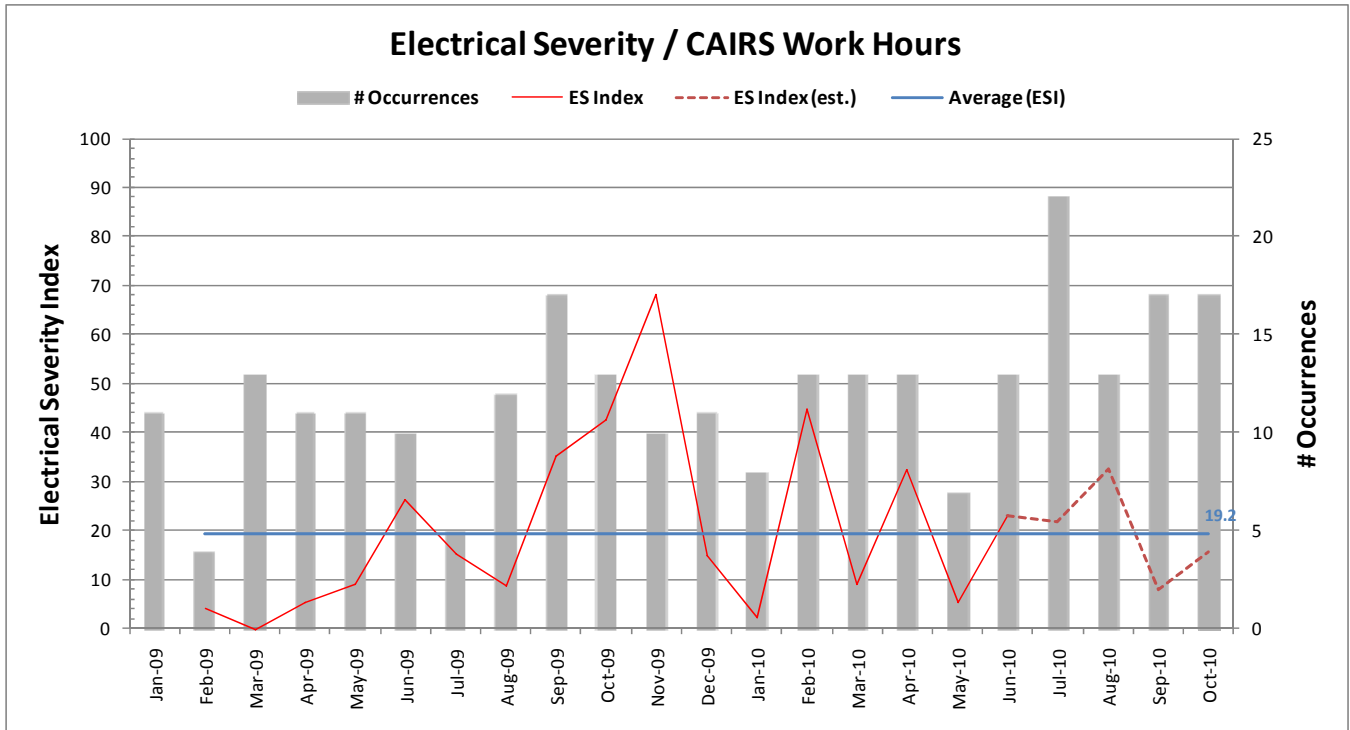
The following chart shows ESI with the number of Occurrences instead of work hours.

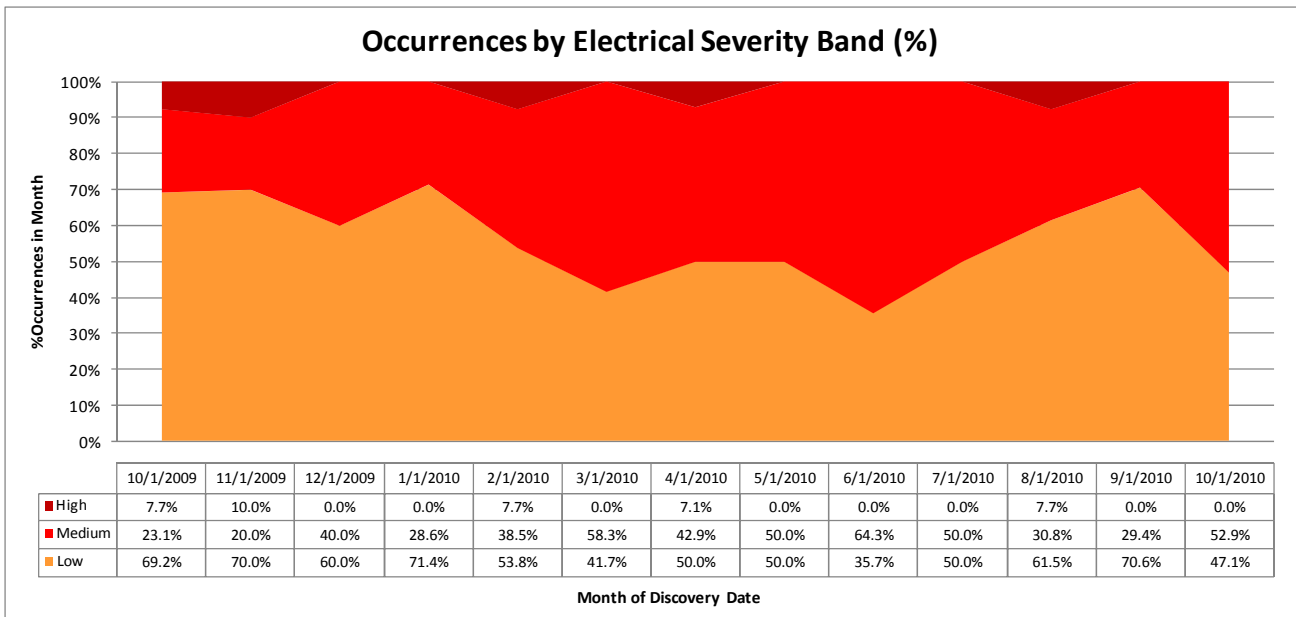
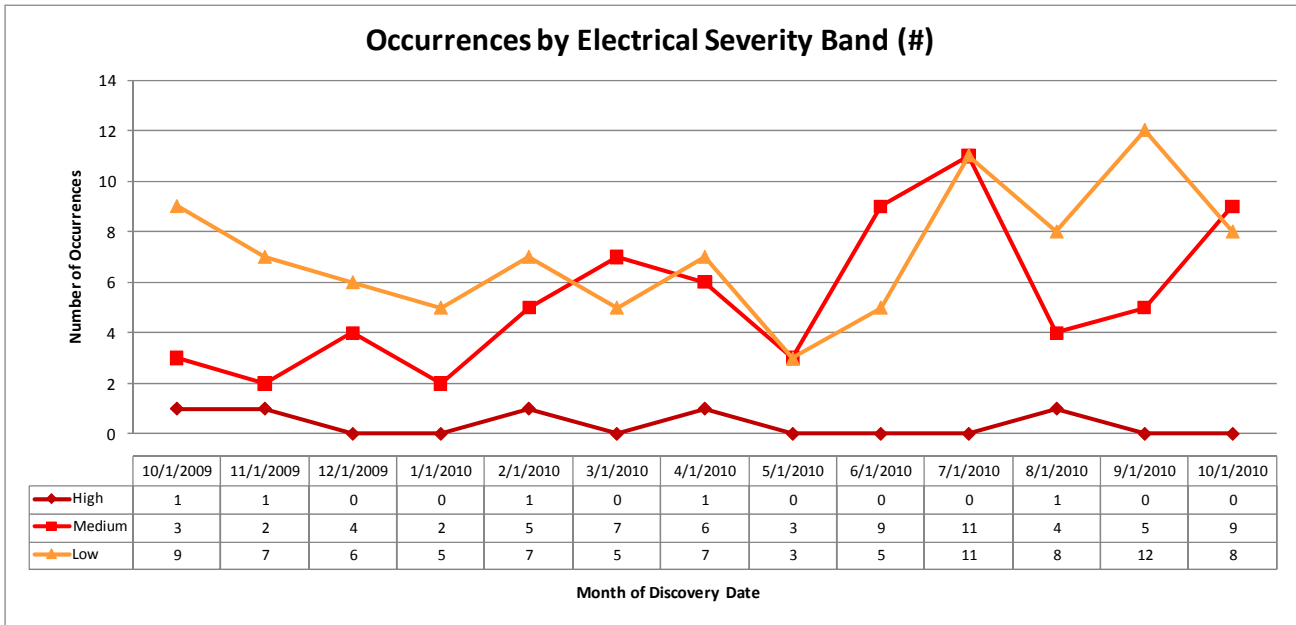
Summary of Occurrences by Severity Band

For the interval October 2009 through October 2010 (current month and the past 12), the two charts below summarize occurrences by severity band and month of discovery date:

- By percentage of total occurrences in month
- By number of occurrences in month

The key observation is that the Medium severity occurrences as a group are increasing in CY2010.

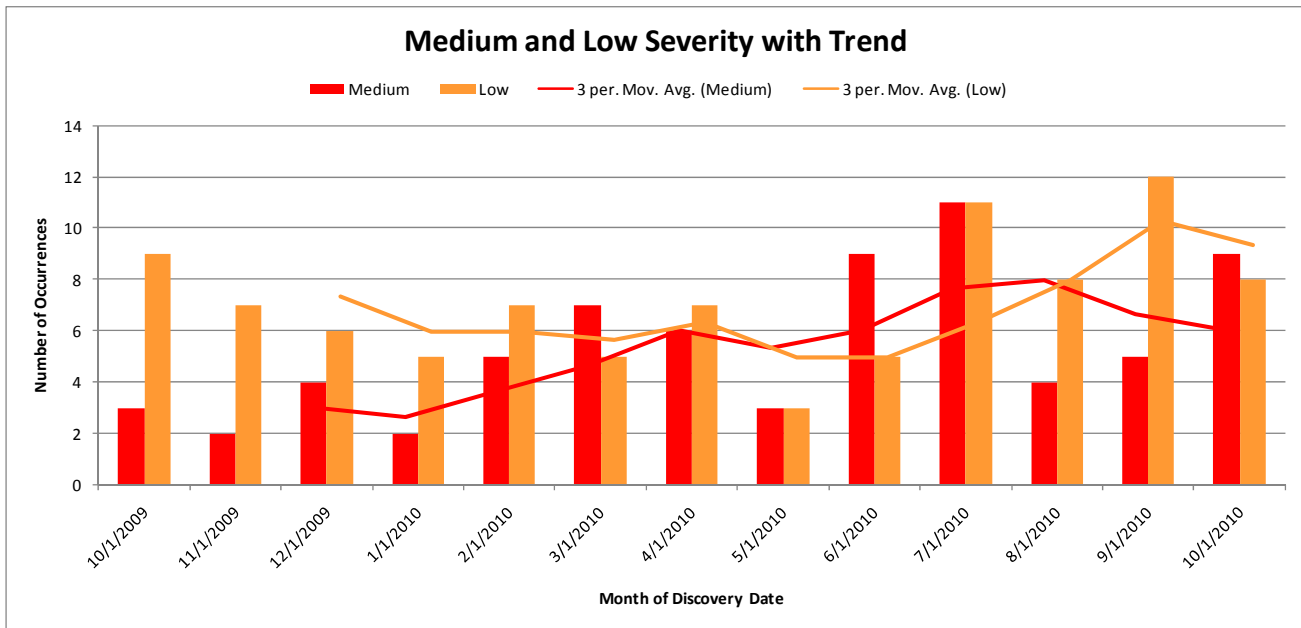
Medium and Low Severity with Trend

The following chart focuses on the Medium and Low severity data series for October 2009 through October 2010. Trend lines are included for each, using a 3-month moving average.

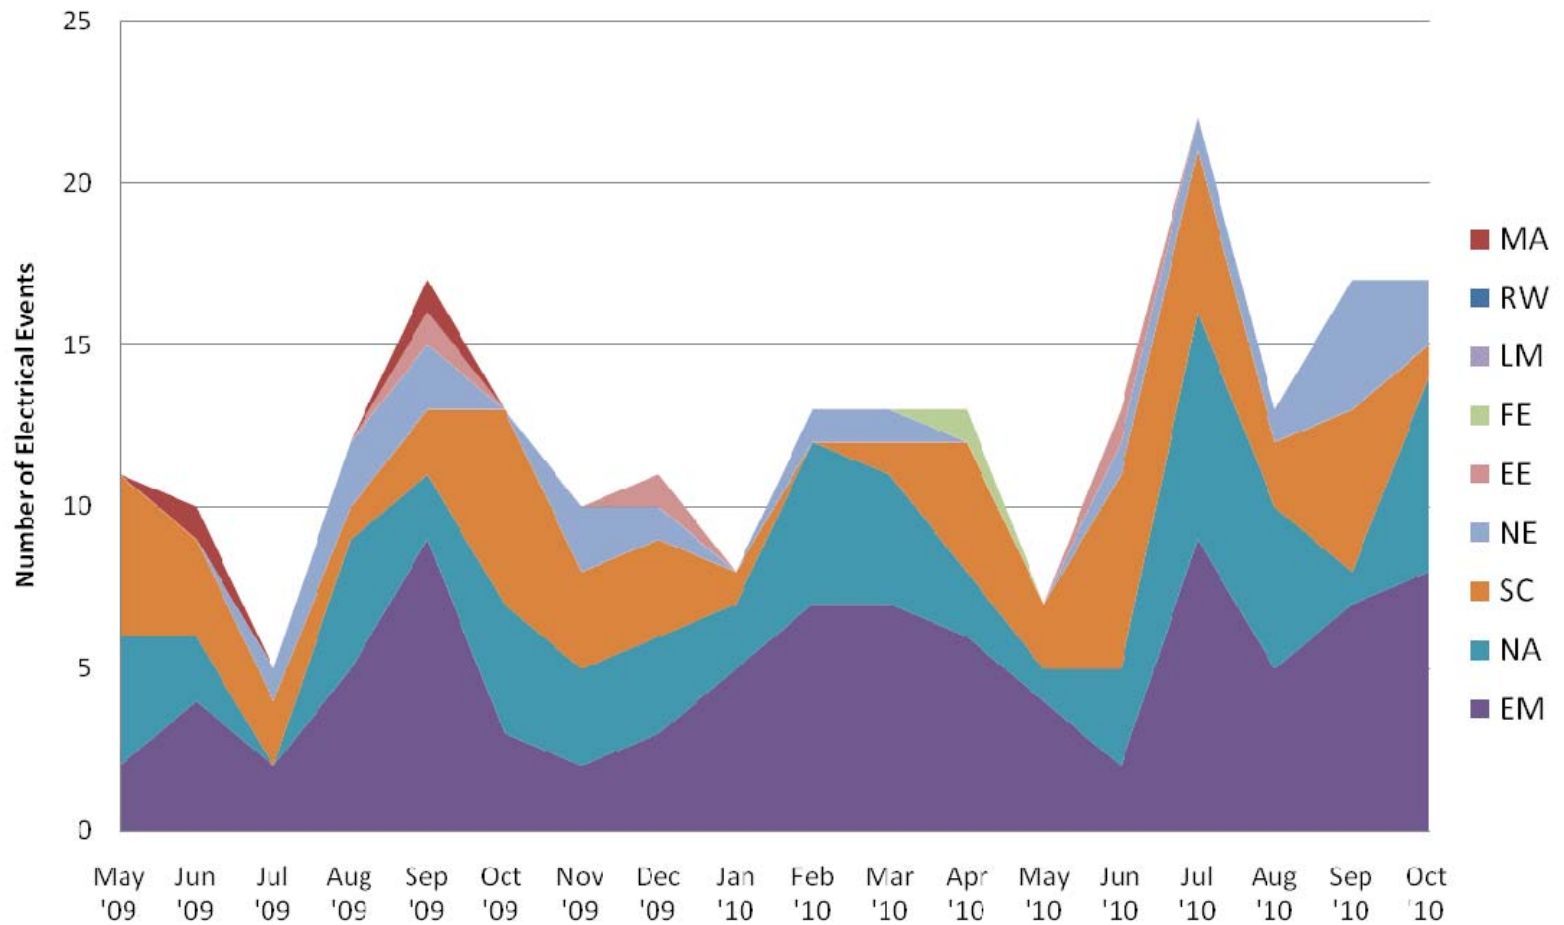
Electrical Events by Month and Secretarial Office

(Rolling 18-Month Chart)

EE - Energy Efficiency and Renewable Energy, EM - Environmental Management, FE - Fossil Energy, LM - Legacy Management, MA - Management, NA - National Nuclear Security Administration, NE - Nuclear Energy, RW - Civilian Radioactive Waste Management, SC - Science
