September 2010

Electrical Safety Occurrences

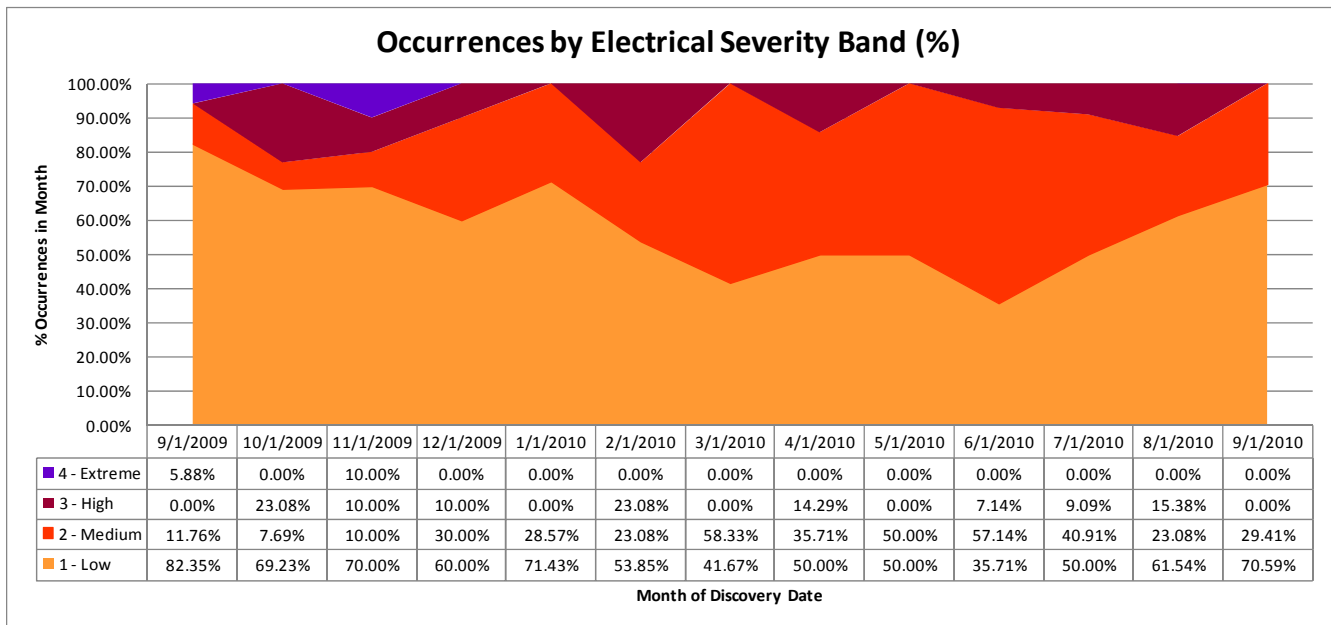
Summary of Occurrences by Severity Band

- By percentage of total occurrences in month
- By number of occurrences in month

The key observation is that Medium severity occurrences as a group are increasing in CY2010.

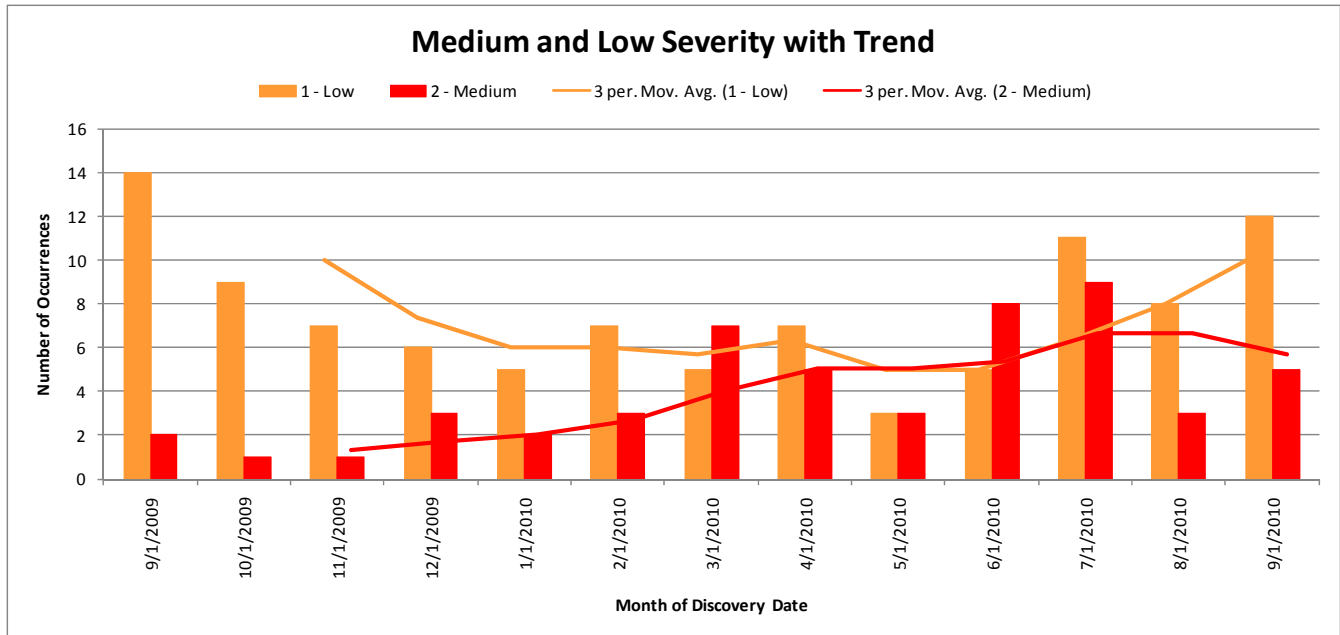
Medium and Low Severity with Trend

The following chart focuses on the Medium and Low severity data series for September 2009 through September 2010. Trend lines are included for each, using a 3-month moving average.
