August 2007 Electrical Safety Occurrences

Electrical Safety Occurrences – August 2007

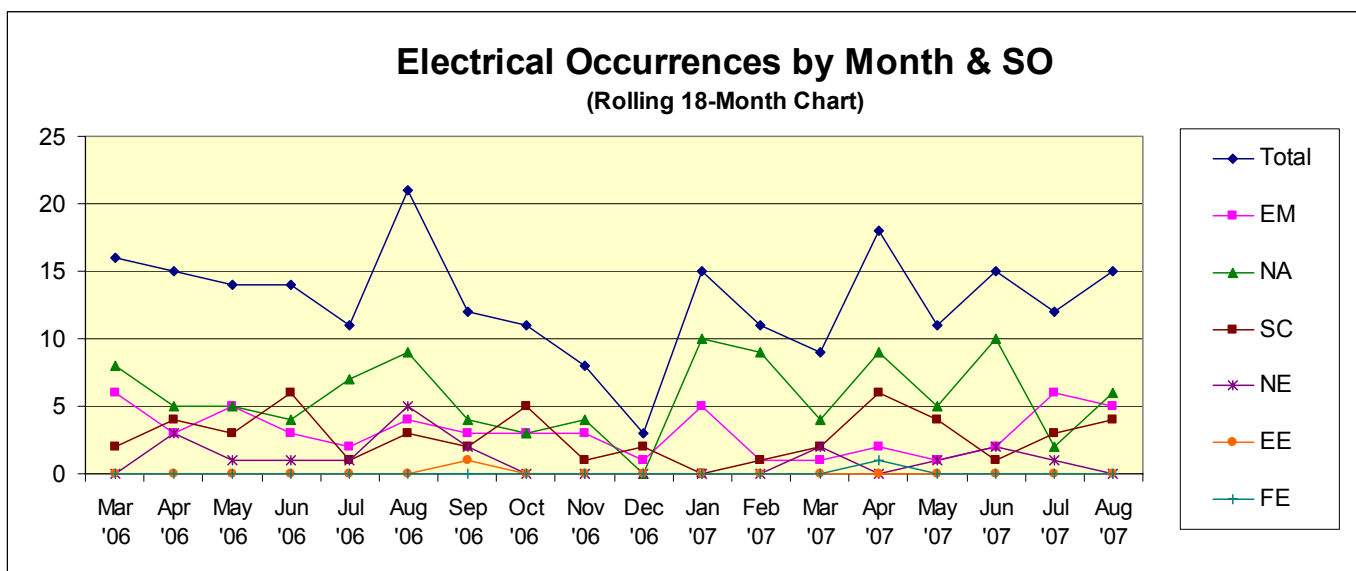
Period	Electrical Safety Occurrences	Shocks	Burns	Fatalities
Jan-07	15	1	0	0
Feb-07	11	3	0	0
Mar-07	9	1	0	0
Apr-07	18	3	1	0
May-07	11	1	0	0
Jun-07	15	5	0	0
Jul-07	12	3	1	0
Aug-07	15	5	0	0
2007 total	106 (avg. 13.3/month)	22	2	0
2006 total	166 (avg. 13.8/month)	26	3	0
2005 total	165 (avg. 13.8/month)	39	5	0
2004 total	149 (avg. 12.4/month)	25	3	1

The average rate of electrical safety occurrences in 2007 is now 13.3 per month, which remains less than the average rate of 13.8 per month experienced in 2006.
