December 2007 Electrical Safety Occurrences

Electrical Safety Occurrences – December 2007

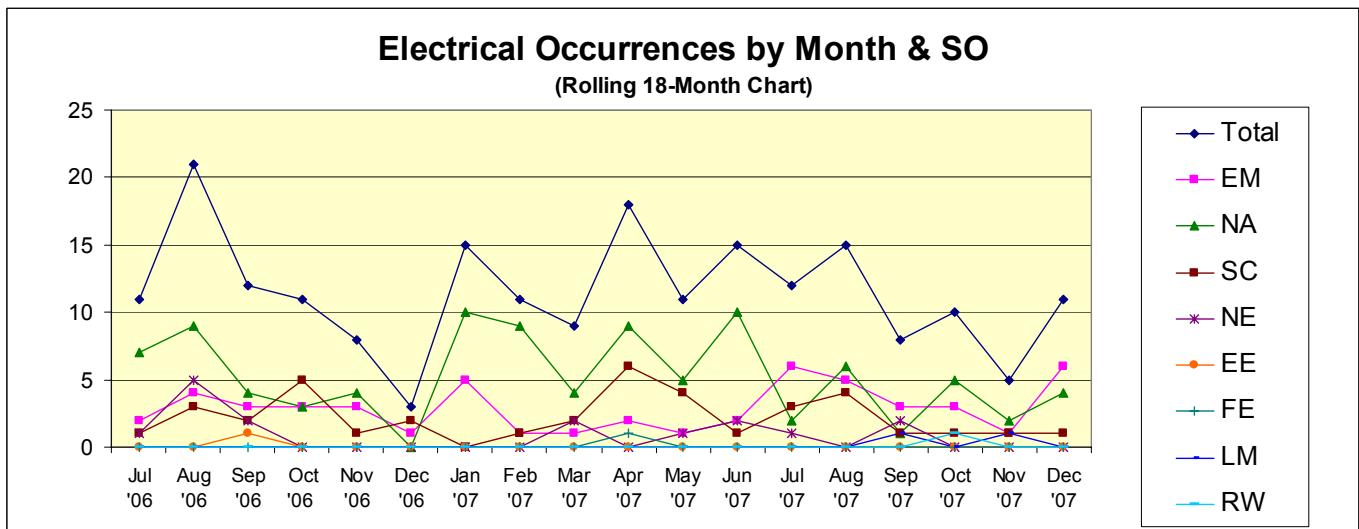
Below is the current summary of 2007 electrical safety occurrences:

The average rate of electrical safety occurrences in 2007 is now 11.7 per month, which remains less than the average rate of 13.8 per month experienced in 2006.
