April 2009 Electrical Safety Occurrences

There were 11 electrical safety occurrences for April 2009:

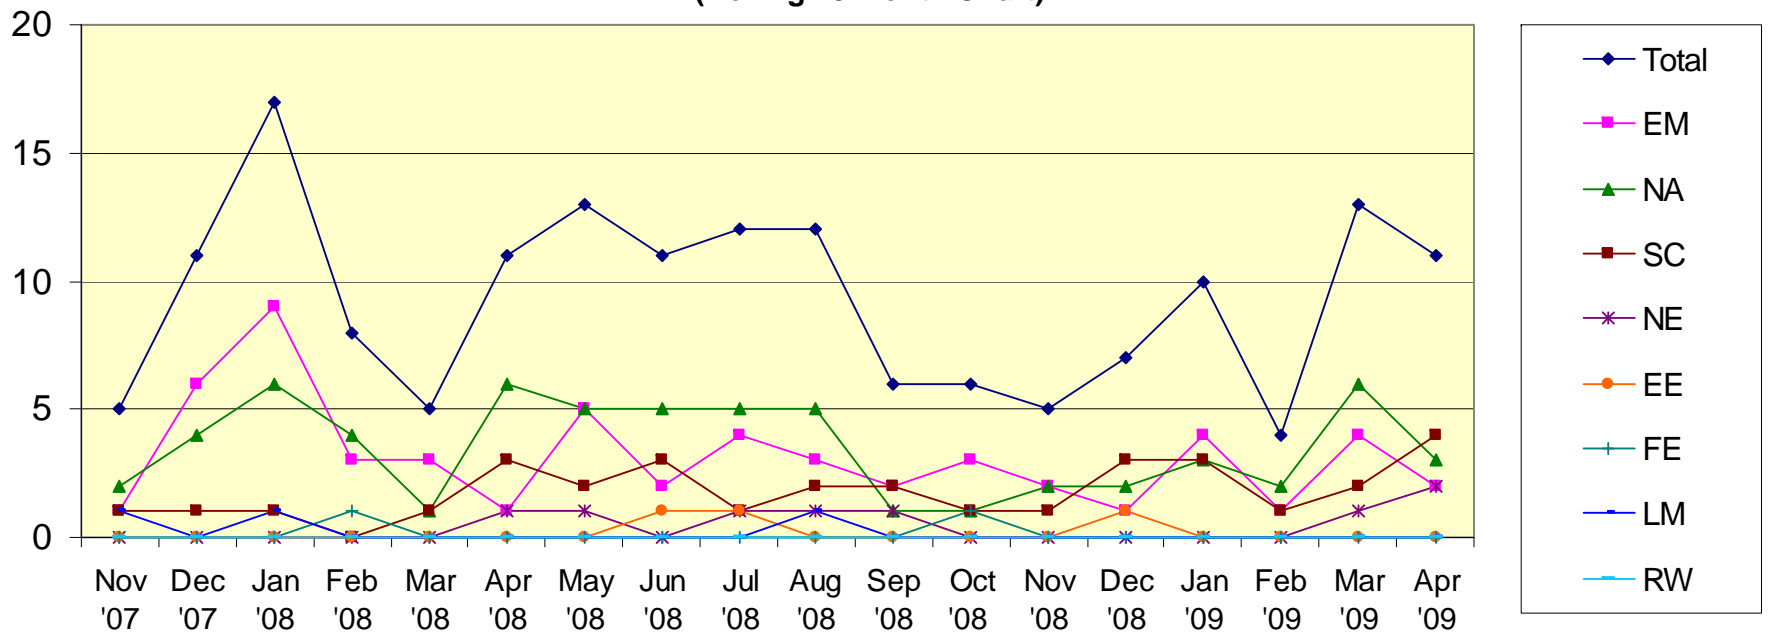
Electrical Occurrences by Month & Secretarial Office

(Rolling 18-Month Chart)

EE - Energy Efficiency and Renewable Energy, EM - Environmental Management, FE - Fossil Energy, LM - Legacy Management, NA - National Nuclear Security Administration, NE - Nuclear Energy, RW - Civilian Radioactive Waste Management, SC - Science
