August 2009 Electrical Safety Occurrences

Electrical Safety Occurrences – August 2009

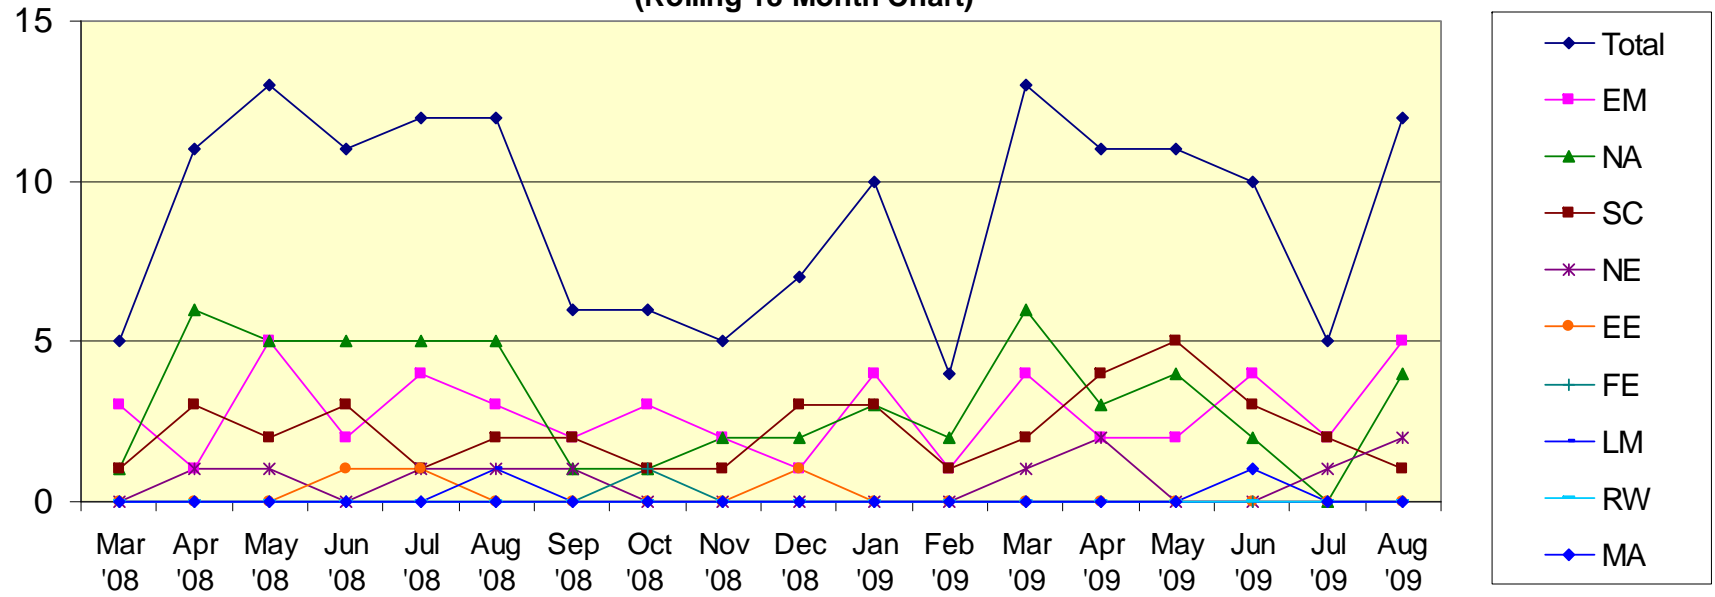
Electrical Occurrences by Month & Secretarial Office

(Rolling 18-Month Chart)

EE - Energy Efficiency and Renewable Energy, EM - Environmental Management, FE - Fossil Energy, LM - Legacy Management, MA - Management, NA - National Nuclear Security Administration, NE - Nuclear Energy, RW - Civilian Radioactive Waste Management, SC - Science
