## July 2009 Electrical Safety Occurrences

## Electrical Occurrences by Month & Secretarial Office

(Rolling 18-Month Chart)

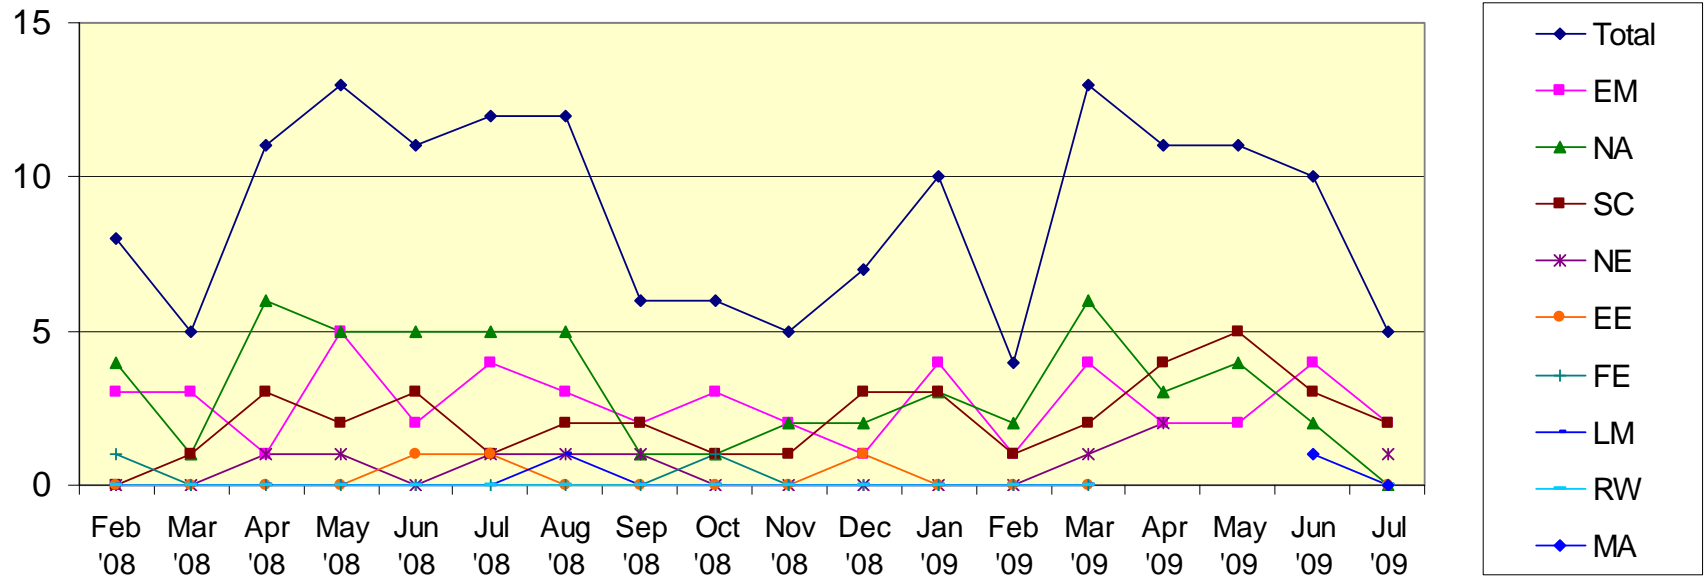
EE - Energy Efficiency and Renewable Energy, EM - Environmental Management, FE - Fossil Energy, LM - Legacy Management, MA - Management, NA - National Nuclear Security Administration, NE - Nuclear Energy, RW - Civilian Radioactive Waste Management, SC - Science
