## March 2010 Electrical Safety Occurrences

There were 13 electrical safety occurrences for March 2010:

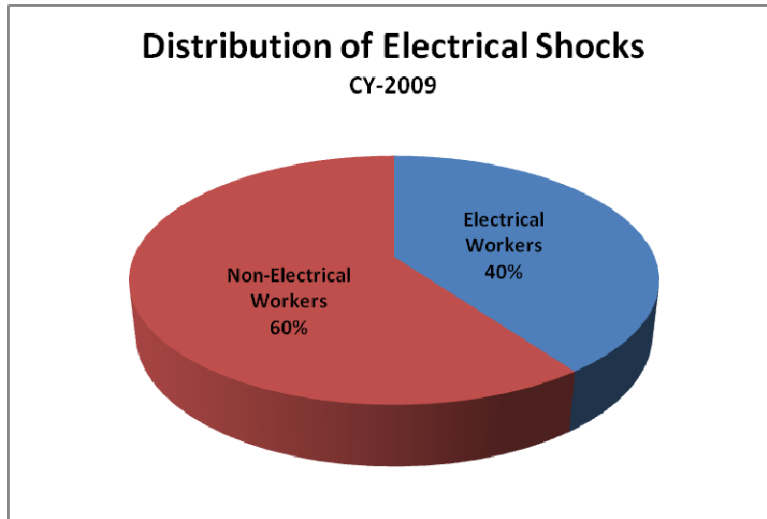
There were two events involving contact with electrical energy and both events involved non-electrical workers. There have been six shocks this quarter, two more than the first quarter of 2009. As the following chart from 2009 data indicates, more non-electrical workers were received electrical shocks during the year. Many of these shocks resulted from contact with defective equipment.

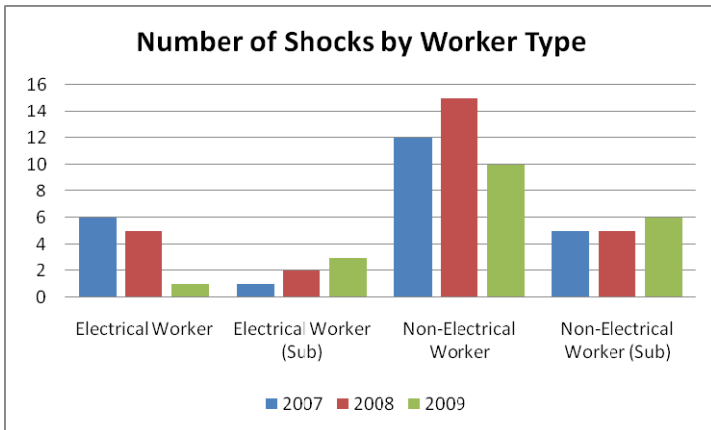
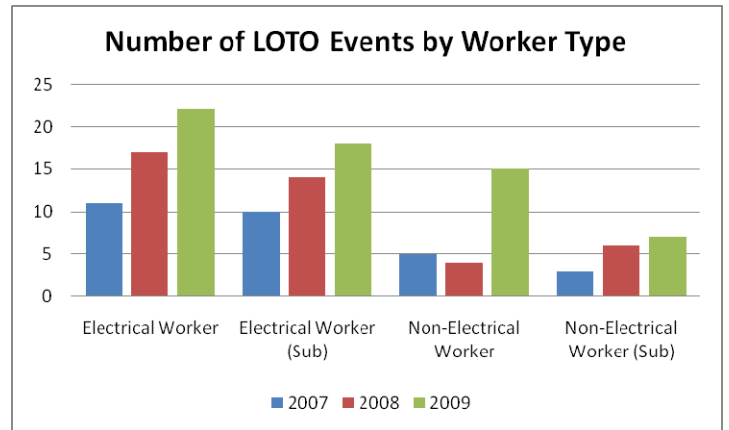
The following two charts look at electrical shocks and hazardous energy control (LOTO) events over a three-year period for different worker types. One of the major issues that we see from month to month is in the area of LOTO. Since 2007 we see a rise in LOTO events involving every type of worker.

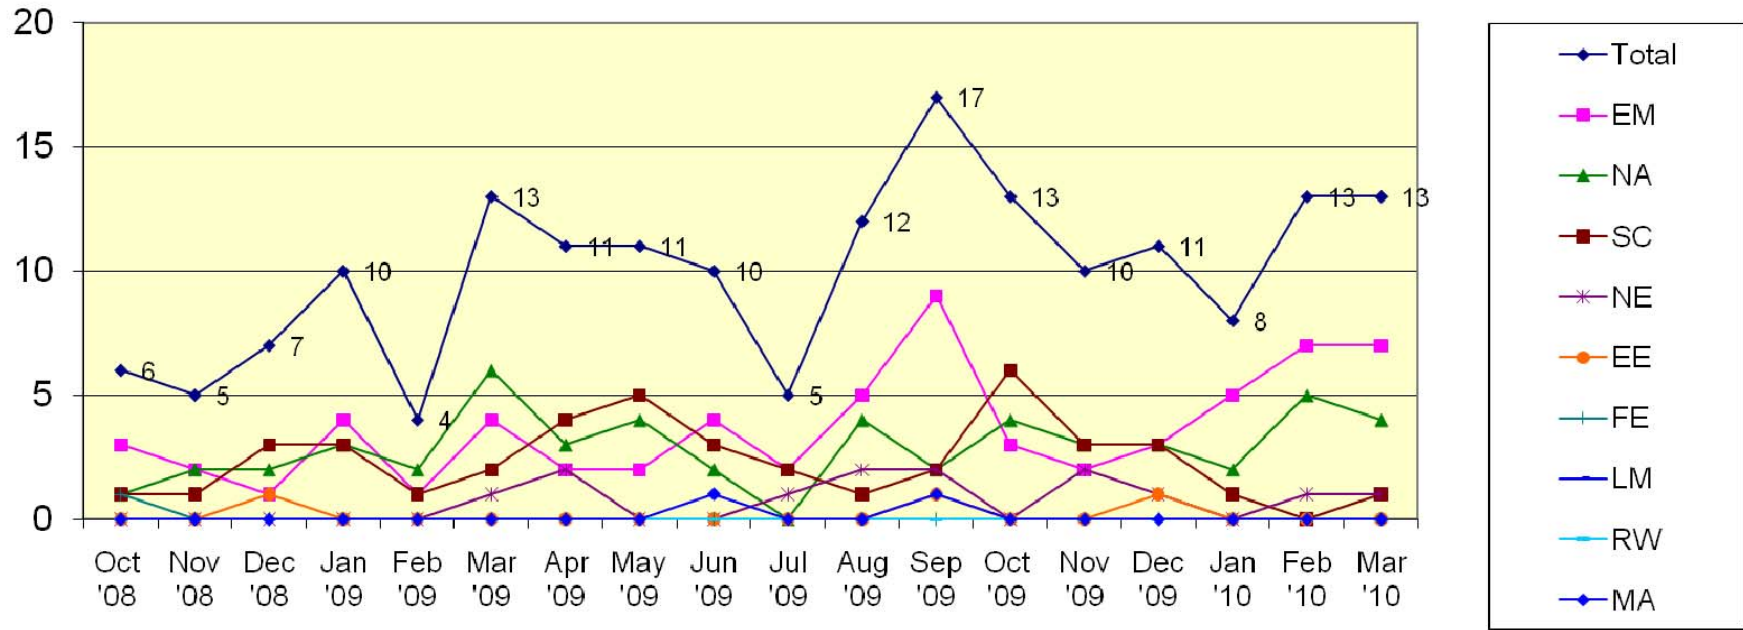
## Electrical Occurrences by Month & Secretarial Office

(Rolling 18-Month Chart)

EE - Energy Efficiency and Renewable Energy, EM - Environmental Management, FE - Fossil Energy, LM - Legacy Management, MA - Management, NA - National Nuclear Security Administration, NE - Nuclear Energy, RW - Civilian Radioactive Waste Management, SC - Science

The first quarter of 2010 has seen an average rate of 11.3 events per month. This is an increase over the rate of electrical safety occurrences in 2009, which averaged 10.7 per month and only 9.3 per month in the first quarter of 2009. The rolling eighteen month chart of electrical safety events shows an average of 9.9 events per month.
