May 2009 Electrical Safety Occurrences

Electrical Safety Occurrences – May 2009

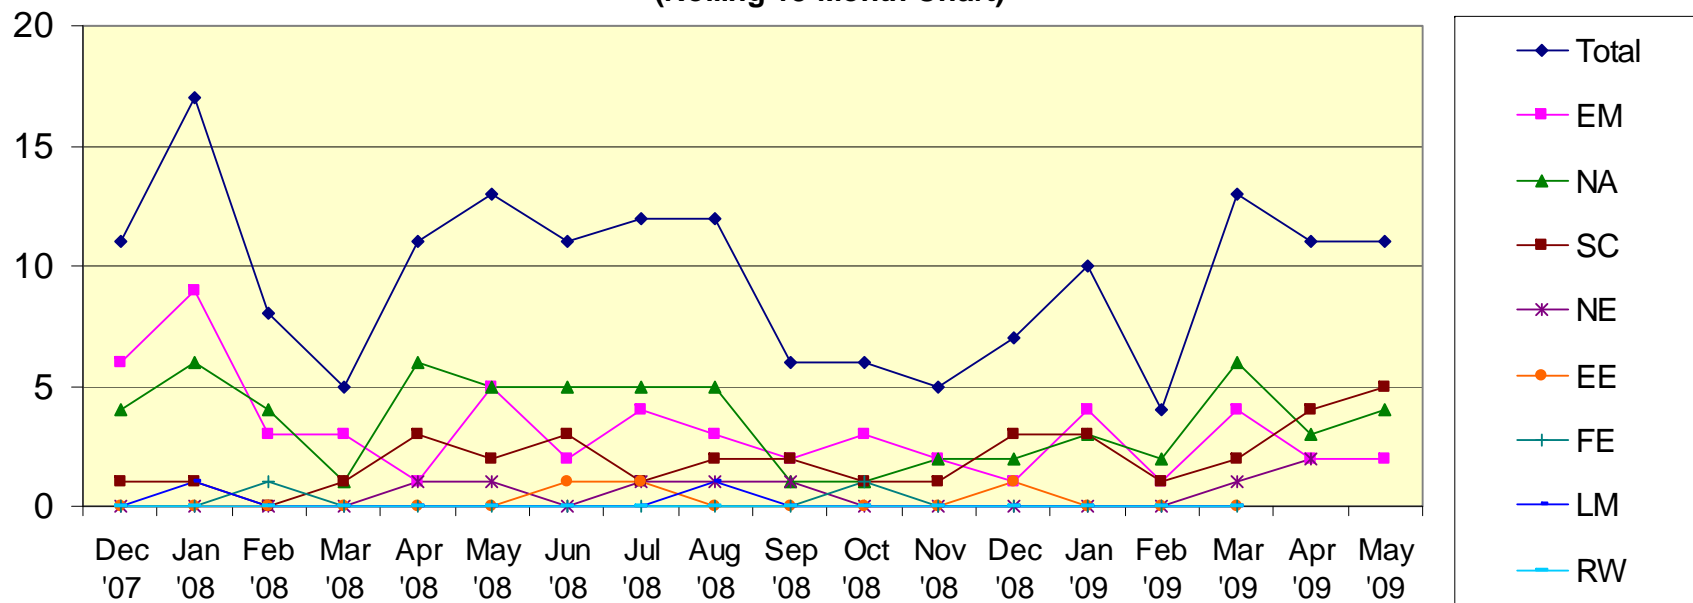
Electrical Occurrences by Month & Secretarial Office

(Rolling 18-Month Chart)

EE - Energy Efficiency and Renewable Energy, EM - Environmental Management, FE - Fossil Energy, LM - Legacy Management, NA - National Nuclear Security Administration, NE - Nuclear Energy, RW - Civilian Radioactive Waste Management, SC - Science
