May 2010 Electrical Safety Occurrences

There were 7 electrical safety occurrences for May 2010:

Electrical Events by Month and Secretarial Office

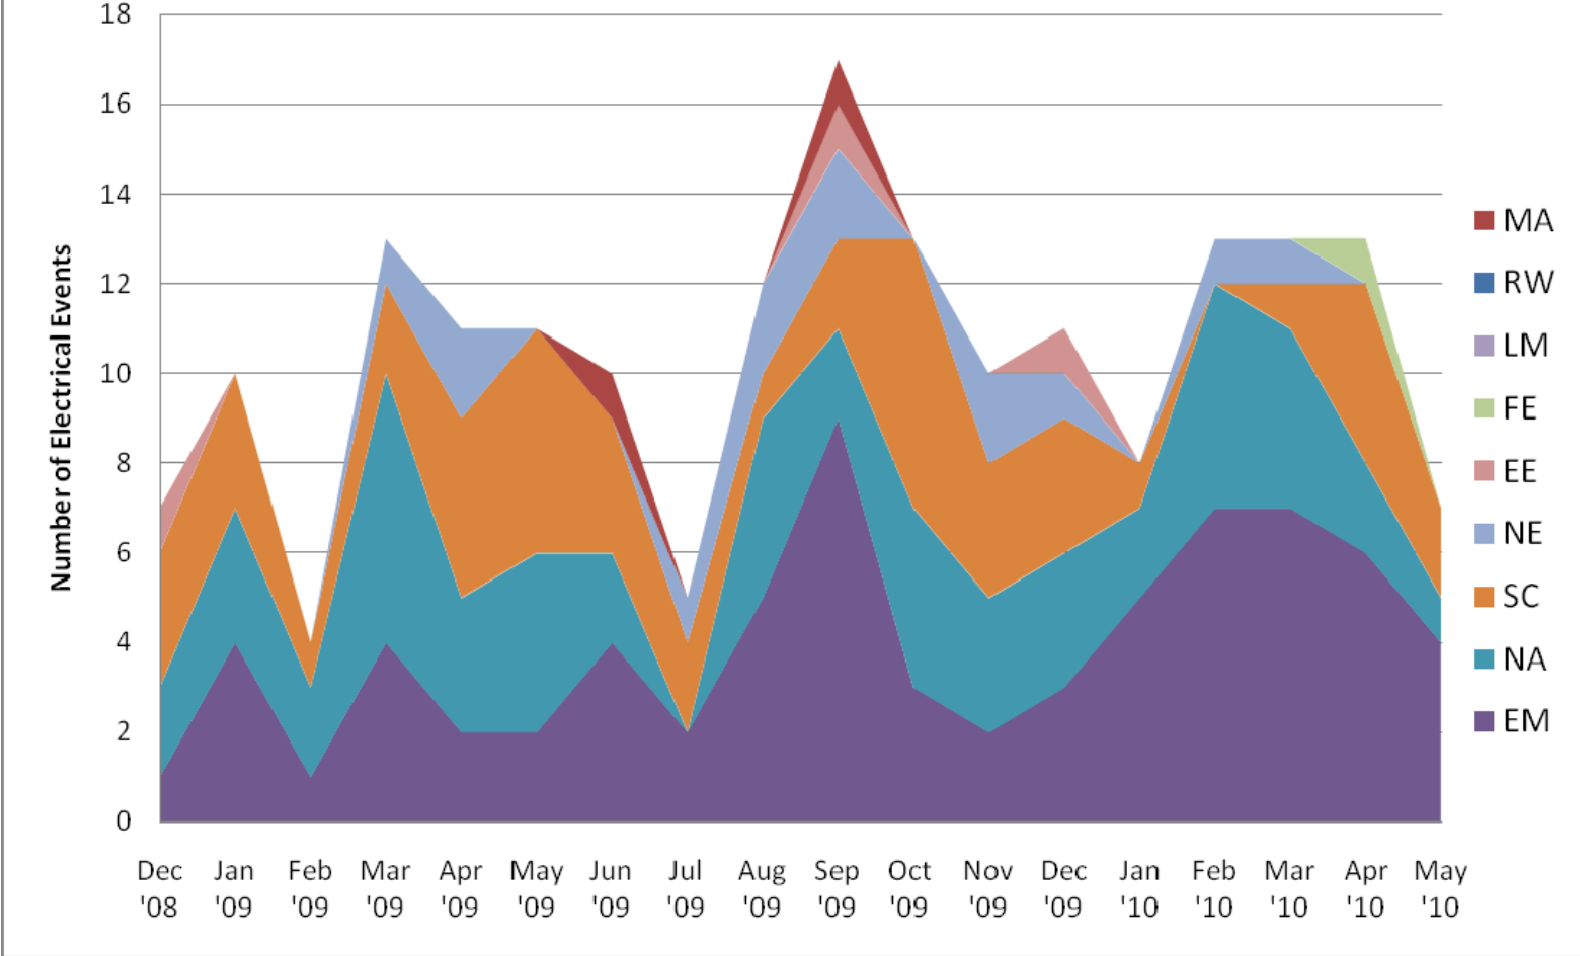
(Rolling 18-Month Chart)

EE - Energy Efficiency and Renewable Energy, EM - Environmental Management, FE - Fossil Energy, LM - Legacy Management, MA - Management, NA - National Nuclear Security Administration, NE - Nuclear Energy, RW - Civilian Radioactive Waste Management, SC - Science
