June 2009 Electrical Safety Occurrences

Electrical Safety Occurrences – June 2009

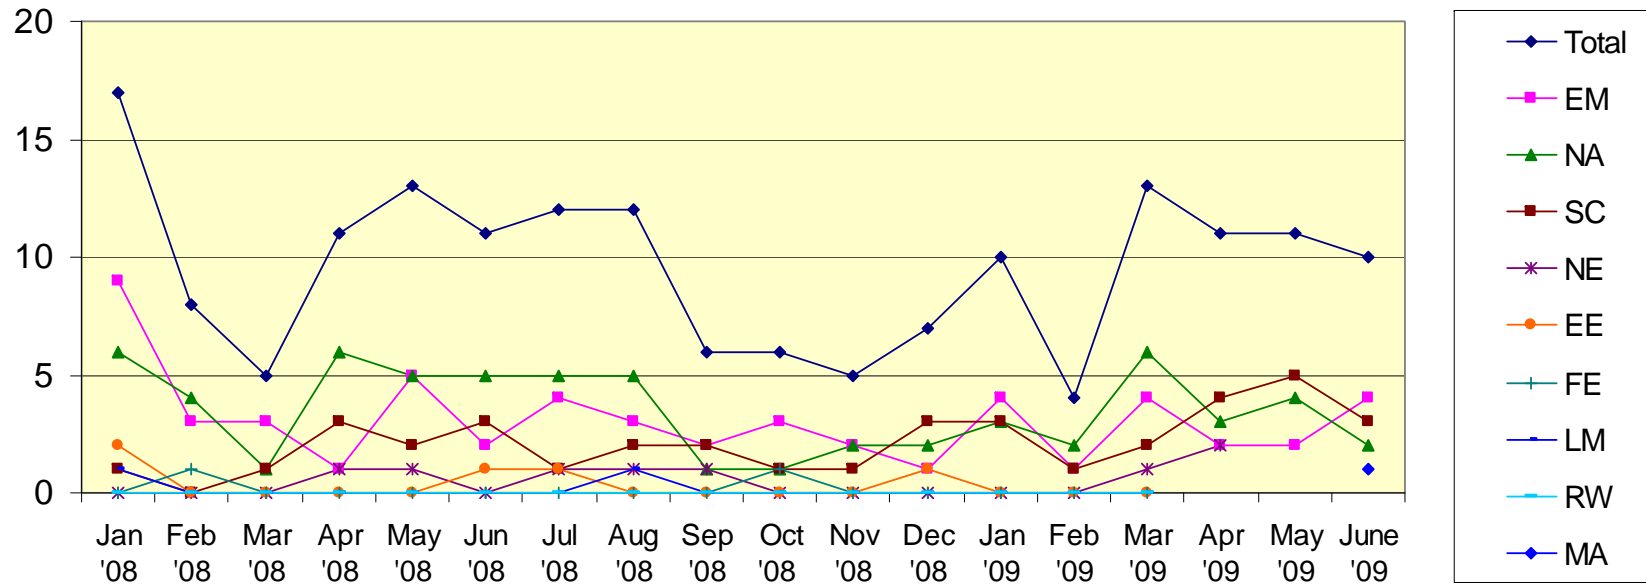
Electrical Occurrences by Month & Secretarial Office

(Rolling 18-Month Chart)

EE - Energy Efficiency and Renewable Energy, EM - Environmental Management, FE - Fossil Energy, LM - Legacy Management, MA - Management, NA - National Nuclear Security Administration, NE - Nuclear Energy, RW - Civilian Radioactive Waste Management, SC - Science
