## November 2009 Electrical Safety Occurrences

## Electrical Occurrences by Month & Secretarial Office

(Rolling 18-Month Chart)

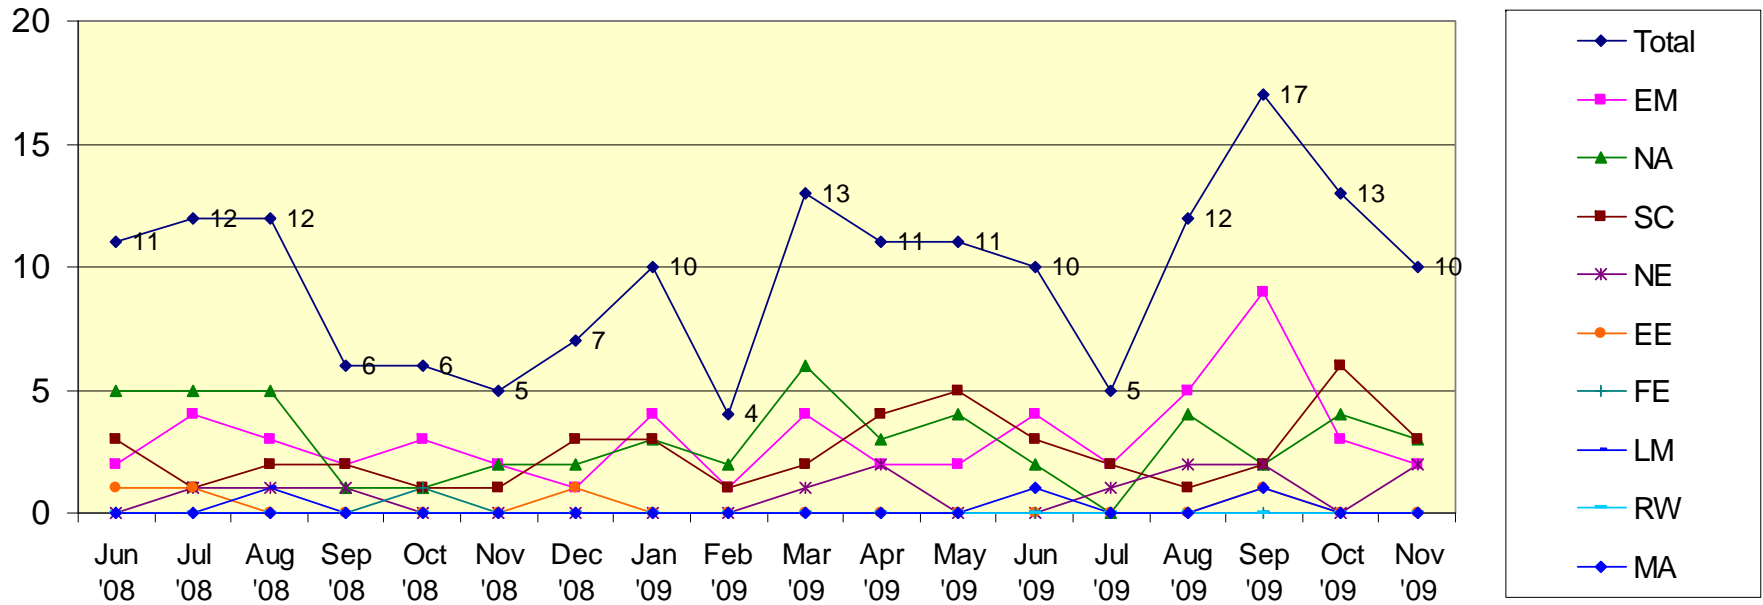
EE - Energy Efficiency and Renewable Energy, EM - Environmental Management, FE - Fossil Energy, LM - Legacy Management, MA - Management, NA - National Nuclear Security Administration, NE - Nuclear Energy, RW - Civilian Radioactive Waste Management, SC - Science
