## April 2010 Electrical Safety Occurrences

There were 13 electrical safety occurrences for April 2010:

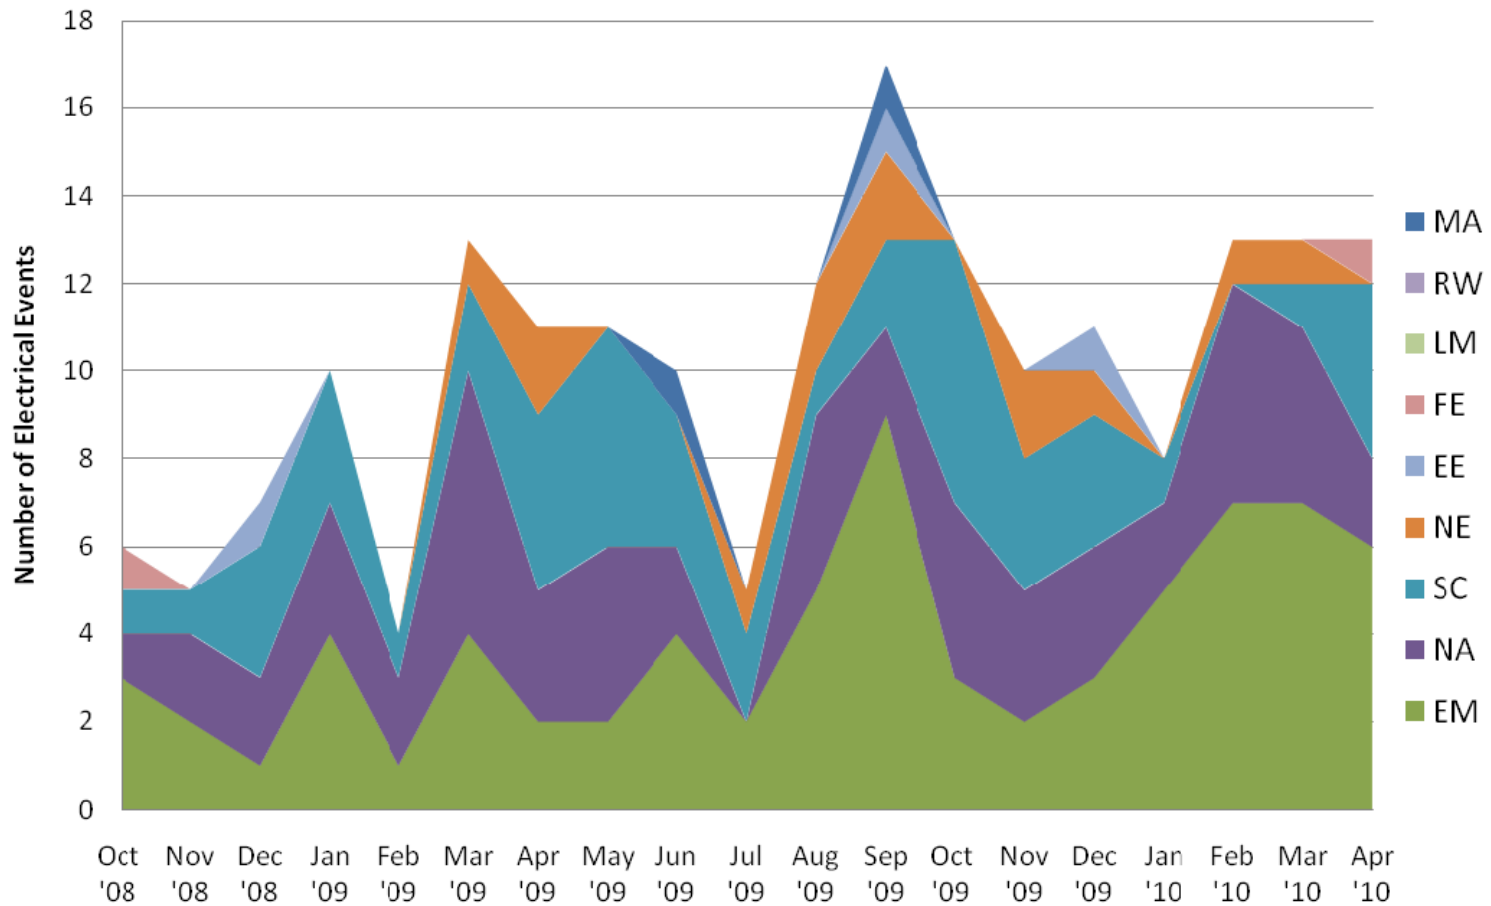
# Electrical Events by Month and Secretarial Office

(Rolling 18-Month Chart)

EE - Energy Efficiency and Renewable Energy, EM - Environmental Management, FE - Fossil Energy, LM - Legacy Management, MA - Management, NA - National Nuclear Security Administration, NE - Nuclear Energy, RW - Civilian Radioactive Waste Management, SC - Science
