Department of Energy
Richland Operations Office
P.O. Box 550
Richland, Washington 99352

11-SED-0124

CONTRACT NO. DE-AC06-08RL14788 – TRANSMITTAL OF SURVEILLANCE REPORT
PLANNING AND EXECUTION OF RADIOLOGICAL WORK (S-11-SED-CHPRC-PFP-002)

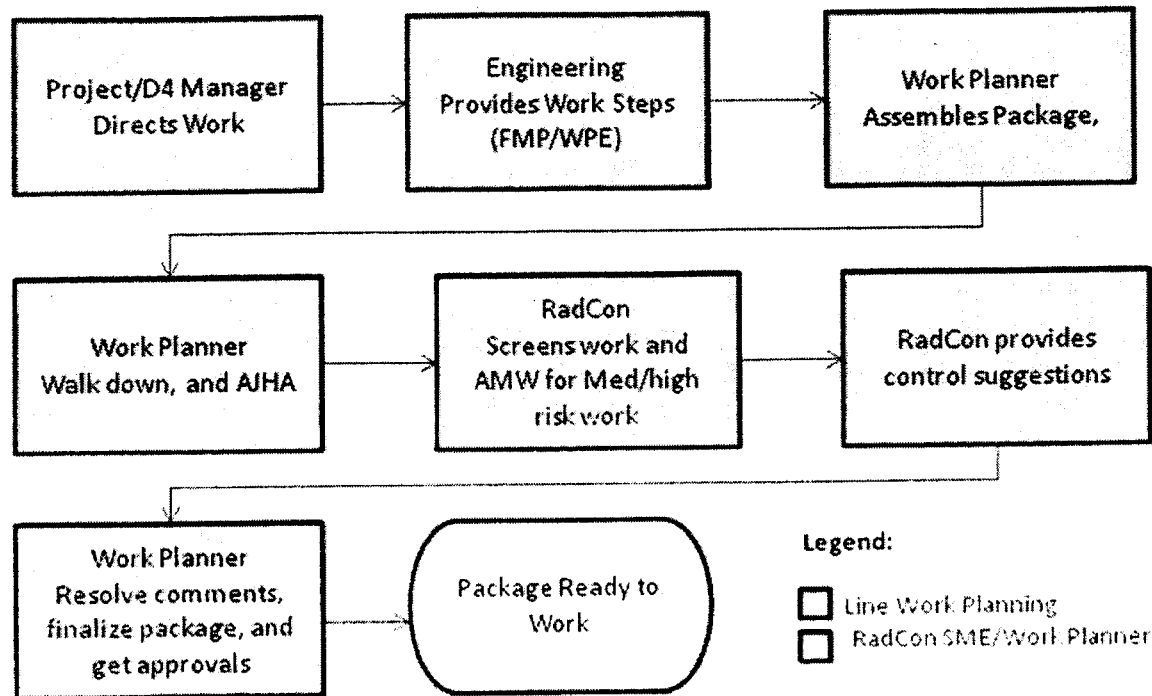
Figure 1 Simplified Work Planning Process Flow Chart

The surveillance team performed a surveillance of the work planning process, looking at the PFP process for planning radiological work. From a review of the contractor procedures, and interviews of personnel, the basic simplified flow chart of the work planning process used at PFP is shown below.
