CHAPTER 4 – WALL DATA COLLECTION GUIDELINES

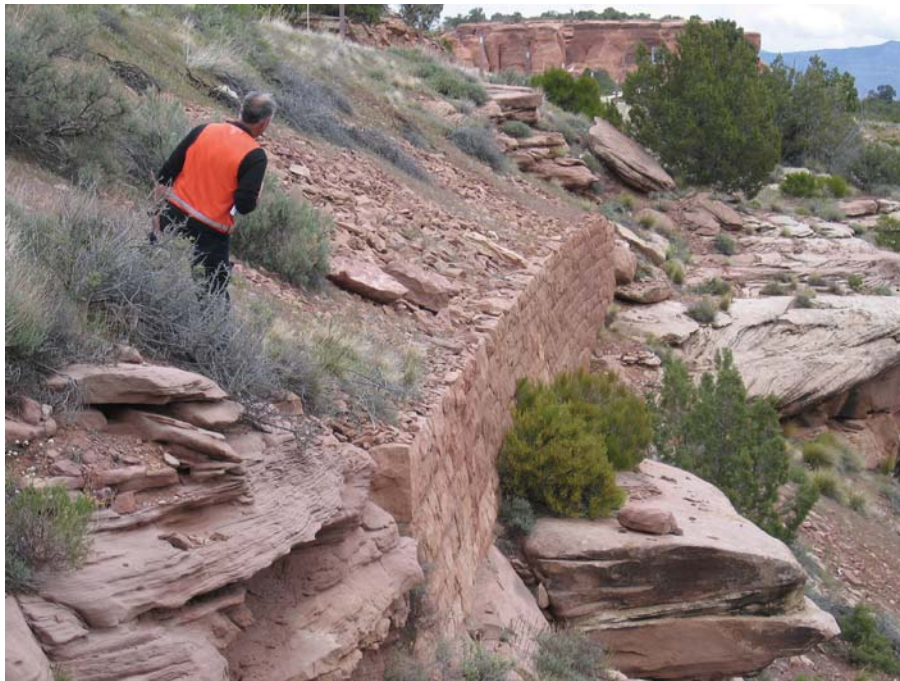
Figure 15. Photo. Retaining walls are found in a wide array of settings. Wall performance is impacted by factors other than constructed components, including foundation materials, top and side slopes, vegetation, drainage, etc.

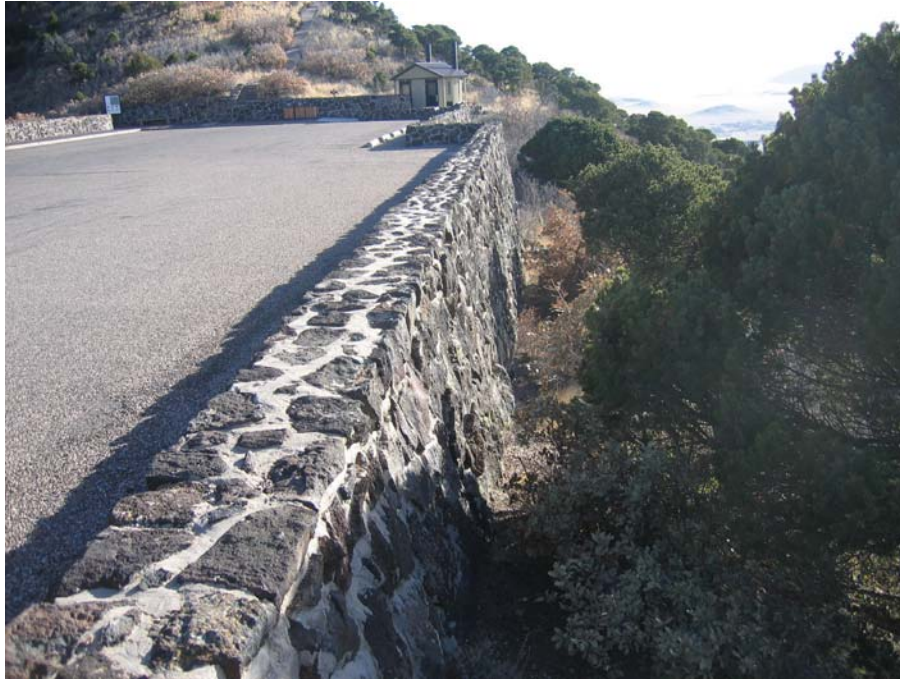
Figure 16. Photo. An example of parking area walls at Capulin Volcano National Monument. The wall in the foreground would be designated P1, the wall at the far end would be P2, and the wall partially shown on the left would be P3 per the WIP counterclockwise wall numbering notation for parking areas.

RIP Parking Area without Visidata: “CAVO-0910-0.000-P3” represents a wall in Capulin Volcano National Monument (Figure 16), located in RIP parking area 0910, with no milepoint data, and is the third wall in the parking area progressing counterclockwise from the entrance.

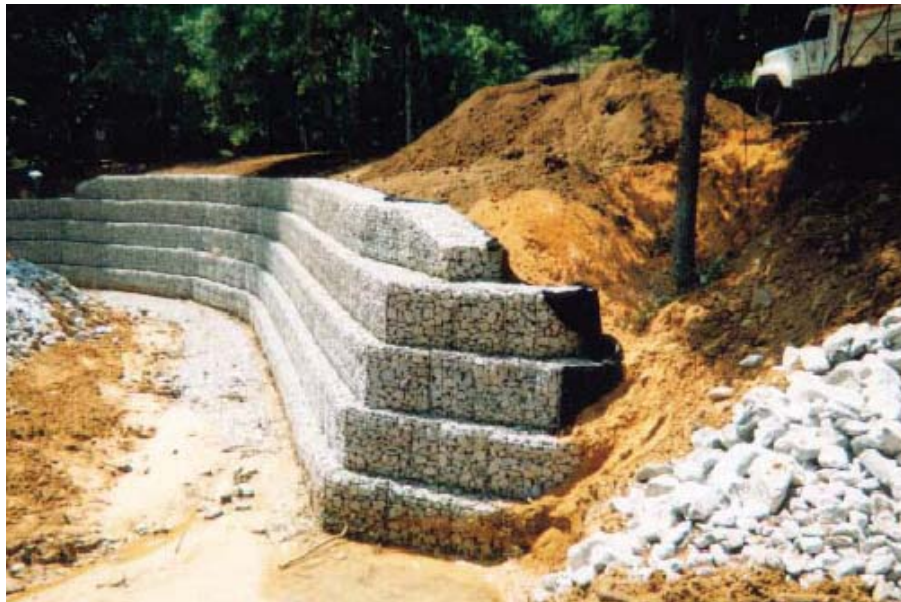
Figure 17. Photo. A gabion gravity fill wall under construction below roadway grade.

Fill Wall [FW]: A “fill wall” (Figure 17) is an earth retaining structure supporting specified soil or aggregate backfill. Fill walls are typically located below roadway grade on the outboard side of the roadway or parking area, but may also exist above travelway grade in locations commonly associated with cut walls. The inspecting engineer should be careful to always characterize the wall by function, and not simply location relative to the roadway or parking area.

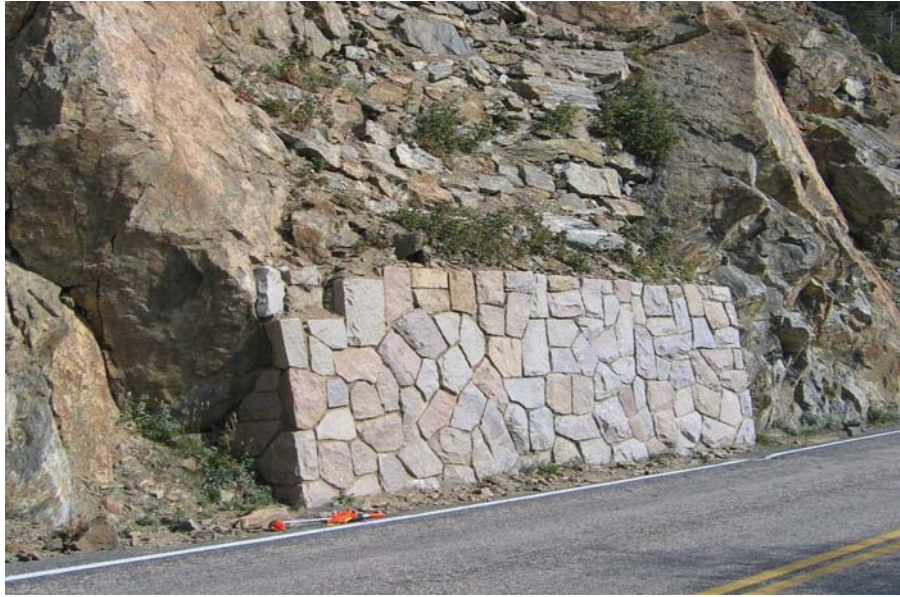
Figure 18. Photo. A mortared stone masonry cut wall at Rocky Mountain National Park.

Cut Wall [CW]: A “cut wall” (Figure 18) is an earth retaining structure directly supporting natural ground; either constructed directly against the excavated soil/rock mass, or against a minor volume of drainage backfill. Cut walls are typically located above roadway grade on the inboard side of the roadway or parking area, but may also exist below travelway grade in

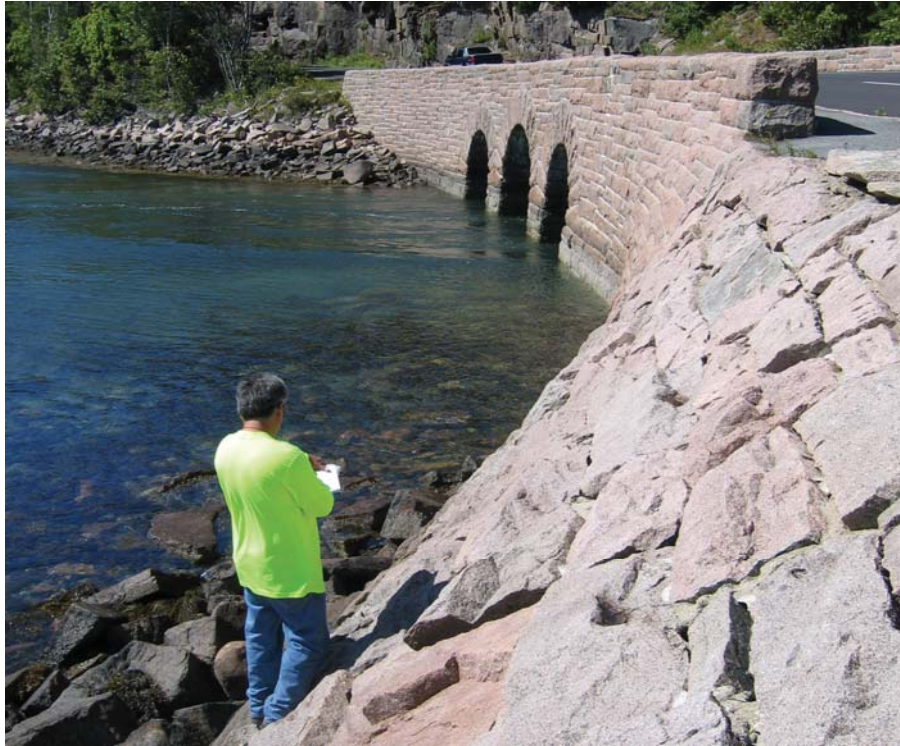
Figure 19. Photo. Example of a highly battered, dry-laid stone masonry wall supporting the bridge approach at Acadia National Park. This wall is not integral to the bridge structure and, therefore, should be assessed as a retaining wall under the Wall Inventory Program.

If wingwalls, as defined above, continue for more than 40 feet beyond the abutment without a change in construction type, the entire wall beyond the abutment (beginning immediately past the end of the bridge deck) should be considered a retaining wall and evaluated under WIP (Figures 19 and 20). If there is a change in construction type within 40 feet of the abutment, the point where the change occurs should be interpreted as the wingwall/retaining wall juncture (Figure 21). In lieu of these criteria for bridge walls, the inspecting engineer may determine that wingwall structures, despite size or construction method, are integral to the bridge and would be included in the BIP program.

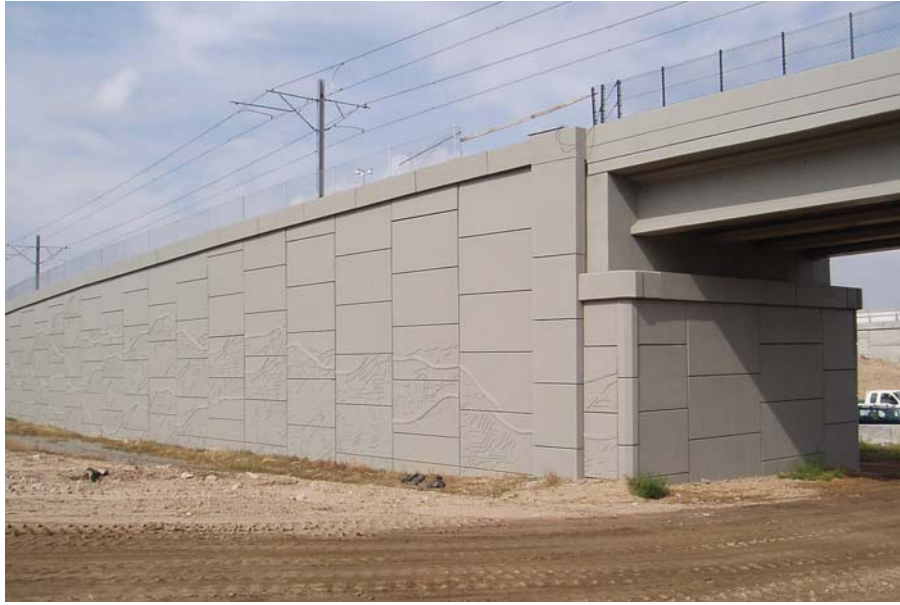
Figure 20. Photo. Although the approach walls are integral to the bridge abutment, they extend sufficiently from the end of the deck to be considered fill walls primarily supporting the roadway. Approach walls such as these should be included in the WIP inventory if not already evaluated under the BIP program.

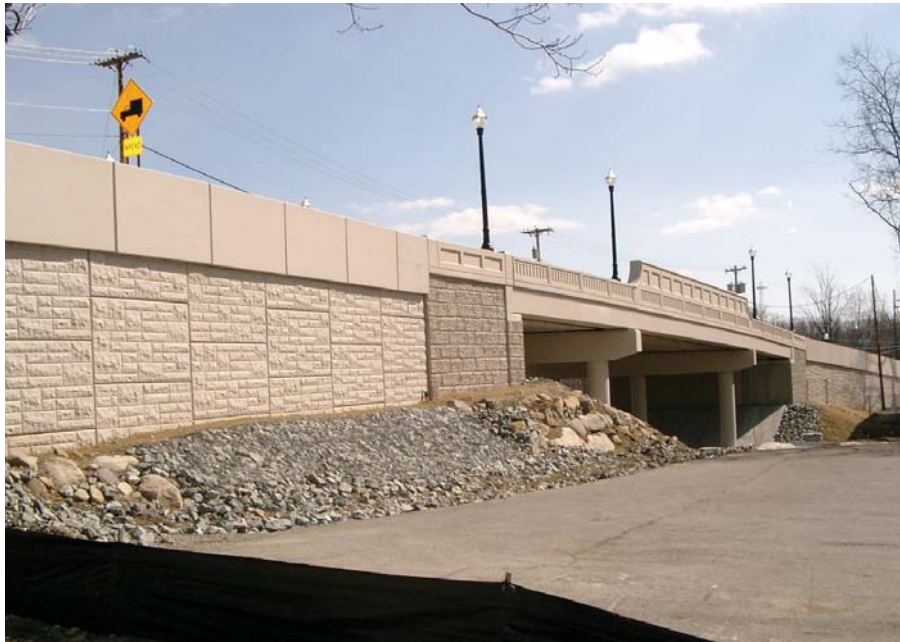
Figure 21. Photo. Example of approach walls clearly distinguished from the bridge abutment by a constructive joint, approximately 15 feet from the end of the deck.

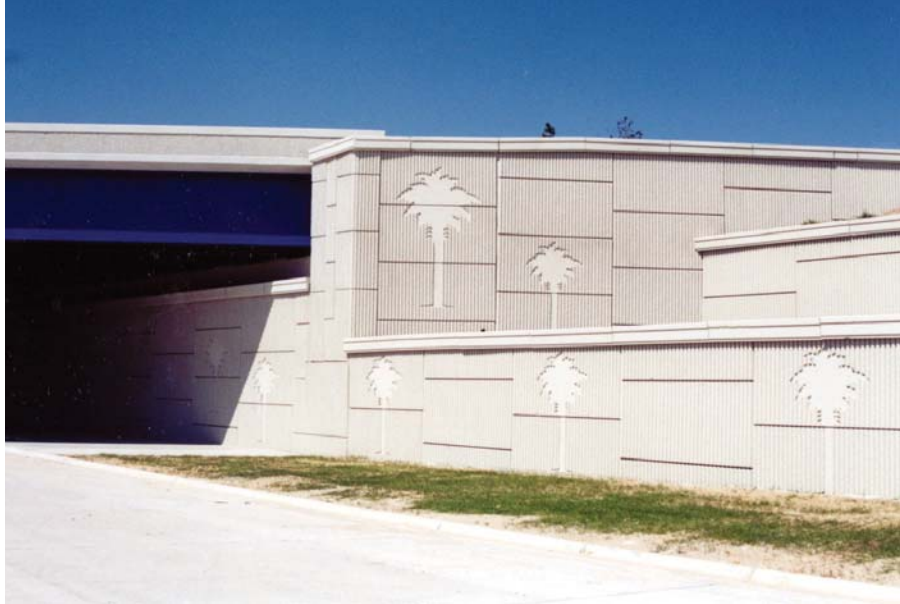
Figure 22. Photo. Example of secondary bridge walls (tiered MSE walls extending from the abutment and approach walls) that are not part of the bridge abutment structure and should be included in the WIP inventory.

Secondary Bridge Abutment Walls: Walls that are under a bridge and in front of an abutment are already inventoried and inspected through the bridge inspection program, and should not be inventoried in the retaining wall program. Walls that are not within the vertical projection of the bridge deck, and are not constructed integrally with either wingwalls or abutments, should be considered WIP-inventoried retaining walls. These structures are commonly found in front of or downslope from wingwalls (Figure 22).

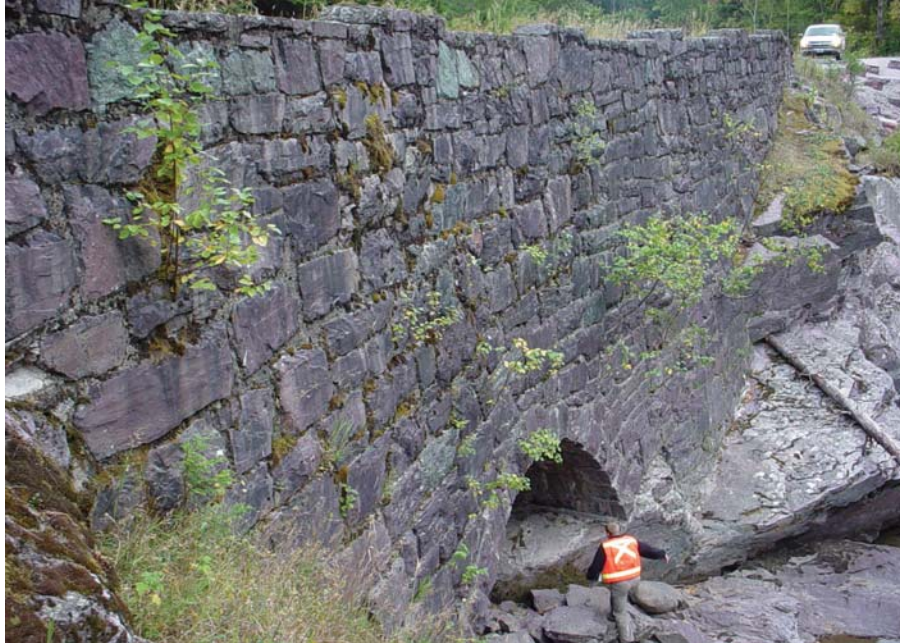
Figure 23. Photo. Is it a fill wall with an elaborate culvert structure, or a culvert with an elaborate headwall? In this case, the outlet was considered a large retaining wall with a culvert, whereas the much smaller inlet was considered a culvert headwall.

Head Wall [HW]: A “head wall” (Figure 23) is a cut or fill wall located at the inlet and/or outlet end of a drainage or passage structure (e.g., water culvert, animal passage). Head walls (including associated wingwalls) should only be included in the wall inventory if they meet the wall acceptance criteria – particularly the special 6 ft head wall height criterion and the intent to support or protect the roadway. If the head wall is of sufficient size, and would significantly impact the roadway were it to fail, it should be included in the inventory. If the same head wall would not directly or immediately impact the roadway if it failed (e.g., a head wall at the bottom of a long, well-vegetated fill slope), it should not be included in the wall inventory. The entire head wall/wingwall structure at either an inlet or outlet should be considered one continuous wall system, as opposed to evaluating each separately (the length would be measured from the end of one wingwall, across the head wall, to the end of the other wingwall).

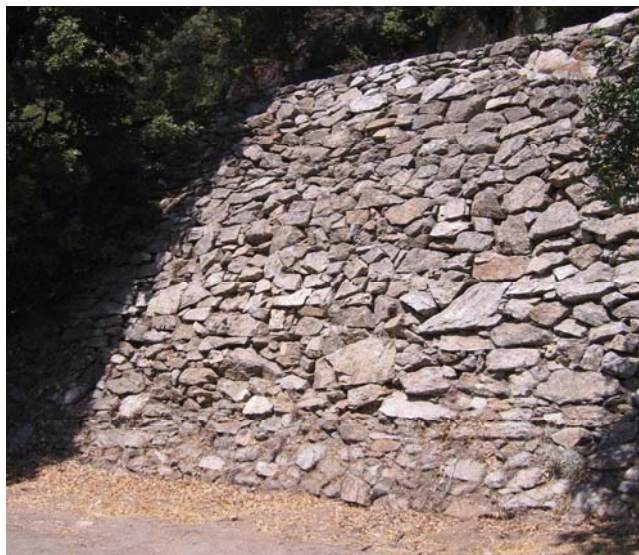
Figure 24. Photo. Example of a mortared stone masonry switchback wall at Sequoia National Park between upper and lower roadway on the inside of a switchback curve.

Switchback Wall [SW]: A “switchback wall” (Figure 24) is a cut or fill wall located on the inside of a switchback curve, simultaneously supporting the upper roadway and protecting the lower roadway. The switchback wall is located and described as it is first encountered along the roadway when traveling in the direction of increasing milepost.

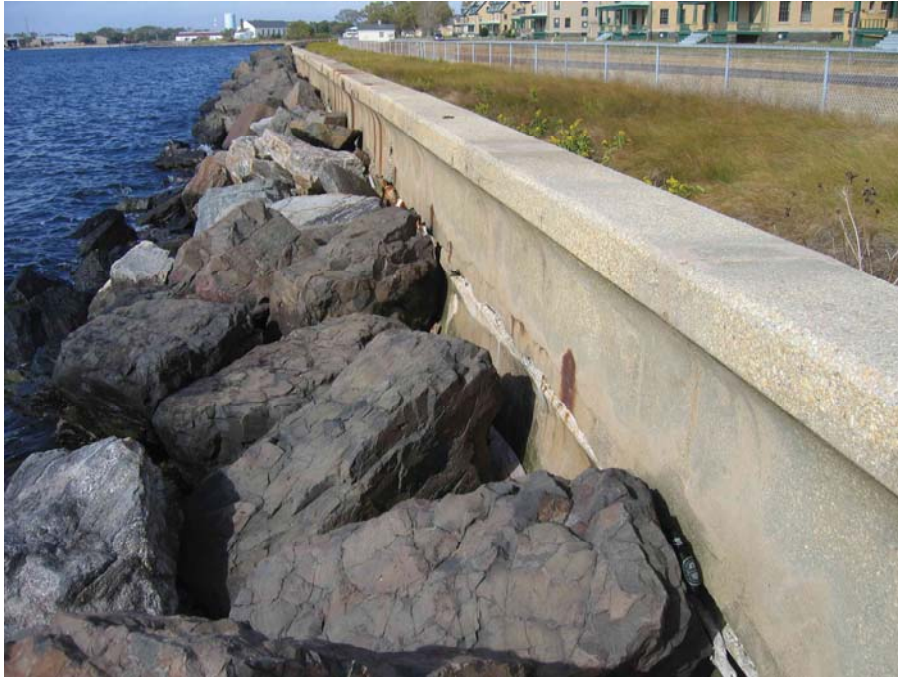
Figure 25. Photo. Although this seawall at the Sandy Hook unit of the Gateway National Recreation Area sits well outside the construction limits of the RIP-surveyed road (back right), failure of this structure would result in rapid and severe shoreline erosion, eventually impacting the roadway.

Flood Wall [FL]: “Flood walls” (Figure 25) encompass earth retaining structures constructed along flood channels, inland surge walls, and seawalls. Although inclusion of these walls in the WIP inventory requires they meet the aforementioned wall acceptance criteria (particularly noting the retained earth height requirements, since many floodwalls are non-earth retaining structures), a special case is worth noting: the flood wall clearly resides outside the road/parking area construction limits, but failure would nonetheless result in roadway/parking area damage. The inspecting engineer will need to use prudent judgment in determining if a flood wall structure sufficiently meets the intent of the program to include it in the inventory.

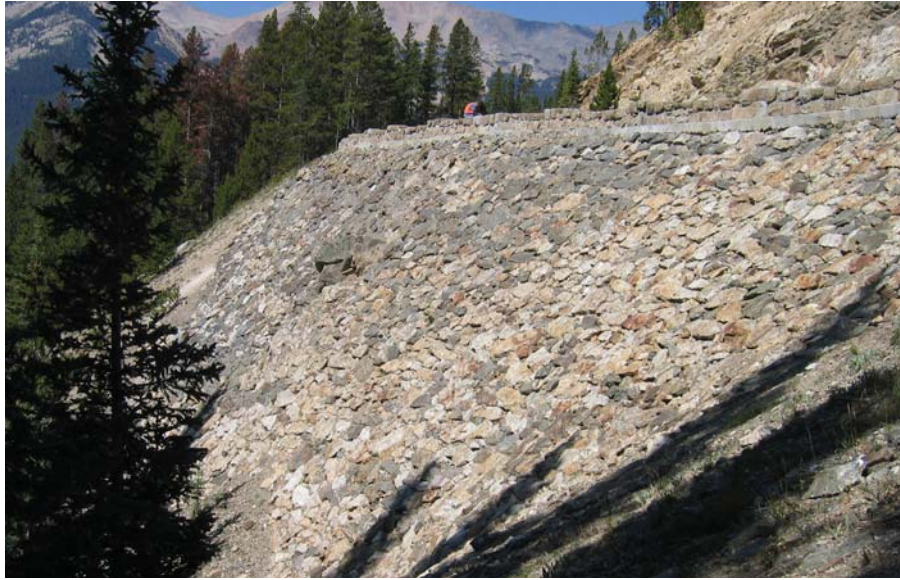
Figure 26. Photo. Machine- and hand-placed slope protection at Rocky Mountain National Park.

Slope Protection [SP]: “Slope protection” (Figure 26) includes earth retention and/or erosion control structures meeting the aforementioned general wall acceptance criteria that may not be considered conventional retaining wall structures. Such structures may include rock buttresses, grouted/ungouted riprap, and stacked or grouted rock inlays constructed at slope ratios $\geq 45^\circ$ (1H:1V), and generally not exceeding 70° (1H:2.5V). These structures are comprised of hand- or machine-placed rock, and should not be confused with over-steepened, end-dumped rock fills. Although not always adhering to the conventional definition or perception of an earth retaining structure, slope protection structures should be included in the inventory as they represent significant park assets supporting and/or protecting roads, and are best evaluated under the WIP inventory. For clarification, rockeries – retaining wall structures far more rigidly designed and specified than rock buttresses, and typically built at face angles $\geq 70^\circ$ – would typically be characterized as cut or fill walls, and not slope protection. Riprap rundowns, primarily used for water conveyance and not earth retention, would not be included as Slope Protection.

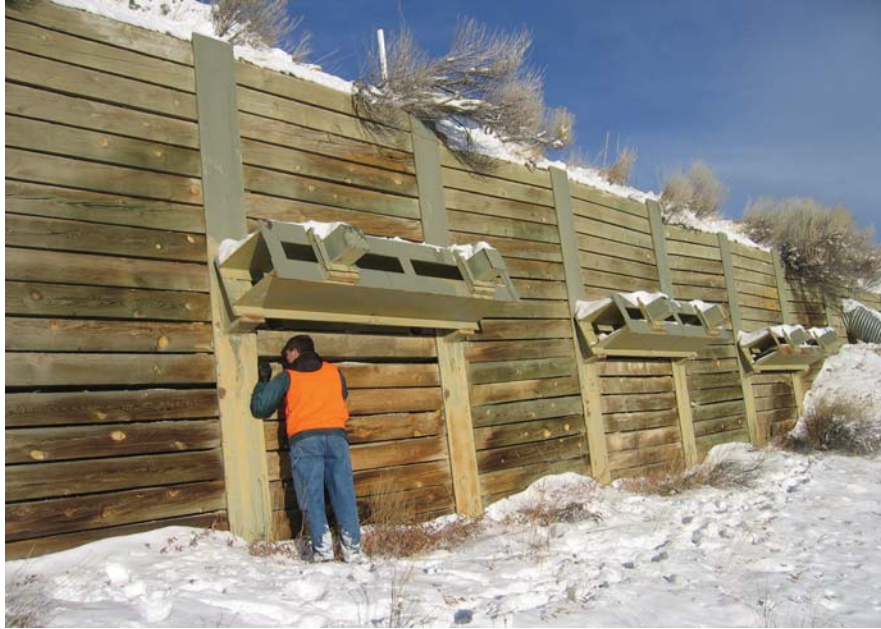
Figure 27. Photo. Timber-lagged soldier pile tieback wall at Mesa Verde National Park. A steel box-frame whaler assembly is used in this example as the bearing member for the ground anchors. Surface treatments are commonly applied to the timber lagging (weathering sealants) and exposed steel pile, whaler and ground anchor assemblies (paint).

Anchor, Tieback H-Pile [AH]: A tieback H-Pile wall (Figure 27), or soldier pile tieback wall, is commonly comprised of H-piles driven on 6-10 ft centers, lagged with timber planks or concrete panels, and secured through the retained earth mass with tieback cables or bar ground anchors. Variations in pile and tieback configurations are common, ranging from flanged piles allowing tieback passage through the pile to tieback whaler assemblies spanning piles. Although generally a cut wall installation, this wall type can also be used as a fill wall in outboard wall applications.

Piles and Shafts: “Piles and Shafts” include driven piles, micropiles or drilled shafts comprising all or part of the visible wall, as well as supplemental structures such as timber, steel or concrete walers (Figure 27). Identify the specific type of pile or shaft (e.g., timber pile; steel H-pile; pre-stressed concrete pile; vinyl sheet pile; cased micropile; secant drilled shaft) and describe the installation method (e.g., driven; drilled; cast-in-place), if known.

Lagging: “Lagging” refers to structural timber, concrete or steel lagging between piles and walers (Figure 27). Describe lagging according to material type, size, treatment and installation method (e.g., treated 6x6 timber lagging; pre-cast 8-ft-square concrete panels).

Anchor Heads: “Anchor Heads” refers to all visible parts of a tieback ground anchor system, including the pad and bearing assembly, generally observed without removing the anchor cap (Figure 27). Describe the bearing structure and manner in which the ground anchor is affixed within the wall structure (e.g., single row of strand ground anchors placed on 8-ft centers through steel, box-frame walers).

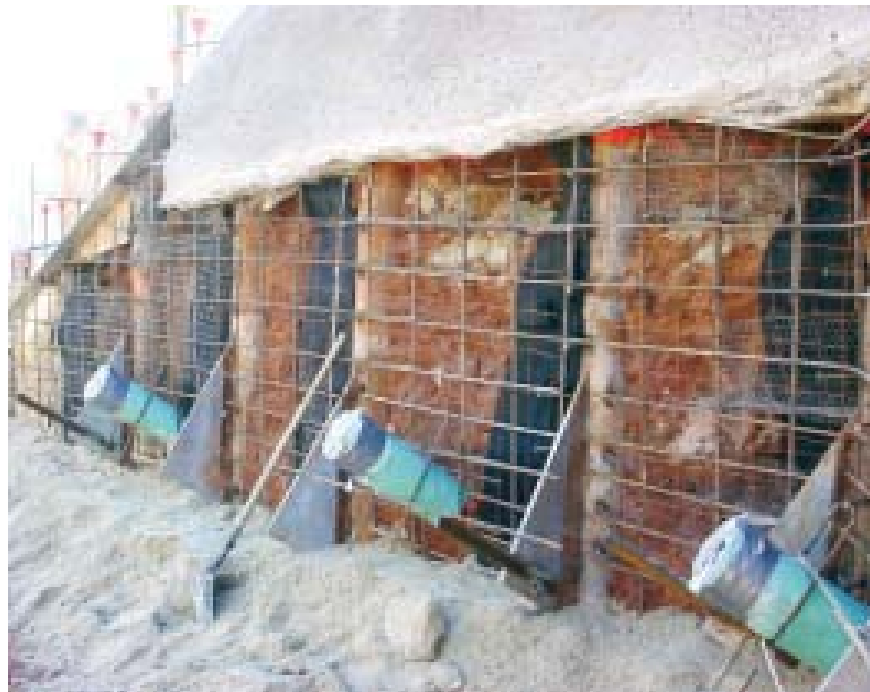
Figure 28. Photo. Micropile tieback wall prior to shotcrete facing finish (ADSC, 2006).

Anchor, Micropile [AM]: The anchor micropile wall (Figure 28) is a rarely used variant of the H-pile tieback system. This cut wall installation, generally comprised of closely-spaced micropiles (3-6 ft), requires a structural wall facing for permanent applications. Shotcrete facings are most common.

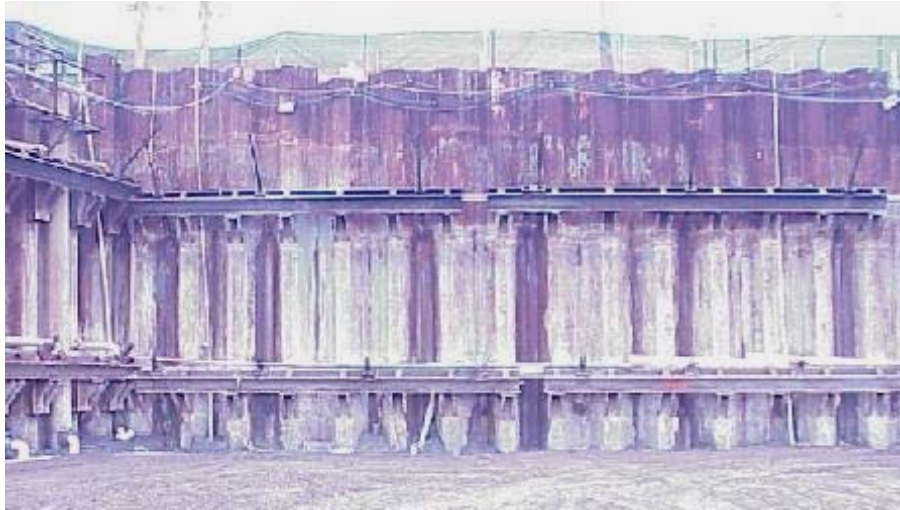
Figure 29. Photo. Steel sheet piling with bar ground anchors placed through steel whalers. This cut wall is constructed “top-down”, with the ground in front of the driven sheet piles excavated in lifts and ground anchor assemblies installed as the excavation proceeds to final grade.

Anchor, Tieback Sheet Pile [AS]: The tieback sheet pile wall (Figure 29) is more commonly used as a temporary excavation support measure than a permanent wall structure. However, this

wall type may be commonly found in seawall applications. The piles may be steel or vinyl and a variety of coatings may be applied to the sheeting, whalers and ground anchor assemblies.

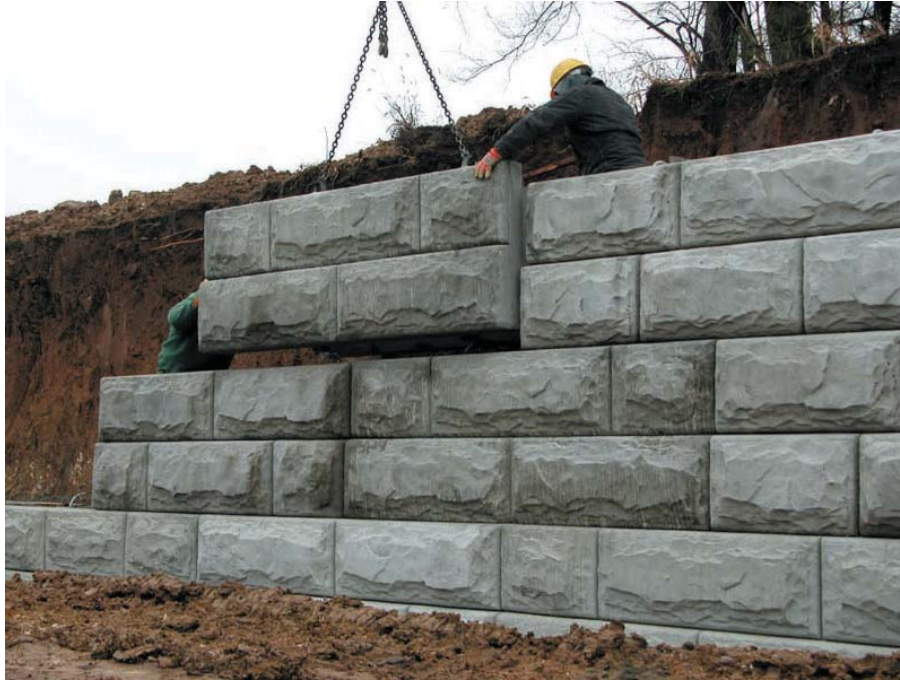
Figure 30. Photo. Precast hollow concrete “bin” blocks, with a formed architectural facing, are dry-laid at this cut wall installation and then aggregate filled for a rapidly-constructed, low-cost alternative to gravity concrete walls. (Courtesy Stone Strong, LLC)

Bin, Concrete [BC]: Concrete bin walls (Figure 30), employing large, steel reinforced concrete box construction are also rarely seen on NPS properties. New products employing hollow cast concrete boxes filled with aggregate and faced with various formliner patterns are becoming popular alternatives to cast-in-place concrete walls or solid block walls.

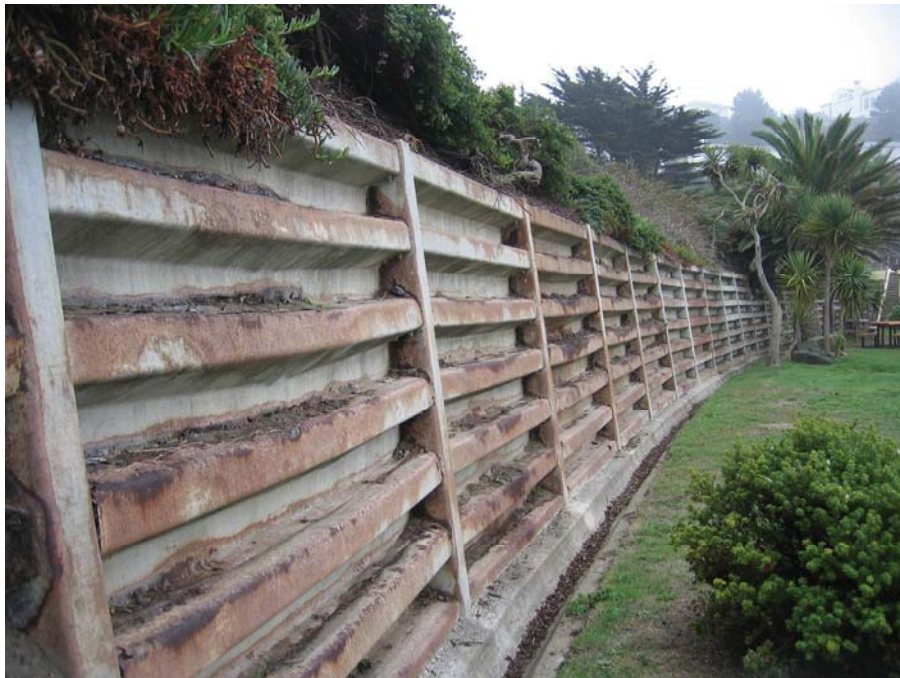
Figure 31. Photo. Heavily corroded metal bin wall at China Beach, Golden Gate National Recreation Area. Constructed in the 60’s, the protective coating on the exposed bin facing elements has long since deteriorated.

Bin, Metal [BM]: Metal bin walls (Figure 31) comprised a significant percentage of the walls inspected during the WIP Cycle 1 inventory and assessment. This type of wall was particularly popular within the western U.S. park system in the 60’s and early 70’s. The steel bins are comprised of individual units generally 8-10 ft wide and of varying depth into the slope, and may be galvanized or sprayed with other corrosion-resistant coatings.

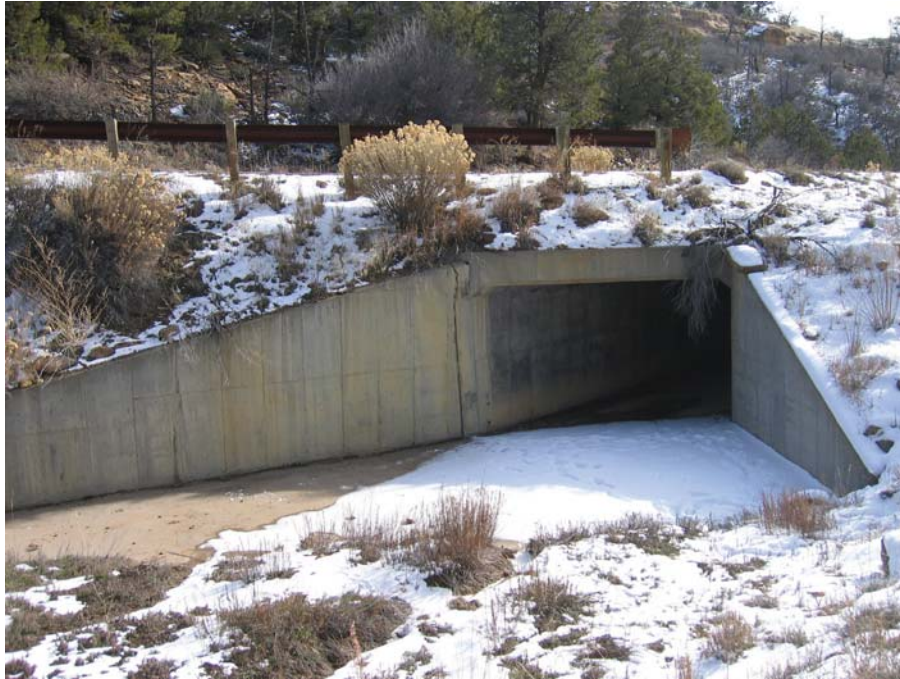
Figure 32. Photo. Cast-in-place concrete cantilever walls are commonly found serving as wingwall structures for large box culvert features within the WIP inventory.

Cantilever, Concrete [CL]: Concrete walls (Figure 32) comprised almost 10% of the total number of walls inspected within the Cycle 1 WIP inventory (most often occurring as culvert head wall/wingwall structures). The cantilever concrete wall, generally a cast-in-place fill wall (though smaller walls maybe precast and transported to the site), likely comprises the majority of the newer concrete wall structures inventoried owing to its cheaper construction. However, unless the stem wall thickness is exposed, it can be very difficult to discern this wall type from a mass gravity concrete structure.

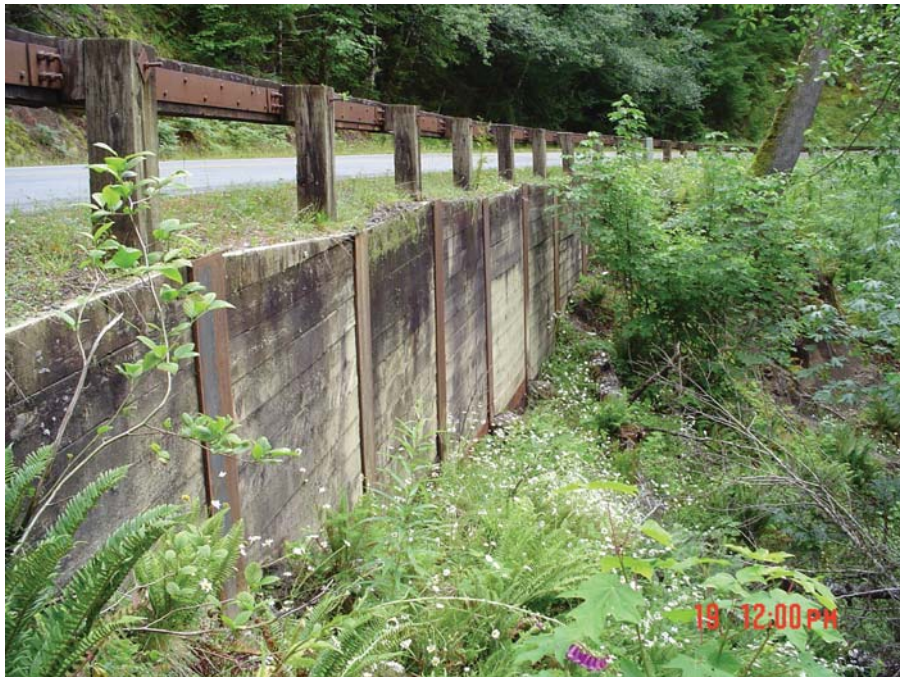
Figure 33. Photo. Timber-lagged, soldier pile fill wall employing steel H-piles at Olympic National Park. To limit wall deflection, unanchored soldier pile walls are generally restricted to heights well under 15 ft, depending on the size of piling employed. Both piles and lagging are commonly treated for corrosion and dry rot, respectively.

Cantilever, Soldier Pile [CP]: The cantilever soldier pile wall (Figure 33) is of similar construction to the tieback version, less the ground anchors. Whereas the tieback version almost exclusively employs steel piling, the soldier pile wall may employ alternative concrete “piling” supporting both timber and concrete lagging. Generally a cut wall installation, this wall type can also be used as a fill wall in outboard wall applications.

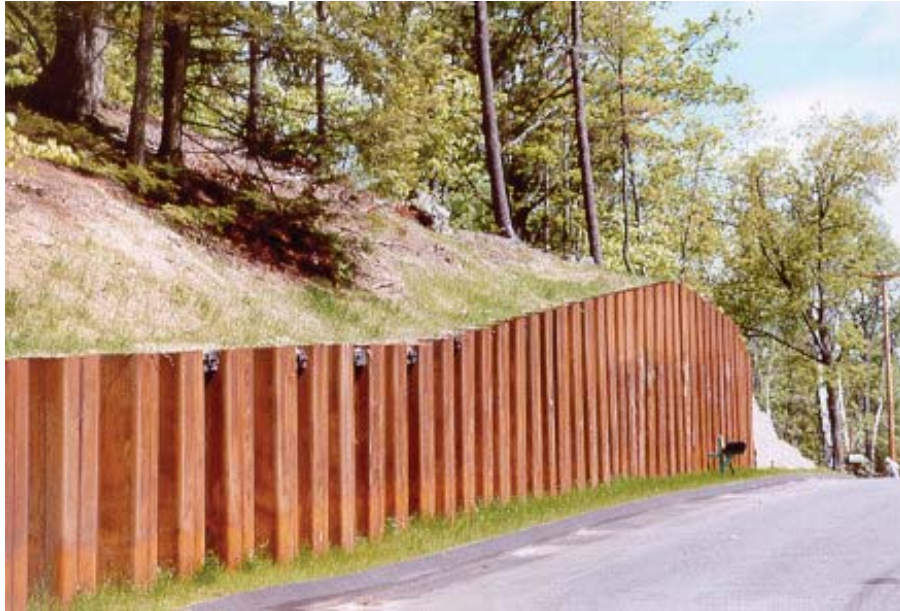
Figure 34. Photo. Cantilever steel sheet pile cut wall with “deadman” anchors placed at the top of the wall to support the higher wall sections.

Cantilever, Sheet Pile [CS]: As with the anchored version, cantilever sheet pile walls (Figure 34) may be constructed of steel or vinyl, and are more commonly associated with applications near water bodies (e.g., coastal sites, bridges). A variety of coatings may be applied to steel sheet piles and metal fixtures. Occasionally, these structures may employ low-capacity “deadman” anchorage along the upper third of the pile, an element that may be overlooked during inspection.

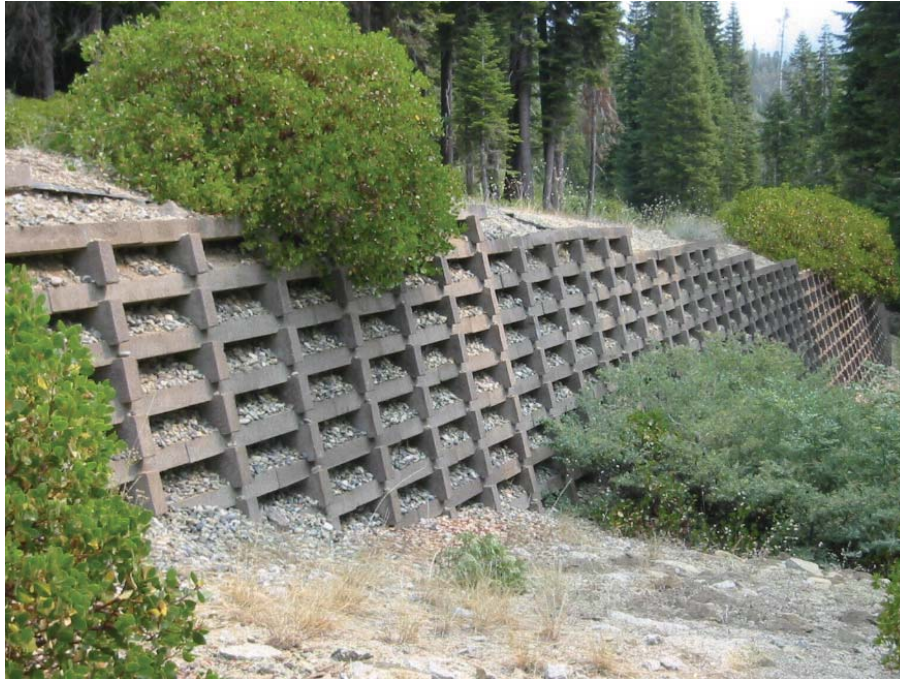
Figure 35. Photo. Concrete crib wall at Sequoia National Park. This wall is filled with crushed aggregate, though many similar structures may be constructed with planted faces.

Crib, Concrete [CC]: An open-faced version of the concrete bin wall, examples of the concrete crib wall (Figure 35) are scattered throughout the park system, coast-to-coast. These wall systems lend themselves to vegetated faces, but also suffer more rapid deterioration due to weathering and vegetation root damage than other wall types.

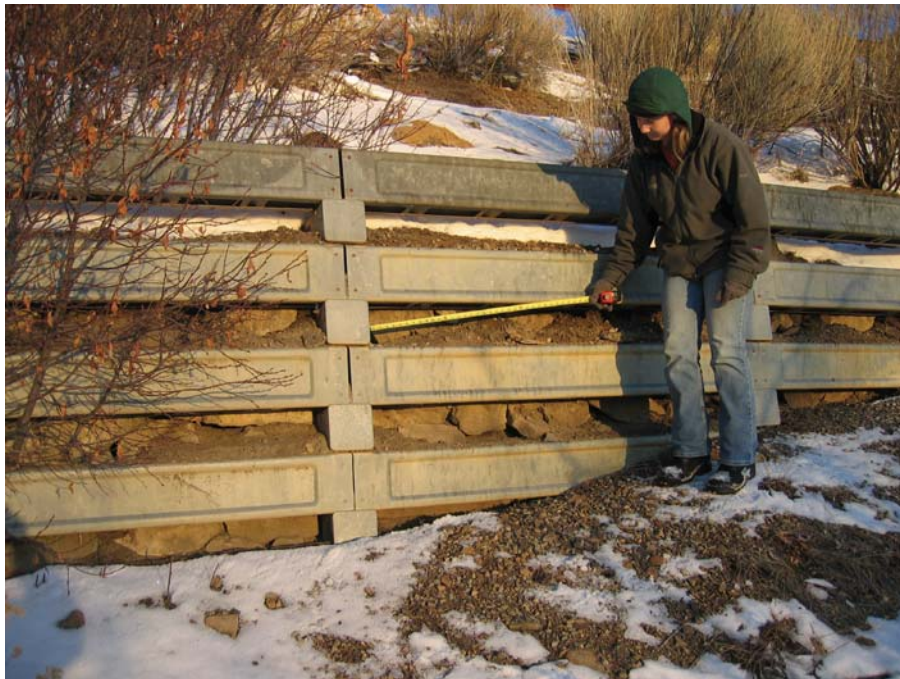
Figure 36. Photo. Metal crib wall at Mesa Verde National Park. Large rock fill was used on this wall to avoid the need for facing mats to retain fill aggregate.

Crib, Metal [CM]: Metal crib walls (Figure 36) were rarely encountered in the WIP Cycle 1 inventory. Of similar construction to the concrete crib version, the metal crib wall also suffers rapid weathering and damage from unchecked vegetation. Crib walls commonly also employ some fashion of backing mat to retain wall fill, an element that should also be rated on this structure.

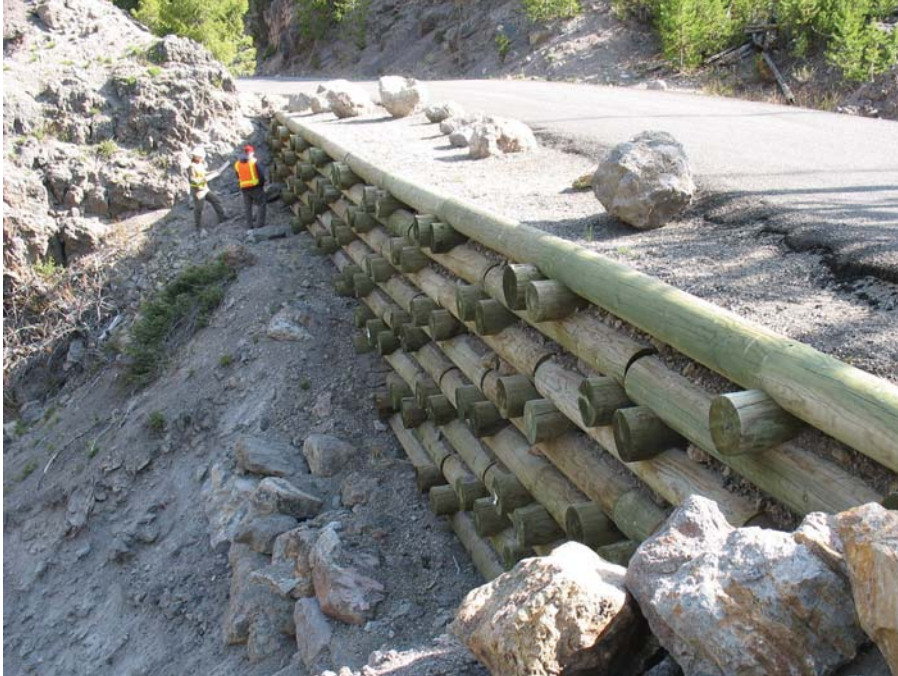
Figure 37. Photo. Timber crib wall at Yellowstone National Park employing large-diameter logs set “Lincoln Log” style on a placed rock fill.

Crib, Timber [CT]: A popular wall construction method of urban landscape architects, the timber crib wall (Figure 37) is seldom encountered in the park system. Although some small timber crib walls, built with 4-6 inch square timbers, were inspected during the Cycle 1 inventory, the more common and robust construction involved large diameter, unshaped logs with crushed rock fill.

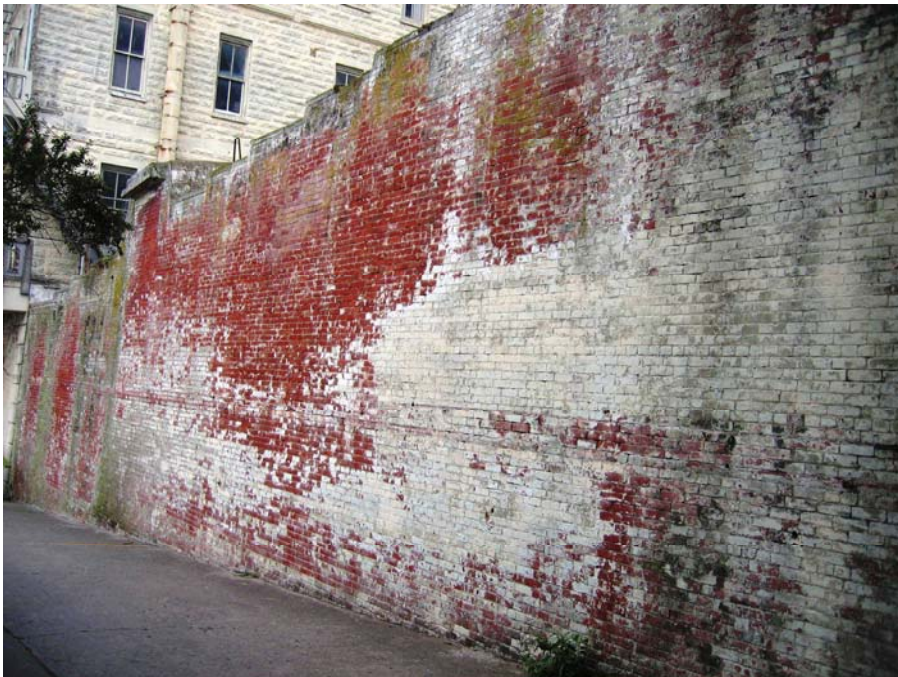
Figure 38. Photo. Tall painted brick wall at the Alcatraz unit of the Golden Gate National Recreation Area. Nearby concrete block walls suggest the interior of this wall may be constructed of larger blocks, with bricks added as a decorative facing.

Gravity, Concrete Block/Brick [GB]: Concrete block/brick walls (Figure 38) were rarely encountered during the Cycle 1 inventory. Many of these were quite tall (>8-10 ft), suggesting a different interior wall construction method (e.g., mass concrete gravity wall) employing a brick facing. Unless the interior of the wall is exposed, the wall should be classified as a brick structure.

Brick Veneer [BV]: Retaining walls are seldom constructed solely of brick. Generally, the interior of the wall is constructed of either mass concrete or larger concrete blocks (also referred to as concrete masonry units (CMU’s), cement blocks, and cinder blocks). Figure 38 is a good example of a suspected brick veneer facing.

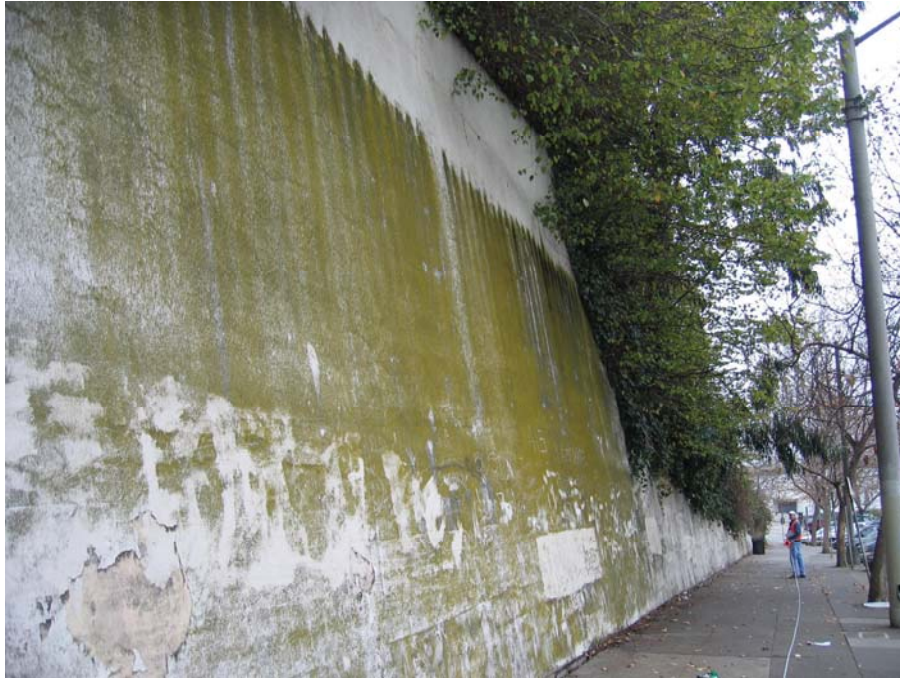
Figure 39. Photo. Painted mass concrete gravity wall bordering Ft. Mason at the Golden Gate National Recreation Area. Although less aesthetically appealing than other wall types or facings, the inspecting engineer should nonetheless be aware of the cultural sensitivity of these structures.

Gravity, Mass Concrete [GC]: As noted earlier, concrete walls accounted for nearly 10% of all walls inspected in the Cycle 1 inventory. Mass concrete gravity walls (Figure 39) generally represented structures constructed prior to 1960. These structures may or may not be steel reinforced, and often suffer from chemical weathering and poor aggregate mixes.

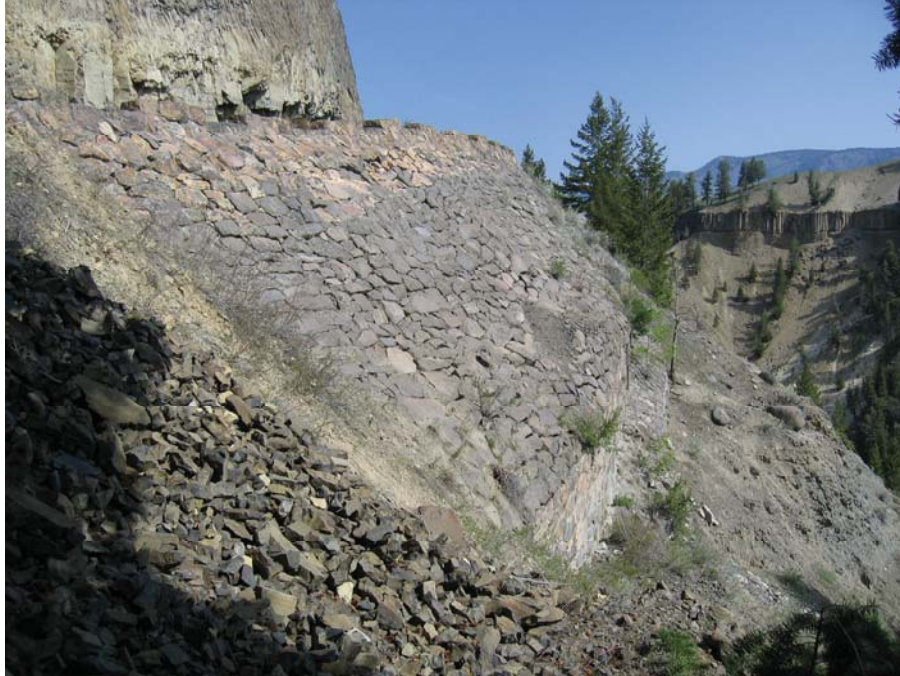
Figure 40. Photo. Dry-laid stone masonry wall at Yellowstone National Park built atop lower stone masonry wall (different construction periods?). The dimension, degree rock cutting, and placement quality of stone masonry work can vary greatly – even within a single wall.

Gravity, Dry Stone [GD]: Dry stone gravity walls (Figure 40), constructed as both cut and fill structures, represented nearly 25% of all walls inspected in the Cycle 1 inventory. Most of these walls were constructed in the 30's and 40's, and historic records indicate that dry-laid stone, either uncut or masoned, was generally used throughout the wall. It is common to find varying levels of workmanship within a single wall structure, requiring careful inspection of the entire wall face.

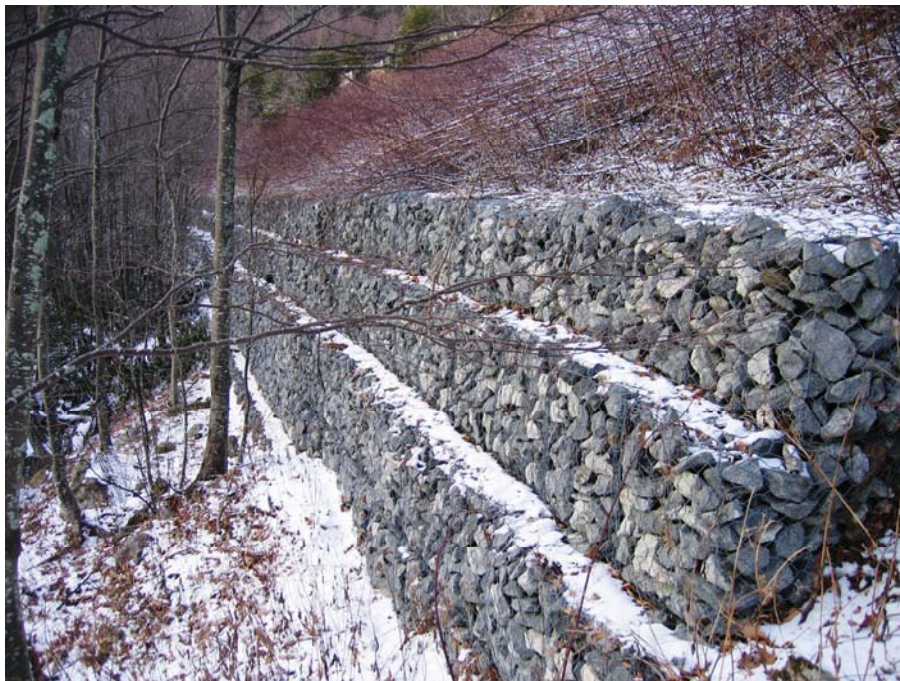
Figure 41. Photo. Angular rock fill gabion wall at the toe of a large fill along the Blue Ridge Parkway.

Gravity, Gabion [GG]: Wire-basket gabion gravity walls (Figure 41) were often encountered as outboard fill walls. In most cases, these structures were constructed at face angles flatter than 70 degrees, often approaching 1H:1V slope ratios. Although this wall system is often used as a facing for a reinforced soil mass (MSE design), unless the inspecting engineer knows otherwise the wall should be considered a gabion gravity structure.

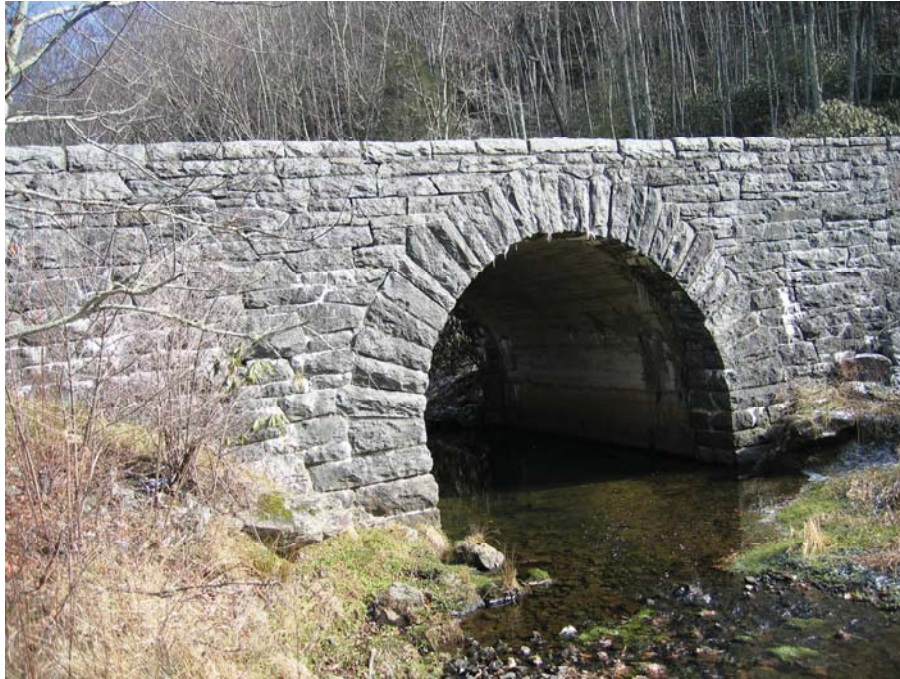
Figure 42. Photo. Mortared stone masonry head wall along the Blue Ridge Parkway. Although the mortar is often highly weathered in these structures, well-masoned and placed rock result in remarkably stable, high-performing, long-life structures.

Gravity, Mortared Stone [GM]: The mortared stone gravity wall (Figure 42) was the most common wall type encountered, accounting for nearly 50% of all walls inspected. This wall type is particularly popular for constructing culvert head walls and wingwalls, employing both uncut and masoned stone. Mortared stone masonry is also often used as an architectural treatment for a number of other wall types (e.g., concrete walls, MSE walls, soil nail walls).

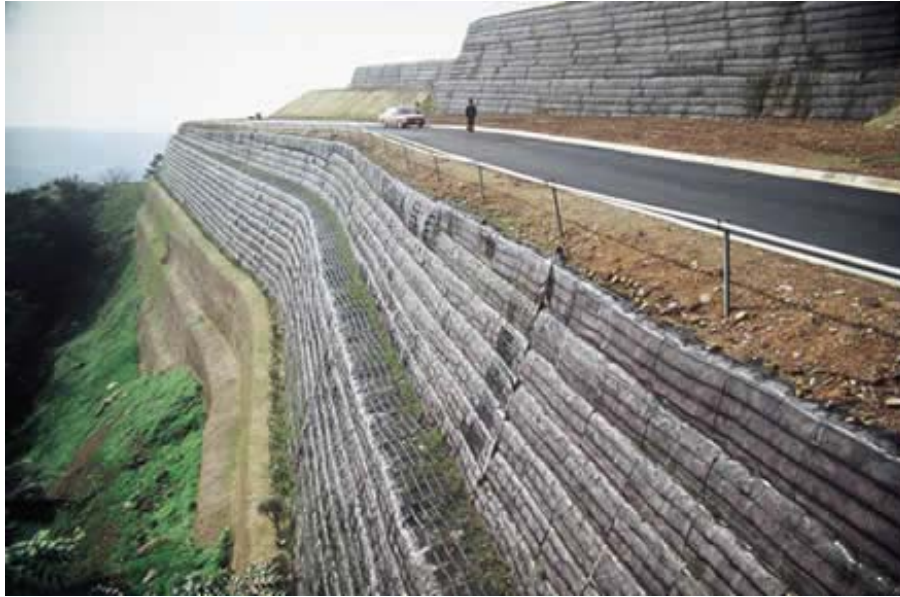
Figure 43. Photo. Multi-tiered, plantable, geosynthetic wrapped MSE wall. Although UV-resistant materials are available, the inspecting engineer should pay close attention to the degradation of exposed geosynthetics versus the age of the wall. (Courtesy Tensar Corp.)

MSE, Geosynthetic Wrapped Face [MG]: The geosynthetic wrapped face MSE wall (Figure 43) is most commonly used either as a temporary wall structure or as a permanent wall with an architectural facing, making it difficult for the inspecting engineer to identify this wall type without prior knowledge of wall construction. These fill wall structures may utilize a variety of wall facing types, including sod-wrapped geogrids providing for a vegetated finish.
