CHAPTER 4 – WALL DATA COLLECTION GUIDELINES

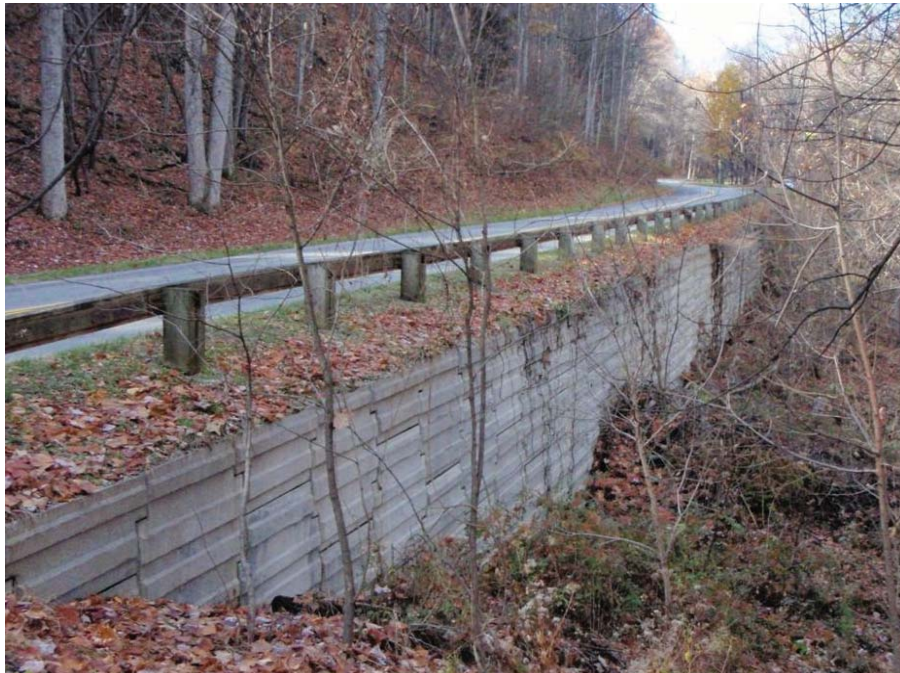
Figure 44. Photo. Precast panel MSE wall at Great Smoky Mountains National Park. A variety of architectural facing options are available, including formed concrete and stained or painted treatments.

MSE, Precast Panel [MP]: Precast panel MSE walls (Figure 44) are very popular within urban areas as the architectural facing is integral to the wall structure, thereby expediting construction in congested traffic corridors. Integral panel construction should not be confused with precast architectural facing panels that simply cover the underlying wall face (typically a wire-faced wall). Both metallic and geosynthetic reinforcements are used with this wall type, though determining which has been used may not be possible during the site inspection.

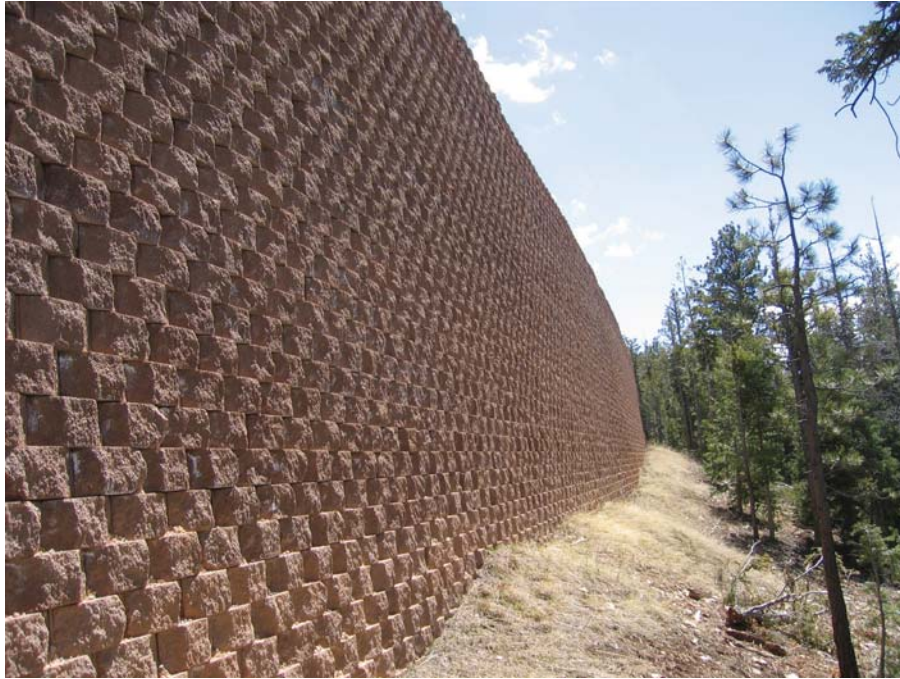
Figure 45. Photo. Segmental block wall with geogrid reinforcement at Bryce Canyon National Park. Although MSE walls can tolerate substantial settlements, brittle facings such as blocks or precast panels can result in severe cracking with relatively minor differential displacements.

MSE, Segmental Block [MS]: A wide variety of block styles and configurations may be used to build segmental block MSE structures (Figure 45). Reinforcements are generally geosynthetic fabrics or grids, and can often be seen extending beneath blocks along the face. As with the

precast panel walls, blocks can also be used solely as architectural facings in front of wire-faced walls.

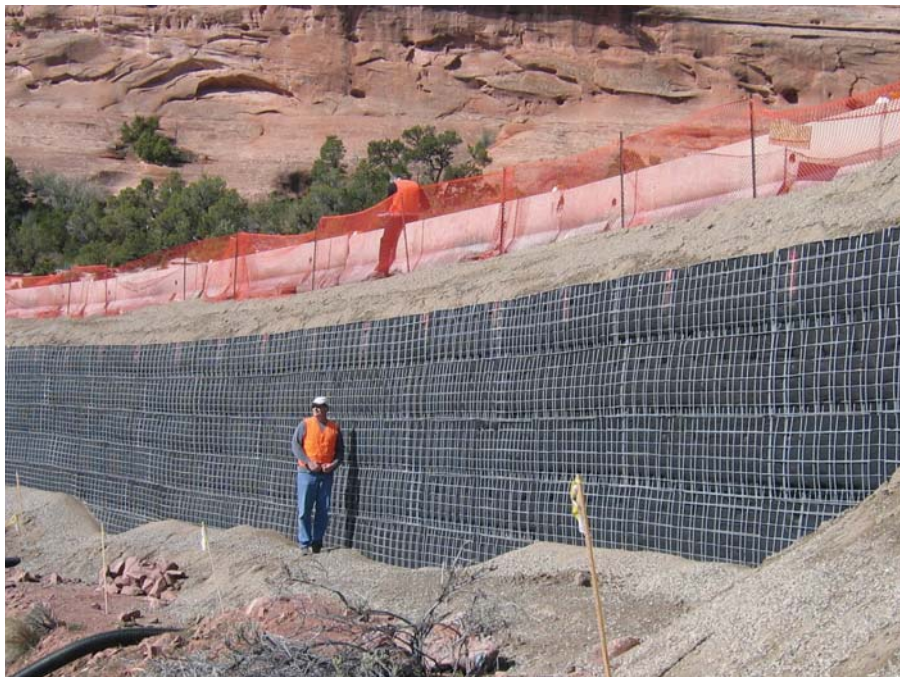
Figure 46. Photo. Wire-faced MSE wall, nearing completion at Colorado National Monument, utilizes a geosynthetic fabric to ensure retention of the metallic-grid reinforced aggregate. Left unprotected, this facing system would be susceptible to UV damage in the years to come.

MSE, Welded Wire Face [MW]: Welded wire face MSE walls (Figure 46) are perhaps the most common MSE applications in the Cycle 1 database. Although standard wire mats are used to retain fill material at the face, supplemental materials such as hardware cloth and geotextiles may be used along with variable sized facing aggregate and face staining options.

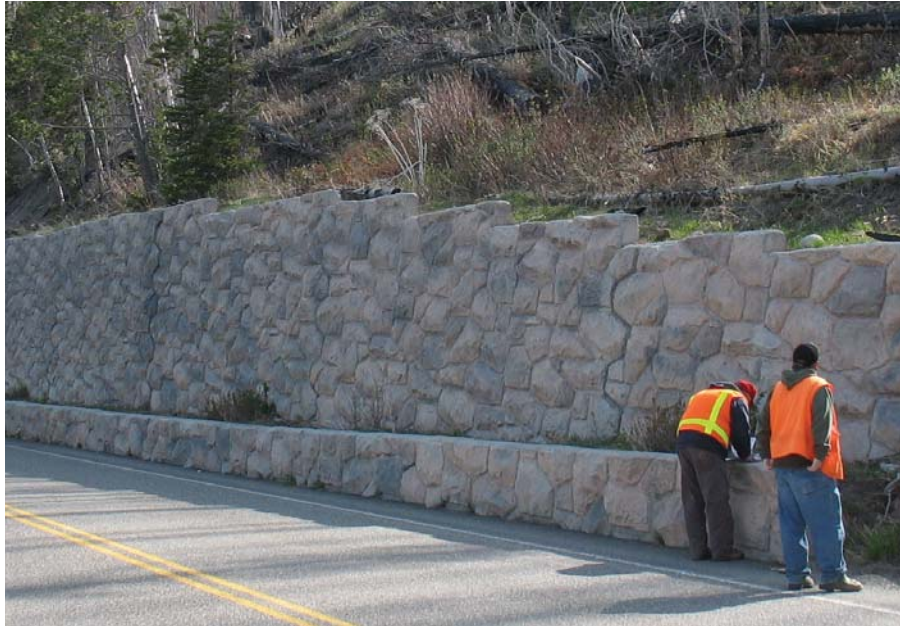
Figure 47. Photo. Soil nail wall at Yellowstone National Park with a form-lined, cast-in-place simulated stone structural facing. The formliner is subsequently stained or painted to better simulate natural stone.

Soil Nail [SN]: Soil nail walls (Figure 47) are a cut wall technique employing grouted steel bars (nails) as ground reinforcement. Permanent soil nail walls typically have at least a structural shotcrete facing, though a wide variety of facings can be employed, ranging from stone masonry work to extravagantly sculpted, stained and/or painted shotcrete. Unless the inspecting engineer is aware of the construction method used at the time of the inspection, correctly classifying a cut wall structure as a soil nail wall can be very difficult, particularly when a rock facing is used.

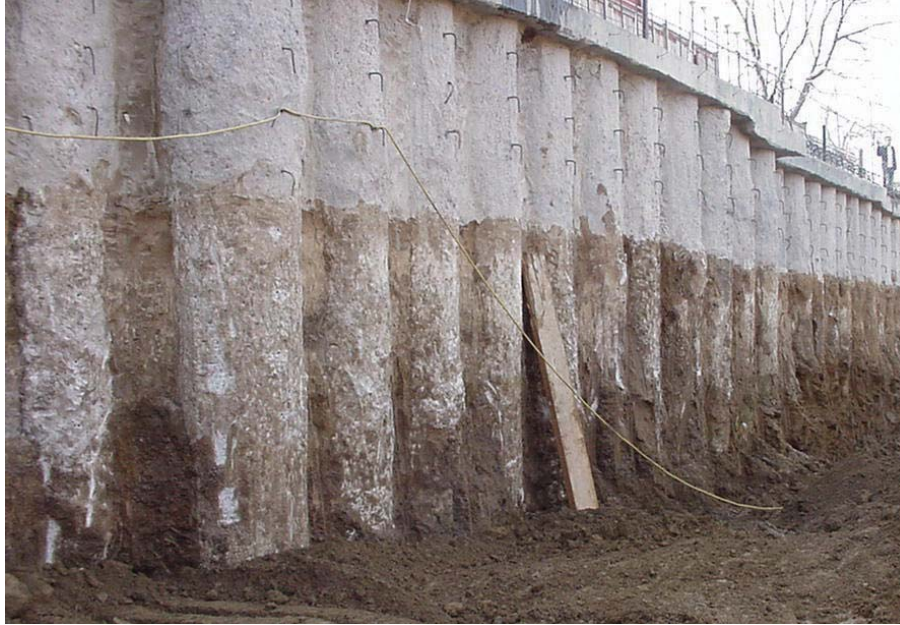
Figure 48. Photo. Tangent pile cut wall constructed of drilled shafts. This expensive wall system is primarily used where top-down soil nail or ground anchor construction is not feasible due to subsurface obstructions within the retained ground mass.

Tangent/Secant Pile [TP]: The tangent/secant pile wall (Figure 48) is a cut wall design typically employed where very small horizontal deflections can be tolerated and tieback systems cannot be used (e.g., urban constructions involving neighboring structures). These walls are typically faced with precast panels upon wall completion, so identifying them in the field would be nearly impossible without prior knowledge of the construction method.

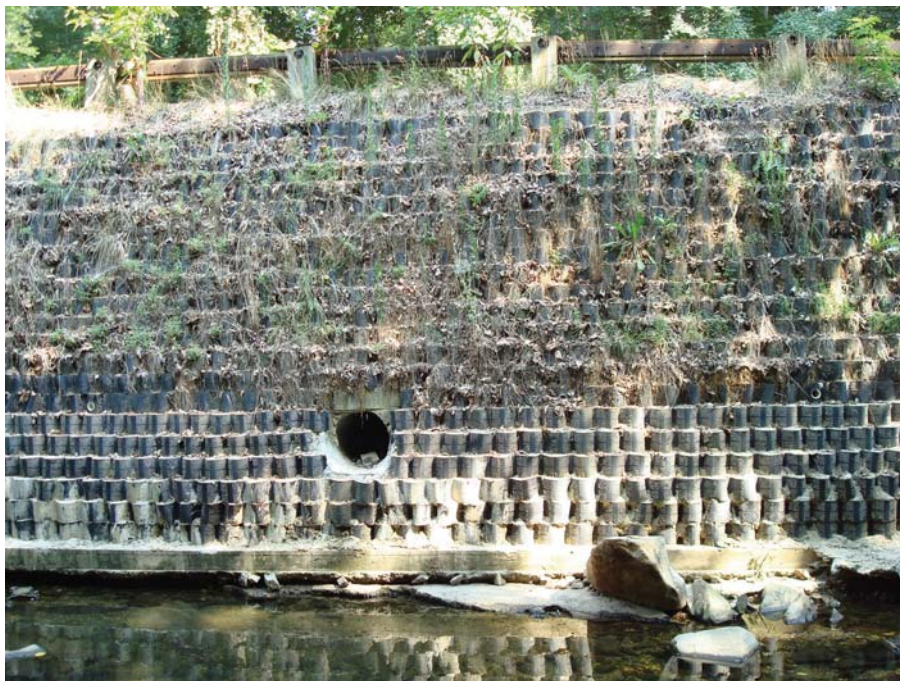
Figure 49. Photo. “Other” wall type: geosynthetic reinforced earth wall with planted geocell facing. This wall facing method may prove to be a superior means for establishing face vegetation in high growth climates. Note the installation of the concrete leveling pad.

Other, User Defined [OT]: “Other” refers to wall types rarely encountered in park roadway construction, including patterned ground anchors, segmental concrete “T” walls, cantilever “Z” walls, slurry walls, split-tire gravity walls, etc. (Figure 49 and 50).

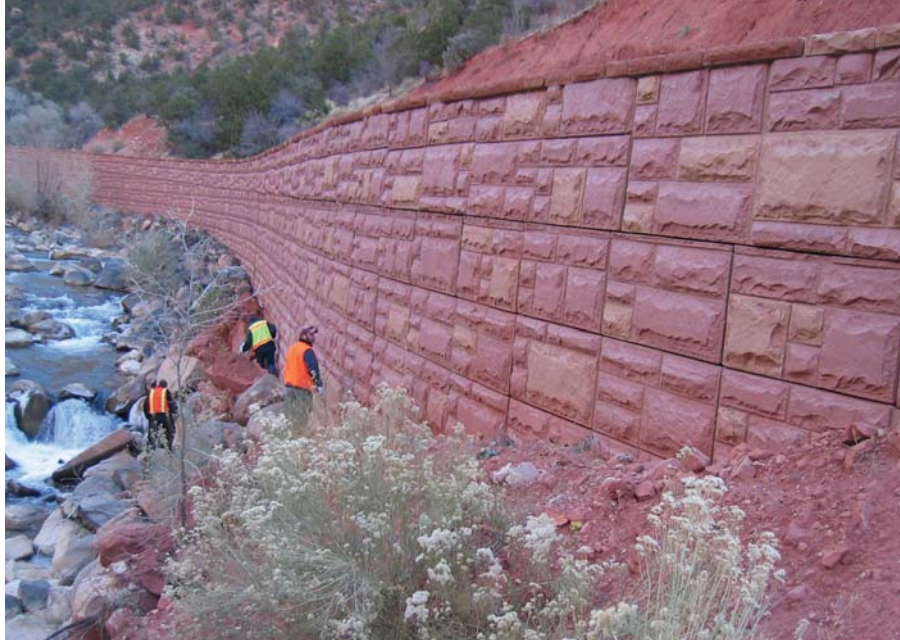
Figure 50. Photo. “Other” wall type: segmental concrete “T” wall at Zion National Park. Each precast “T” panel has concrete ribs extending into the compacted retained fill to serve as ground reinforcement and facing panel anchorage. The Ashlar block formliner was stained to match the surrounding country rock.

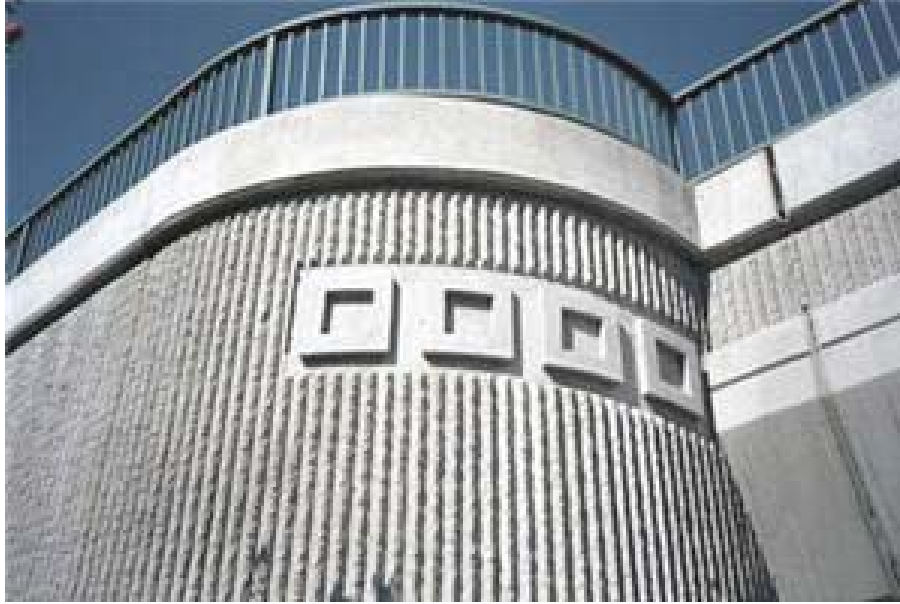
Figure 51. Photo. Example of one of the many “Fractured Fin” formliner architectural facing treatments available and commonly used in urban construction. (Courtesy Fitzgerald Formliners)

Fractured Fin Concrete [FF]: Fractured fin concrete (Figure 51) refers to a specific, yet popular category of formlined architectural treatments employing smooth/rough linear relief (striations, grooves, ridges – “fins”). This family of architectural concrete patterns is commonly seen throughout urban architecture, but is rarely seen within the park system.

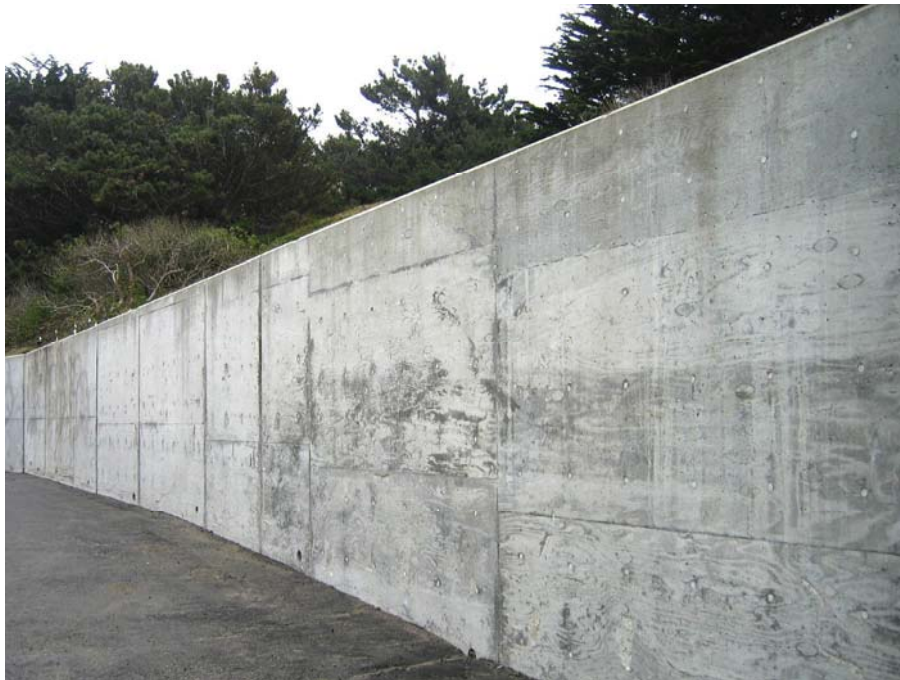
Figure 52. Photo. Although a seemingly accidental wall finish, a rough wood formliner was actually used in the construction of this concrete cantilever wall at Golden Gate National Recreation Area to simulate historical concrete construction practices throughout the park. This example emphasizes the need to discuss the cultural attributes of retaining walls with park resource staff prior to undertaking site inspections.

Formlined Concrete [FL]: Formlined concrete (Figure 52) refers to a broad category of concrete facing finishes achieved by placing patterned molds within the concrete forms. Examples range from the aforementioned geometrical “Fractured Fin” patterns to simulated stone or brick patterns, to extravagant reliefs involving images of landscapes, animals, unique designs, etc. Figures 47 and 50 are typical examples of formliner applications within the park system. Surface treatments including color additives, stains and paint may be used in conjunction with formliner facings.

Plain Concrete (float finish or light texture) [PC]: As the name implies, plain concrete simply refers to a float finish with minimal texturing applied, if any. As illustrated in Figure 52, the inspecting engineer should be careful to not minimize the potential cultural importance of these facing finishes.

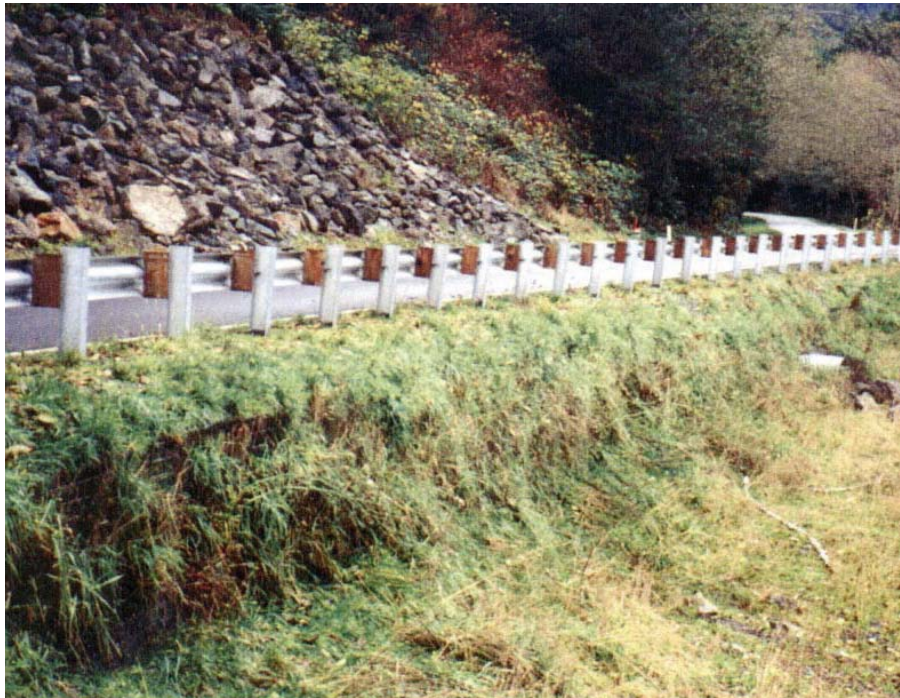
Figure 53. Photo. A well-vegetated wire-faced MSE wall in Siskiyou National Forest. Grasses, small bushes and other forms of light ground cover are appropriate for vegetated wall faces. Trees growing from the wall face or along the top of the wall, present a wall performance threat.

Planted Face [PF]: Planted face architectural treatments (Figure 53) are often found on geosynthetic-wrapped walls, but may also be used in conjunction with wire-faced MSE and gabion walls, as well as a variety of tiered wall types. Planting pockets can be sources for the onset of wall facing failures. The inspecting engineer should also consider that although it may be desirable for a particular wall face to be vegetated, not all forms of vegetation are good for long-term wall stability (e.g., trees growing from the facing).

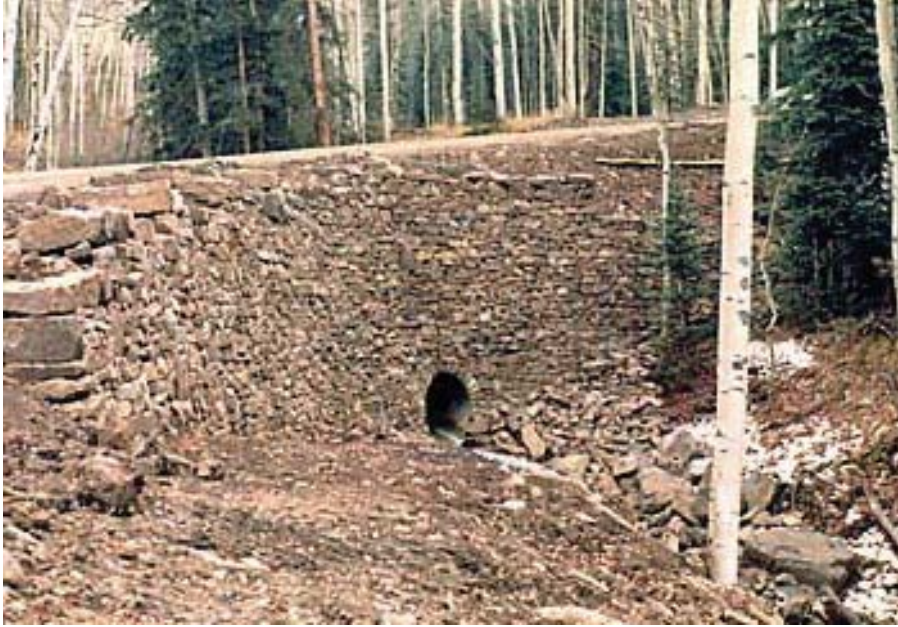
Figure 55. Photo. Single-course, mortared stone facing placed in front of an MSE wall structure. Well-built facings can make it very difficult to discern modern facades from historical structures. (Courtesy Mountain Village Metropolitan District, Telluride, CO)

Stone [SO]: Stone facings, mortared or dry-laid treatments comprised of one or more courses of stone across the thickness of the facing, are occasionally used in front of soil nail walls and MSE structures (Figure 55). Stonework can range from highly-masoned, “hand-sized” pieces to large machine-placed rockery material.

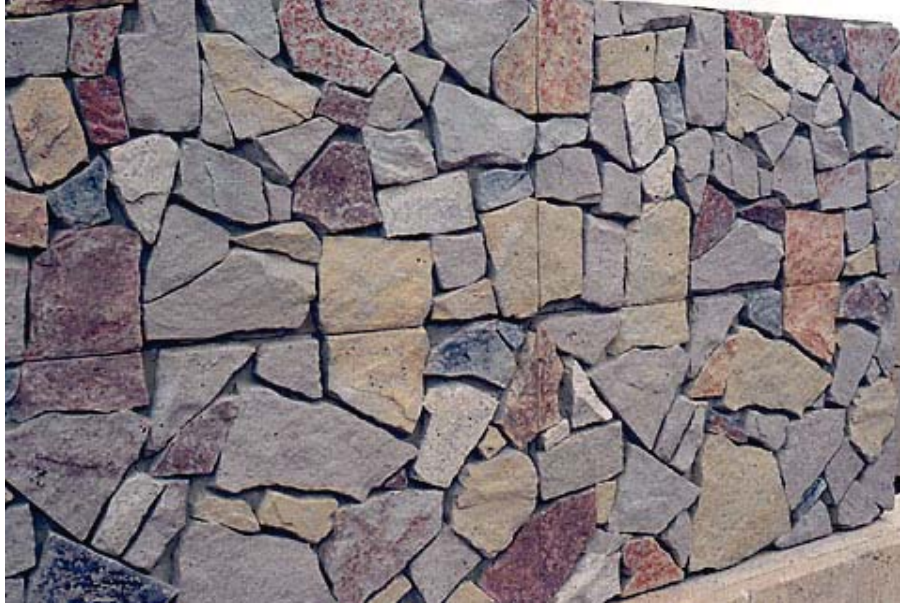
Figure 56. Photo. Simulated stone using a deep-inset formliner and individually stained rock units. This application attempted to disguise the form joints by matching whole rocks panel-to-panel. (Courtesy Vail Associates)

Simulated Stone [SS]: Simulated stone (Figure 56) is generally considered a type of formliner treatment, but may also include such things as individual artificial stone products mortared on the wall face or precast concrete simulated stone masonry blocks (e.g., Ashlar blocks).

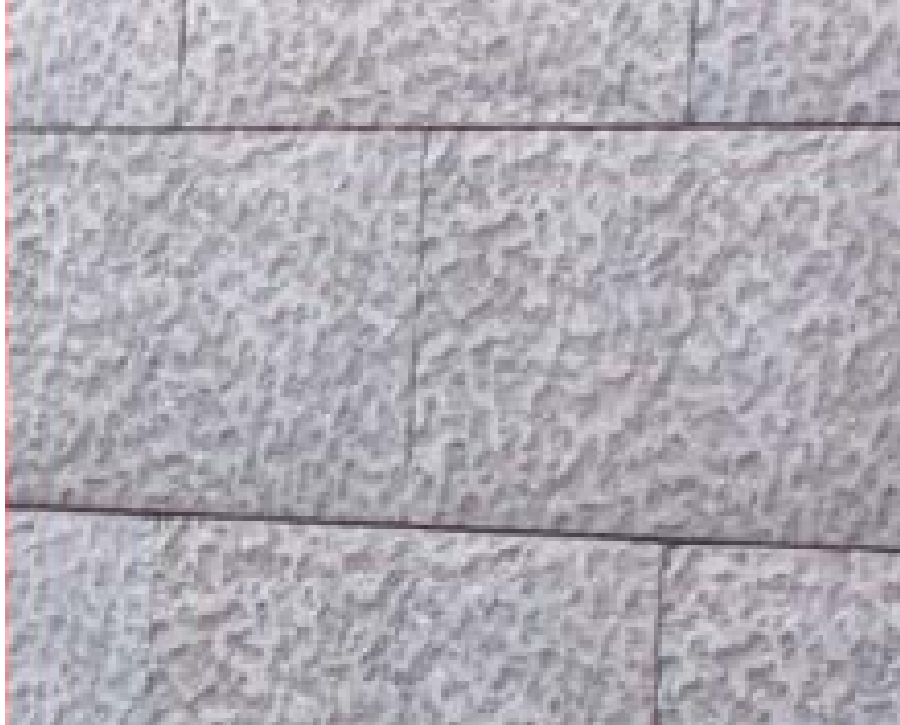
Figure 58. Photo. Example of concrete blocks textured with a bush hammer prior to placement. A range of textures can be created with this technique, depending on the hammer head size and configuration. (Courtesy Doublewal Corporation)

Bush Hammer (tool-textured concrete) [BG]: A bush hammer is a masonry tool used to texturize stone and concrete (Figure 58). As the tool impacts the surface, a rough, pockmarked texture is created that simulates a naturally weathered surface. Tooling of the material may be done on site, in the case of cast-in-place concrete structures, or may be completed on precast wall elements prior to shipping. Although this surface treatment is rarely applied to park concrete structures, it is often seen on concrete panels used as architectural facings for MSE walls.

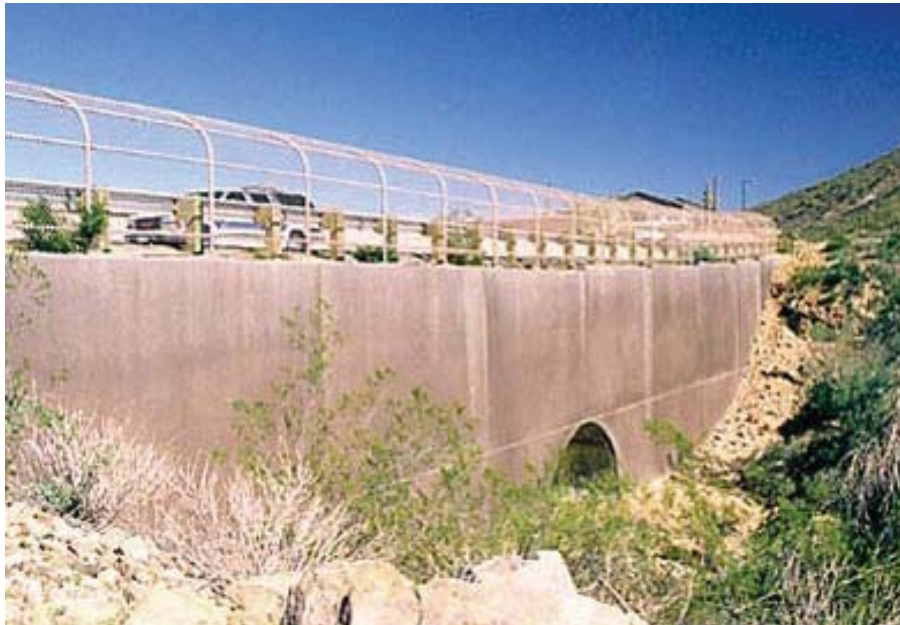
Figure 59. Photo. Example of float-finished, colored shotcrete applied over an MSE wall facing. (Courtesy Maricopa County, AZ)

Color Additive [CA]: Color additives may be added to both cast-in-place and precast concrete wall elements (Figure 59), including modular blocks and architectural facing panels (Figures 44 and 49). Colored shotcrete is used for both sculpted and nozzle finish applications.

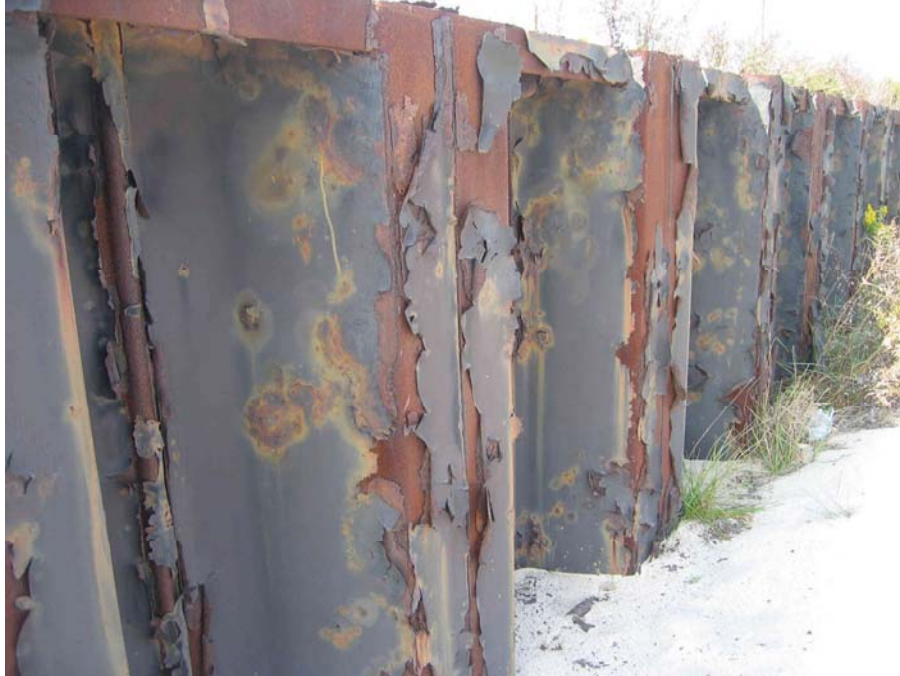
Figure 60. Photo. Severe weathering distress is evident on painted steel sheet piling at the Sandy Hook Unit, Gateway National Recreation Area. Less conspicuous weathering of painted surfaces can be difficult to discern without close inspection and knowledge of the most recent paint applications.

Painted [PA]: The most common application of paint-based treatments is corrosion protection of steel piling and non-galvanized steel fixtures (Figure 60). However, paint is also used on concrete, brick and wood surfaces, and ranges from poorly-applied, unprimed coatings to highly crafted applications simulating natural stone.

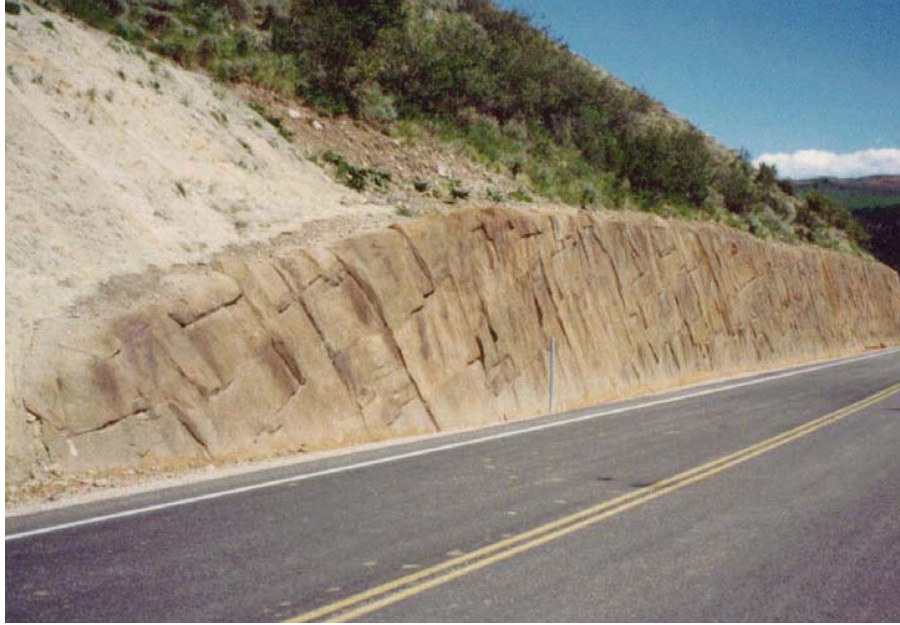
Figure 61. Photo. Example of sculpted shotcrete stained to match the surrounding landscape. Fading due to seasonal weathering and UV damage may require additional staining to meet aesthetics objectives.

Stain [ST]: Stains (Figure 61) can be applied to a wide range of wall types and architectural facings, including concrete, shotcrete, metal and wood elements, as well as rock fills in MSE and gabion walls. Although stains are generally applied for aesthetic purposes, many types of stain treatments also serve as wall element preservatives.

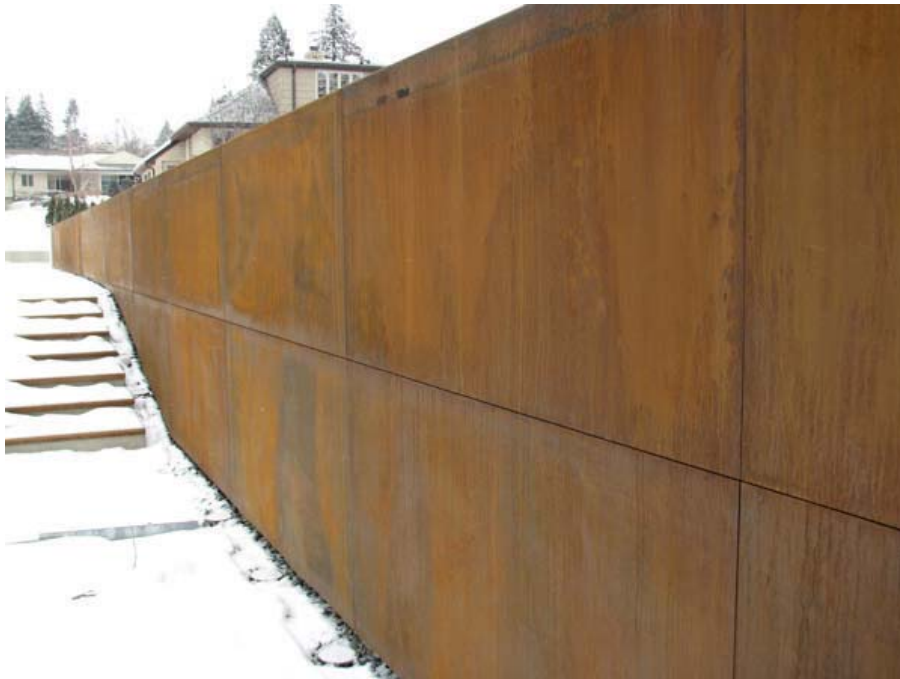
Figure 62. Photo. Weathering steel, sold under the “CORTEN” trademark, can provide a long-life, low-maintenance surface treatment for wall systems in the right environment. (Courtesy Richer Metal, Dodge Center, MN)

Weathering Steel [WS]: Weathering steel (Figure 62), best-known under the trademark CORTEN steel, is a group of steel alloys developed to eliminate the need for corrosion protective coatings and painting, forming a rust-like appearance if exposed to the weather for several years.

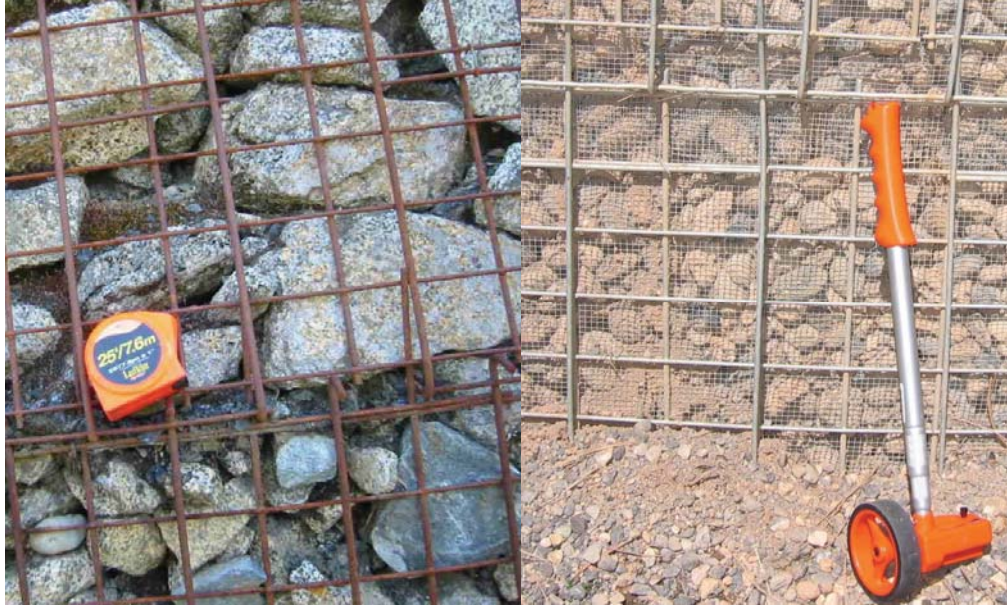
Figure 64. Photo. Not all MSE wall facing systems are the same. Mats may or may not be galvanized (left) and, depending on the size of facing fill versus the minimum wire mat opening, hardware cloth may or may not be required for fill retention (right).

facing stone that may be readily observable in the wall facing (Figures 46 and 64). Describe the component materials, placement location, special appurtenances (e.g., facing panel struts) and method of construction in the condition narrative (e.g., 4-in-square, galvanized wire mesh gabion baskets with 6-in to 8-in round river rock fill; sod-rolled, geogrid-wrapped, geogrid reinforced face).

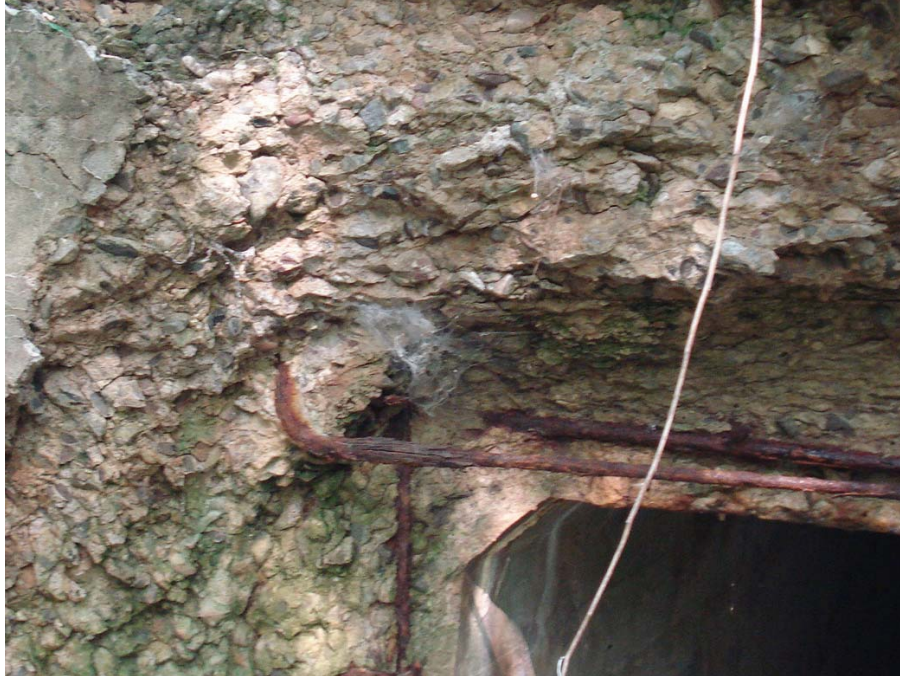
Figure 65. Photo. Severely weathered reinforced concrete headwall at Delaware Water Gap National Recreation Area.

Concrete: “Concrete” refers to visible precast or cast-in-place concrete wall and footing elements (Figure 65). Concrete piles, lagging, crib blocks, manufactured block/brick, and architectural facing elements are not included under this element. Describe the type of concrete (if known), size of aggregate (if visible), and method of construction (pre-cast/cast-in-place) (e.g., non-reinforced, cast-in-place concrete with rounded “river run” aggregate).

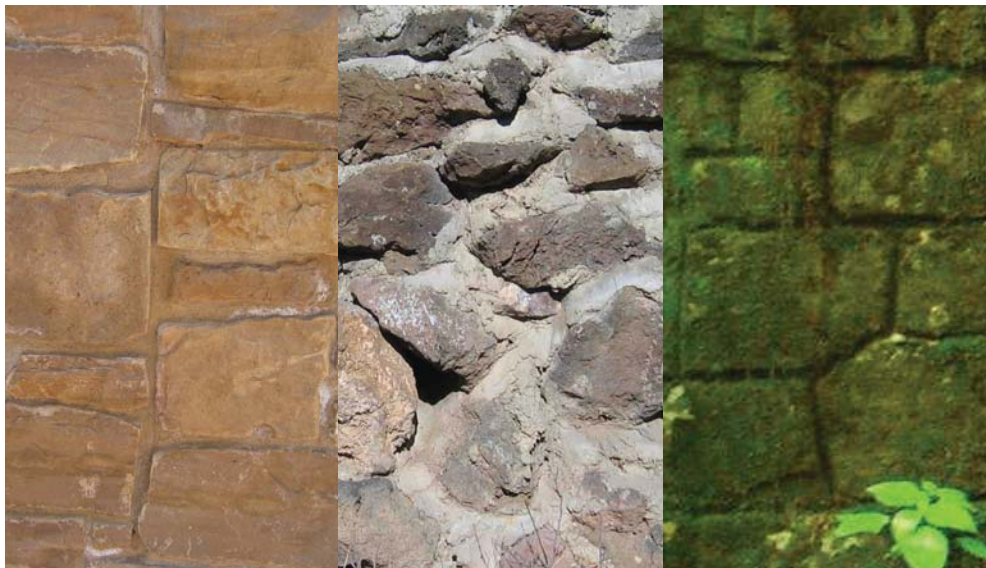
Figure 66. Photo. Not all mortar applications are the same: (from left-to-right) highly-crafted mortar placement on fairly new wall at Bryce Canyon National Park; poor, inconsistent mortaring at Capulin Volcano National Monument; well-placed, yet highly weathered mortar showing signs of excessive seepage through headwall at Great Smoky Mountains National Park.

Mortar: “Mortar” refers to visible mortar used between either uncut, “pitched” (hand-worked) or masoned rock, between manufactured blocks or brick, or used for wall repairs (Figures 66 and 67). Describe the type of mortar used (if known), placement quality, whether or not the mortar was placed at the time of wall construction, if repointing work is evident, and if mortar reinforcement was used (e.g., mortared stone masonry wall with unfinished mortar joints; trowel-finished, mortar set solid cinder blocks; trowel-finished mortar patch with chicken wire reinforcement). [NOTE: Additional discussion on repointing is provided in sections 1.3 A Program Perspective on Deferred Maintenance and 4.4.6 Recommended Action.]

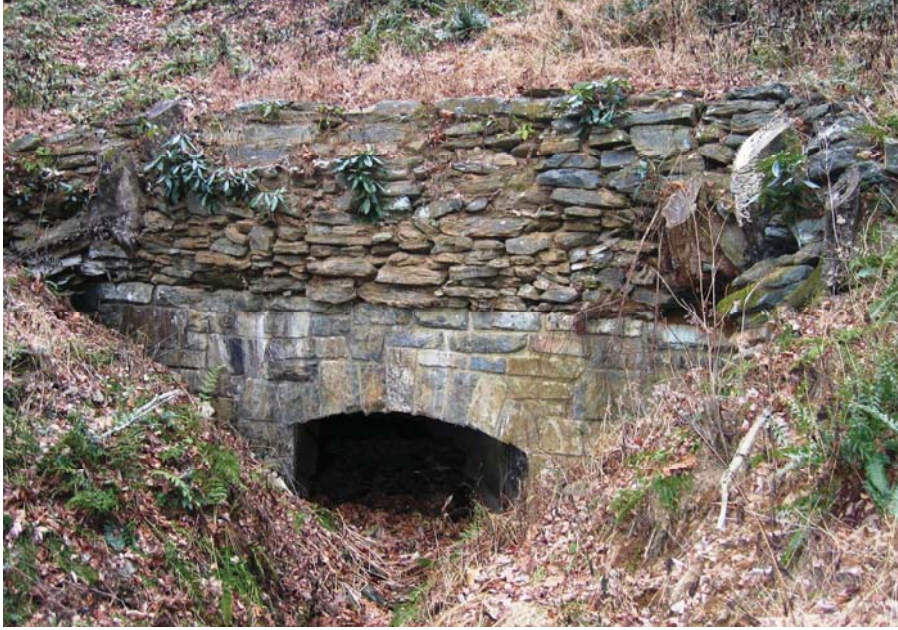
Figure 67. Photo. A mortared stone masonry headwall along the Blue Ridge Parkway, subsequently overlain with a dry-laid, placed-stone retaining wall built around trees growing at either end of the headwall.

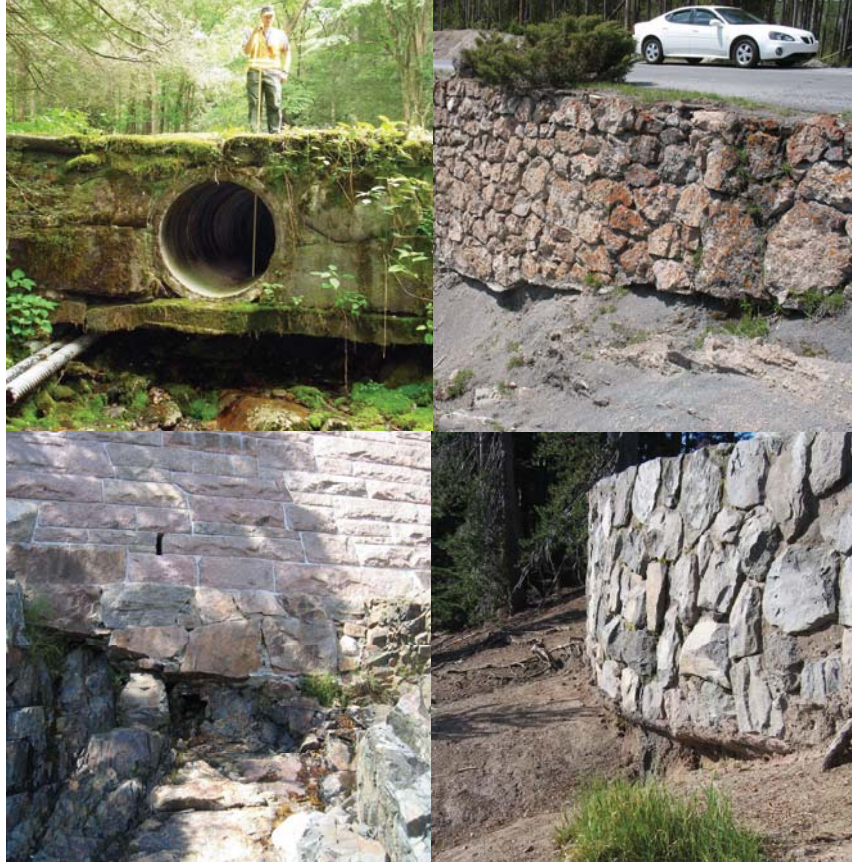
Figure 68. Photo. Examples of deteriorating wall foundation conditions: (clockwise from upper left) outlet scour at culvert headwall, Great Smoky National Park; soft soil erosion from under mortared stone masonry walls at Yellowstone and Crater Lake National Parks; deteriorating rock foundation at Acadia National Park.

Wall Foundation Material: “Wall Foundation Material” refers to the visible soil and/or rock immediately adjacent to and supporting the wall, within 2-4 ft of the wall toe or noticeable bench in front of the wall on steep slopes (Figure 68). Describe the type of foundation material present or missing, apparent strength of the foundation material, and construction characteristics of the foundation (e.g., hard, intact bedrock foundation throughout; soft, clayey soil foundation, scoured beneath 50% of the wall). The performance of buried foundation elements such as spread footings or piles is not captured under this condition element but, rather, under the “Performance” element in the “Wall Performance” section of the condition assessment (described later in this section).

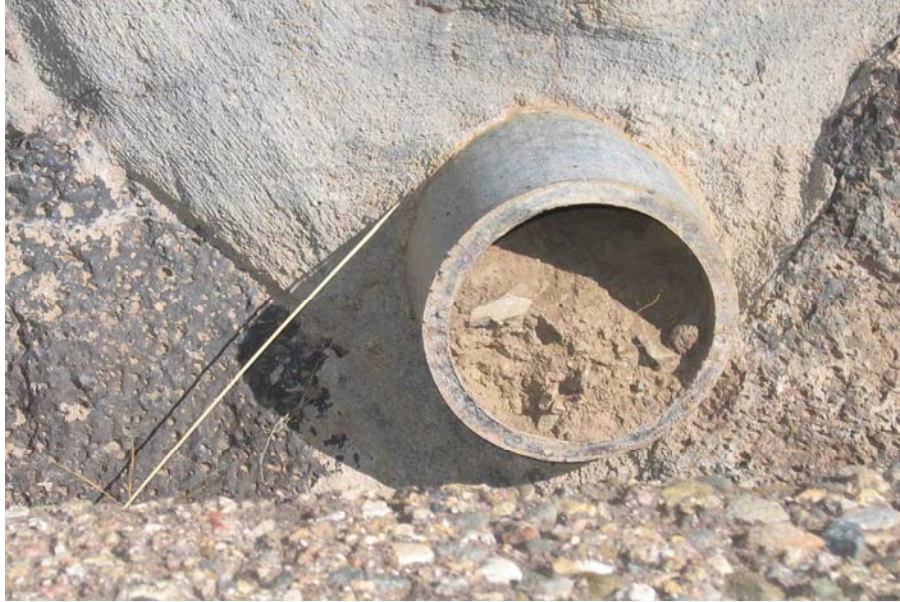
Figure 69. Photo. Plugged “weephole” drain at bottom of mortared stone masonry wall.

Wall Drains: “Wall Drains” refers to the function and capacity of visible drain holes, pipes, slot drains, etc., providing wall *internal or subsurface drainage* (Figure 69). Describe the type and occurrence of wall drain(s), as well as the occurrence and magnitude of seepage through and around the wall (e.g., PVC weephole drains at toe of wall on 50-ft centers). A lack of visible wall drains requires the inspecting engineer to judge the overall drainage capability of the retaining structure, noting the presence of such things as soft and/or wet foundation soils, retained material piping from the wall face, excessive corrosion staining/efflorescence at specific wall locations, distressed elements immediate to seepage locations, etc. In the absence of visible wall drains and potential water-related problem areas, Wall Drains should be judged as functioning as intended.

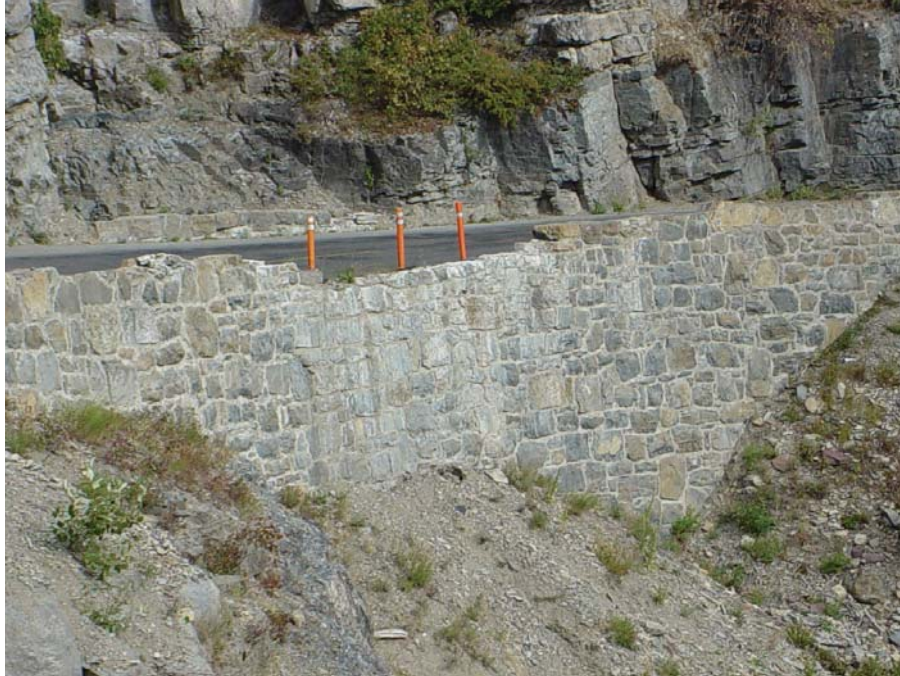
Figure 70. Photo. A section of parapet along this mortared stone masonry wall at Glacier National Park has been damaged due to vehicular impact. This portion of the wall would be assessed and rated under the “Traffic Barrier/Fence” secondary element.

Traffic Barrier/Fence: “Traffic Barrier/Fence” (Figure 70) refers to the condition of barriers, guardwalls, parapets and/or fences above, below or within the influence of the wall. Only describe and rate the barrier relative to wall performance, not its performance as a barrier (traffic barrier performance is evaluated under other asset and/or roadway safety programs). Describe the type, size and location of the barrier relative to the wall in the condition narrative (e.g., galvanized “W” guardrail on wood posts; mortared stone masonry parapet serving as constructed guardwall). This element should not be rated when the barrier structure lies outside the known or assumed influence of the wall, including the retained earth volume and adjacent slopes.

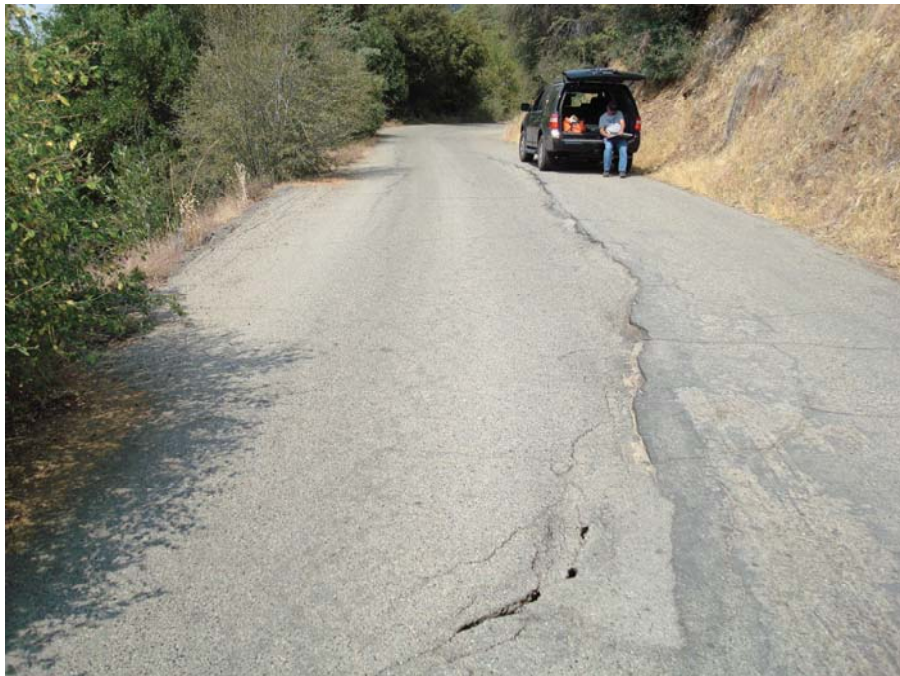
Figure 71. Photo. Severe roadway damage due to timber crib wall fill settlement, loss of fill material, foundation bearing failure or global slope instability (or combination thereof).

Road/Sidewalk/Shoulder: “Road/Sidewalk/Shoulder” (Figure 71) includes the road, sidewalk and/or shoulder above or below a wall, and within the influence of the wall. These features should only be described and rated relative to wall performance; for example, pavement performance should not be rated, however, wall fill settlement seen as roadway patches should be described and rated. Describe the type, size, location and construction method(s) for each of these elements (e.g., 20-ft wide asphalt road surface with 5-ft-wide gravel shoulders on 3H:1V outboard slope; 6-ft-wide concrete sidewalk). The shoulder is generally defined as extending no greater than 5 ft horizontally from the roadway/sidewalk, and with less than a -5 ft vertical offset.

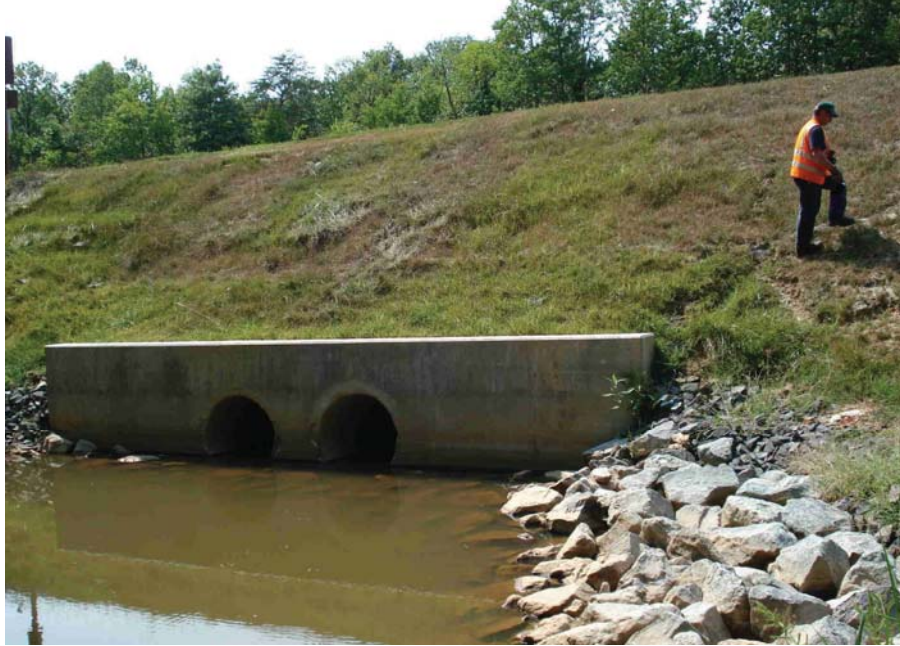
Figure 72. Photo. Assuming the head wall height meets the 6-ft criterion, the overlying slope would be evaluated as an “Upslope” secondary element.

Upslope: “Upslope” (Figure 72) refers to the groundslope above a wall affecting wall condition and/or performance. Describe and rate the upslope condition for all walls located above roadway grade, regardless of slope ratio. Rate the upslope condition for all walls located below roadway grade, regardless of slope ratio, when the vertical offset to the wall is greater than 5 ft (otherwise include the condition of the upslope under the “Road/Sidewalk/Shoulder” element). Look for slumps, cracks, seeps, bulges, erosion, etc. that may affect wall performance. Describe the approximate slope ratio, slope height, and slope soil/rock constituents (e.g., lightly vegetated roadway fill extending 15-ft above top of wall at a 1.5H:1V slope ratio).

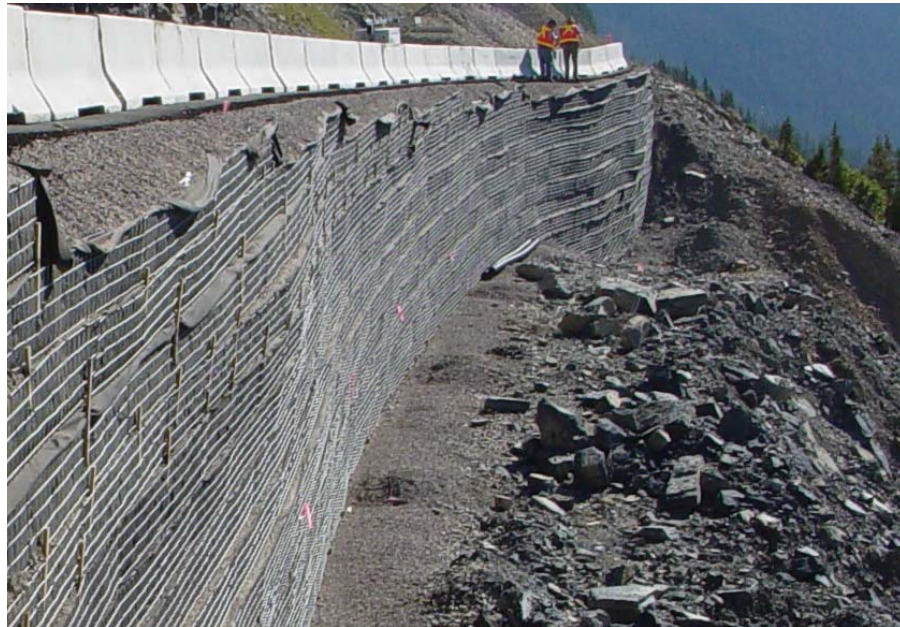
Figure 73. Photo. MSE wall at Glacier National Park awaiting final facing. The bench in front of the wall would be evaluated as a “Wall Foundation Material” primary element. The rocky slope below the bench would be evaluated as a secondary element under “Downslope”.

Downslope: “Downslope” (Figure 73) refers to the groundslope area below a wall, distinct from the Wall Foundation Material element, and possibly affecting wall condition and/or performance. Describe and rate the downslope condition for all walls above or below roadway grade, regardless of slope ratio. In the case of above grade walls (e.g., cut wall above inboard ditchline), describe the downslope below the foundation materials, which may include the ditchline and roadway bench. For walls that toe into the bottom of steep upslopes (e.g., culvert inlet headwall in an inboard ditch), describe the downslope setting (actually grading uphill from the toe of the wall/inlet structure) and the slope conditions. For walls that toe into an inlet/outlet drainage, describe the condition of the drainage. Look for slumps, cracks, seeps, bulges, erosion, etc. that may affect wall performance. Describe the approximate slope ratio, slope height, and constituent soil/rock materials (e.g., 10-ft of highly eroded roadway fill material on a 1H:1V downslope over 100+ ft of highly weathered rock; inboard headwall toes at base of steep (4H:1V) stable rock slope; stream channel below outlet headwall is deeply incised in soil/cobble matrix, with signs of head-cutting to headwall and wingwall foundations).

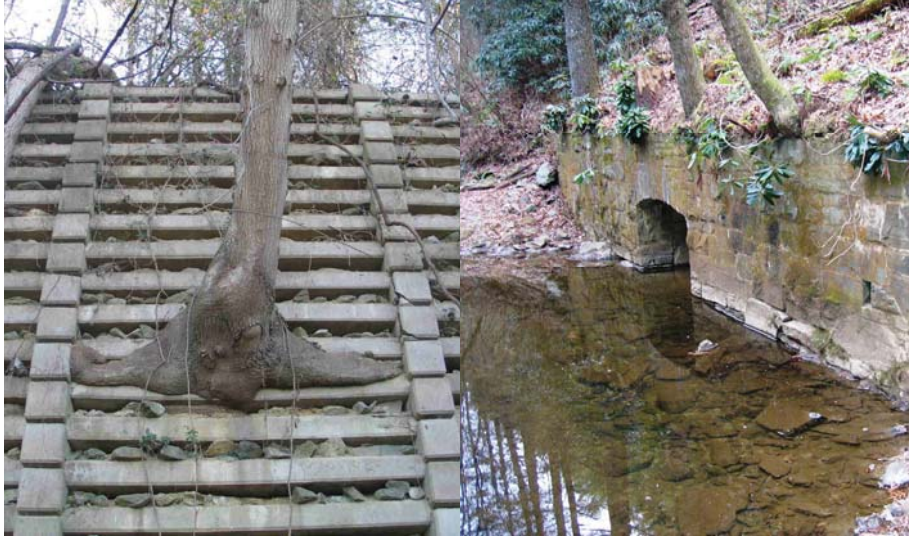
Figure 74. Photo. Left unchecked, trees will grow just about anywhere, and can cause severe damage to retaining walls.

Vegetation: “Vegetation” refers to all forms of vegetation near the wall or on the wall face affecting wall performance (Figure 74). Describe the type, size, relative age and extent of vegetation when current growth impacts wall performance, or may potentially impact wall performance in the future. The overall impact of vegetation should also be carefully considered – good or bad – and noted in the condition narrative (e.g., roots from approximate 6-in-diameter trees at top of wall are pushing dry-laid stones from wall face; shrubs growing above, between, and below gabion baskets are mitigating run-off erosion of soft, silty soils).
