CHAPTER 4 – WALL DATA COLLECTION GUIDELINES

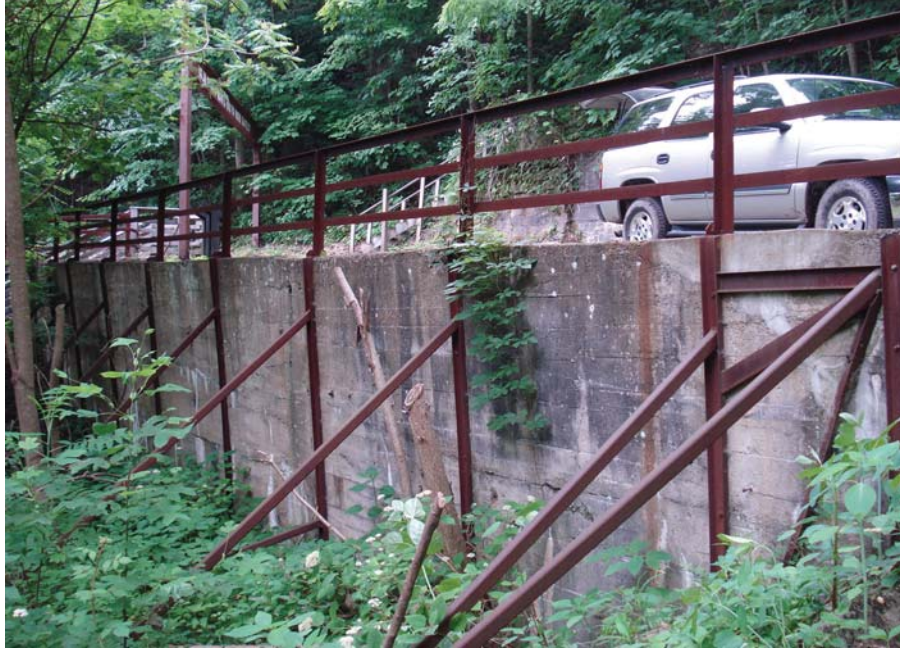
Figure 76. Photo. Developing wall problems at New River Gorge National River evidenced by post-construction remedial actions.

Figures 75 and 76 present examples of wall distress that would be captured in the overall wall “Performance” description.

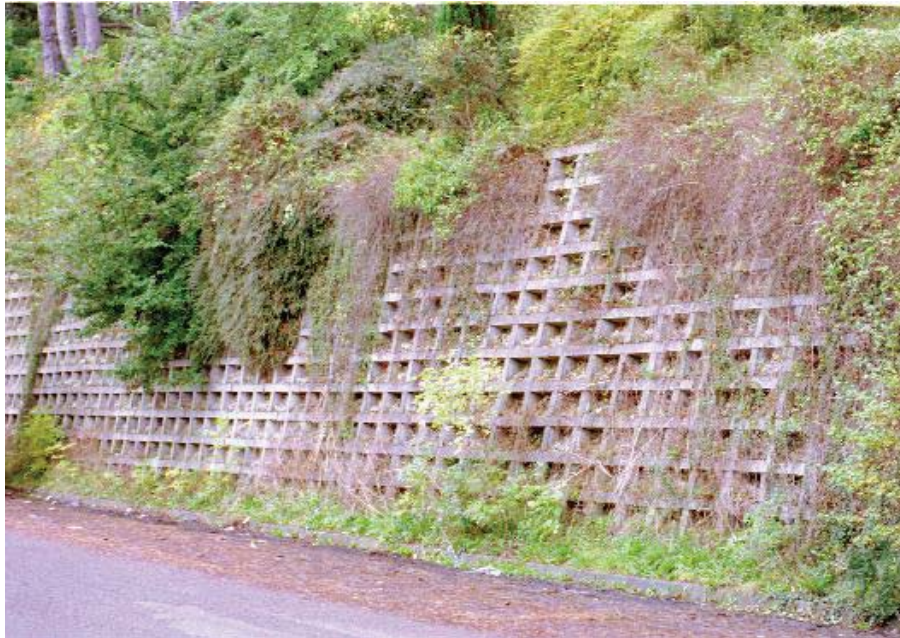
Figure 78. Photo. A sizeable portion of this concrete crib wall is obscured by heavy vegetation. Although observed conditions are sufficient to rate the condition of wall elements, additional investigations might be required or recommended to better understand element performance, particularly if material or structural problems were suspected. (Data Reliability Factor = 2)

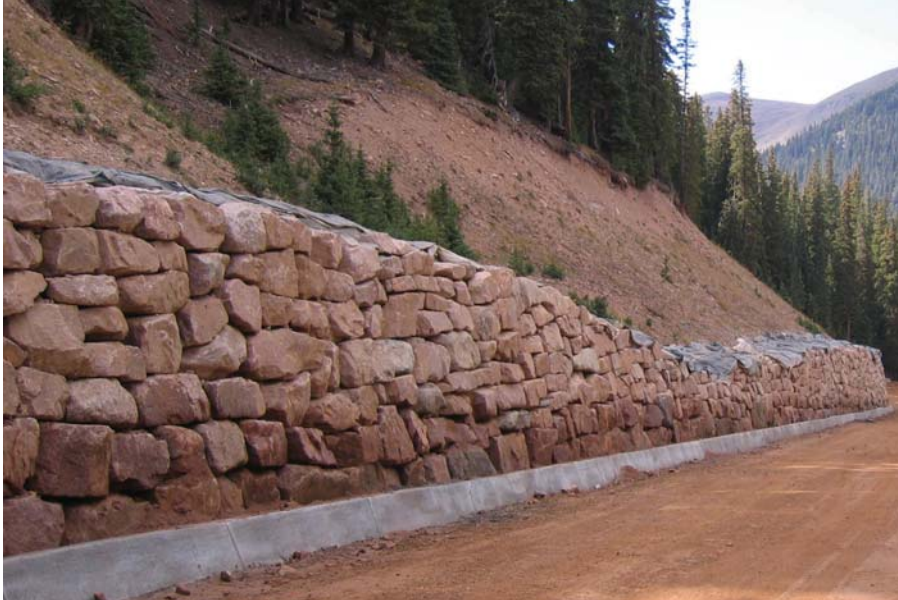
Figure 79. Photo. Although built to strict material and construction standards, this new rockery wall along the Guanella Pass Road in Colorado is a non-AASHTO design.

- **None:** Does not meet any known design standards or systematic construction methods commonly used at the time of construction;
- **Non-AASHTO:** Does not meet AASHTO design standards (Figure 79), but is consistent with other structures of its type and period of construction exhibiting established construction workmanship and good performance; or
- **AASHTO:** Appears to meet AASHTO geometric, design, materials, and construction standards in effect at the time of construction.

For example, a newly constructed MSE wall, with proper facing fill, face batter, basket construction, toe and crest grading, apparent embedment, and systematic drainage in all likelihood meets AASHTO design requirements. Although clearly a non-AASHTO structure, intact and highly performing 70-year-old mortared stone masonry walls showing a high degree of craftsmanship and attention to foundation preparation and drainage would be considered a well-designed structure, consistent with other quality retaining structures of its period. In contrast, a rockery built with little consideration of stone size requirements, proper stone placement, or required drainage would be classified in the inventory as meeting no form of design criteria.

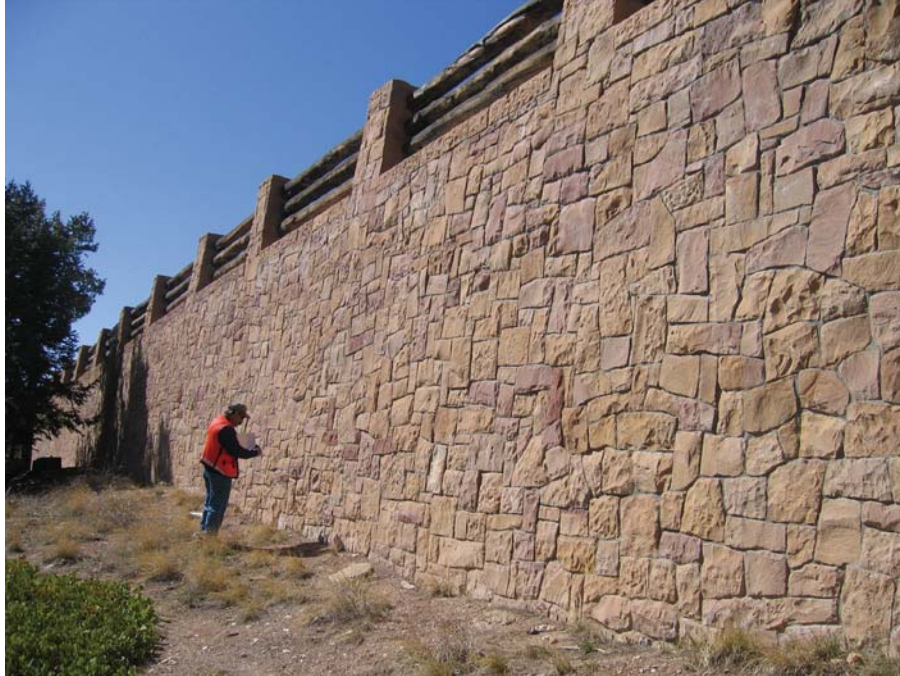
Figure 80. Photo. Although this stone masonry-faced MSE wall at Bryce Canyon National Park is a relatively new structure built to AASHTO standards, it is nonetheless culturally sensitive as it contributes to the cultural context of the roadway corridor.

“Cultural Concern?” refers to whether historic and/or cultural aspects of the wall should be considered and incorporated into the repair/replace recommendations. The inspecting engineer is required prior to the site visit, and at the time of the inventory kick-off meeting with park facilities and resource personnel, to determine if any or all park walls are culturally significant or are part of a cultural corridor, requiring special repair or replacement methods, materials, and/or construction standards. The specific types of repairs and processes for repair need to be well understood by the inventory team, with questions pertaining to specific walls directed to the park Cultural Resource Specialist at the time of the inventory. **All stone walls should be assumed culturally significant in the absence of additional information** (Figure 80).

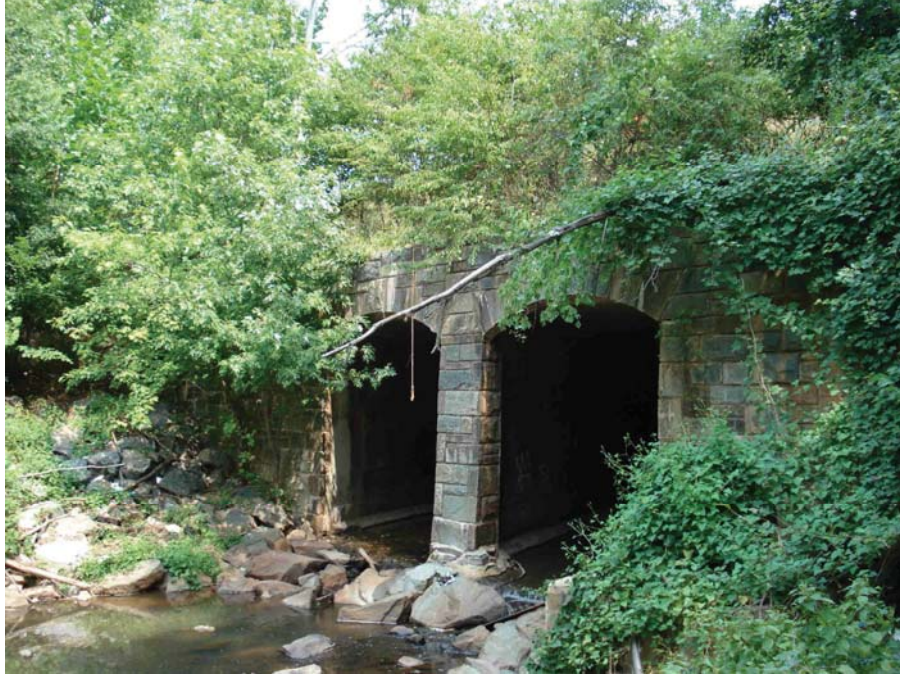
Figure 81. Photo. Culvert headwall along the Baltimore-Washington Parkway requiring removal of harmful vegetation along the top of the headwall. Vegetation removal was the most common type of maintenance item recommended throughout the Cycle 1 WIP inventory effort.

- **Maintenance:** Routine or cyclic maintenance is required to correct minor or low severity recurring deficiencies spanning a single wall element or the entire structure in order to minimize or delay further wall deterioration (Figure 81).

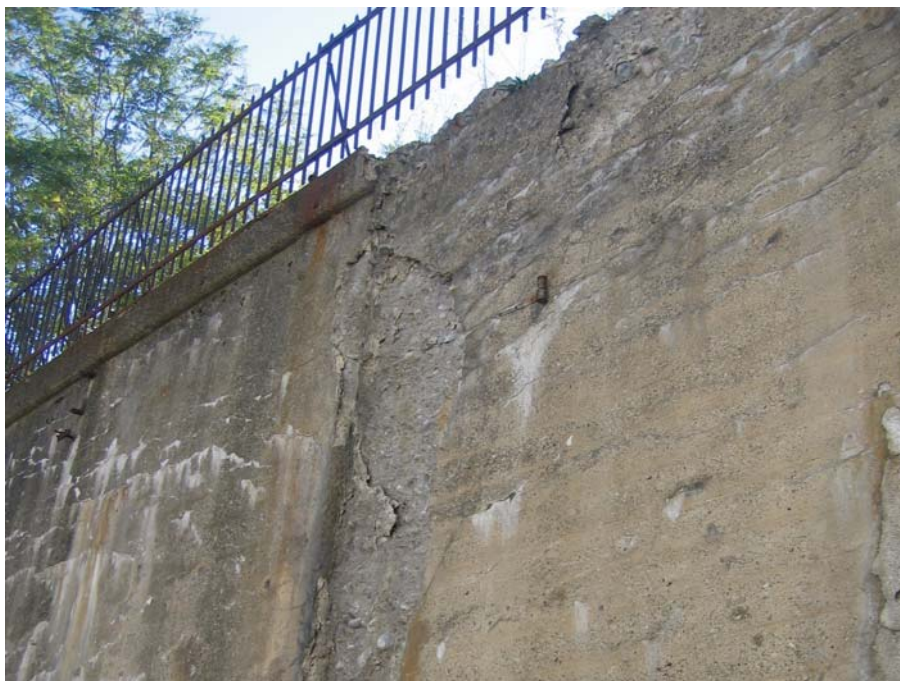
Figure 82. Photo. Much needed concrete repair on a cast-in-place gravity wall at Steamtown National Historic Site in Pennsylvania.

- **Repair Elements:** Minor to extensive repair of wall element(s) is required in the near-term to prevent rapid element deterioration, loss of performance or failure (Figure 82).

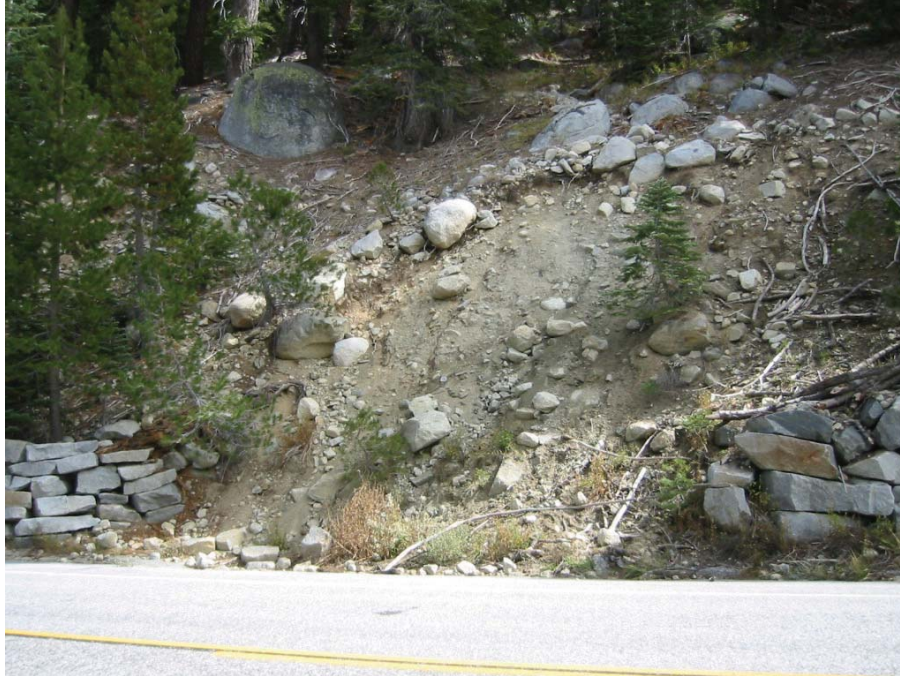
Figure 83. Photo. Dry-laid stone masonry elements in need of replacement at Yosemite National Park following minor slope instability.

- **Replace Elements:** Replacement of specific wall element(s) or an entire section of wall is required in the near-term to preserve wall stability (Figure 83).

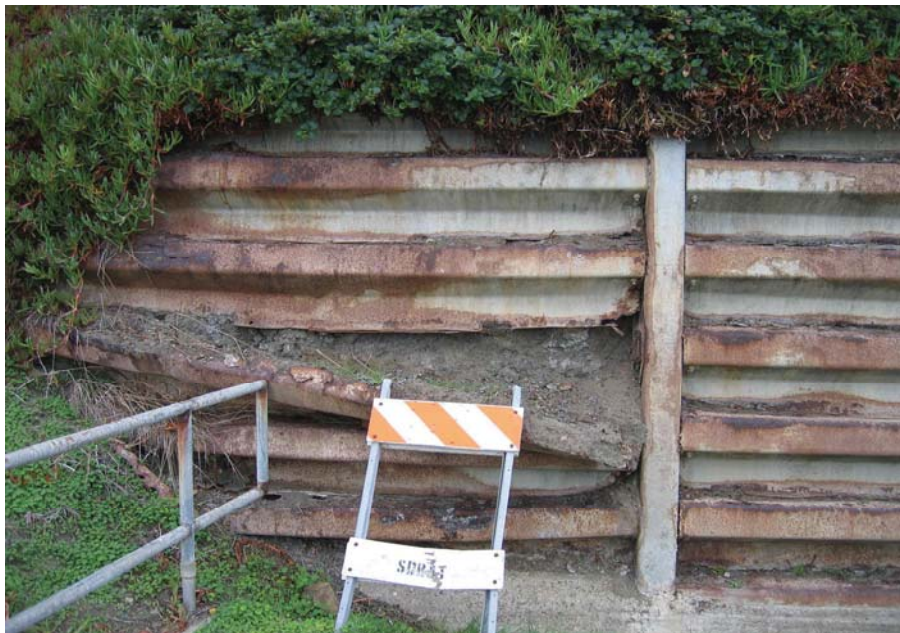
Figure 84. Photo. Severely corroded metal bin wall in serious need of complete replacement at China Beach within the Golden Gate National Recreation Area.

- **Replace Wall:** Replacement of the entire wall structure is required to reestablish the intended function of the wall (Figure 84).

For example, a 30-year-old metal bin wall is being evaluated along the main entrance road to a seasonally popular park. Significant corrosion has occurred in the exposed face of the bin wall, allowing the bin to be easily punctured with a geologist’s pick. Several areas of the wall face, particularly near the bottom of the wall are beginning to develop open corrosion holes, with some loss of bin fill evident. Although the wall facing steel is highly distressed, the wall appears to be functioning well, with no signs of lost bearing capacity, settlement or displacement apparent in the wall face or along the overlying roadway. The inspecting engineer is concerned that the buried bin elements may also be suffering from significant corrosion, and has recommended additional investigation. The wall was built to well-defined standards at the time of construction and does not qualify as a cultural resource. The engineer, carefully considering all of these factors, determines that only minor maintenance is required at this time. However, due to the high ADT and critical-park-route nature of the roadway, it is recommended, and expensed within the work order, that a subsurface investigation be conducted to determine the integrity of the buried portion of the bin (is it better or worse than the facing steel?).
