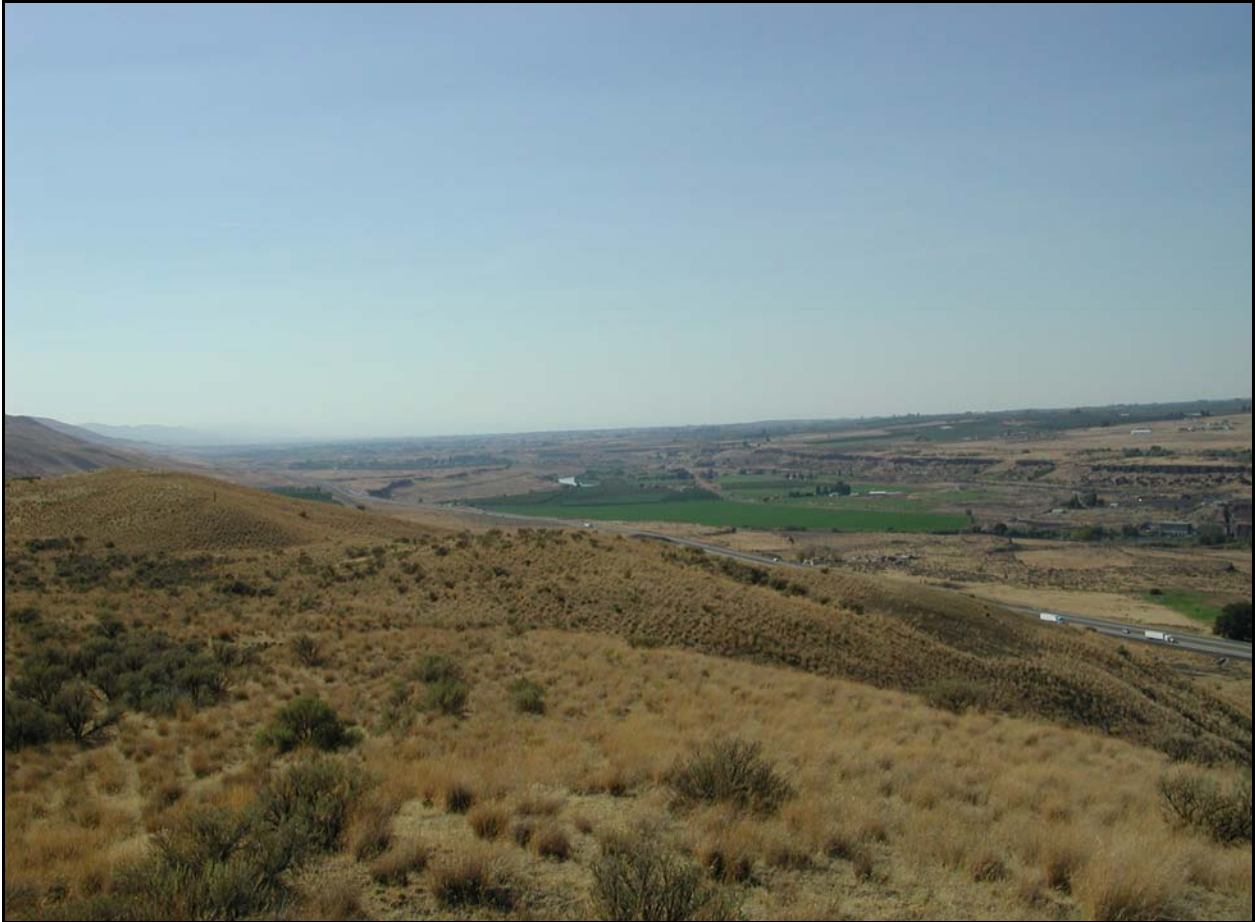
Figure 11. Photo. Site of historical road deformation along Interstate-82 near Benton City.

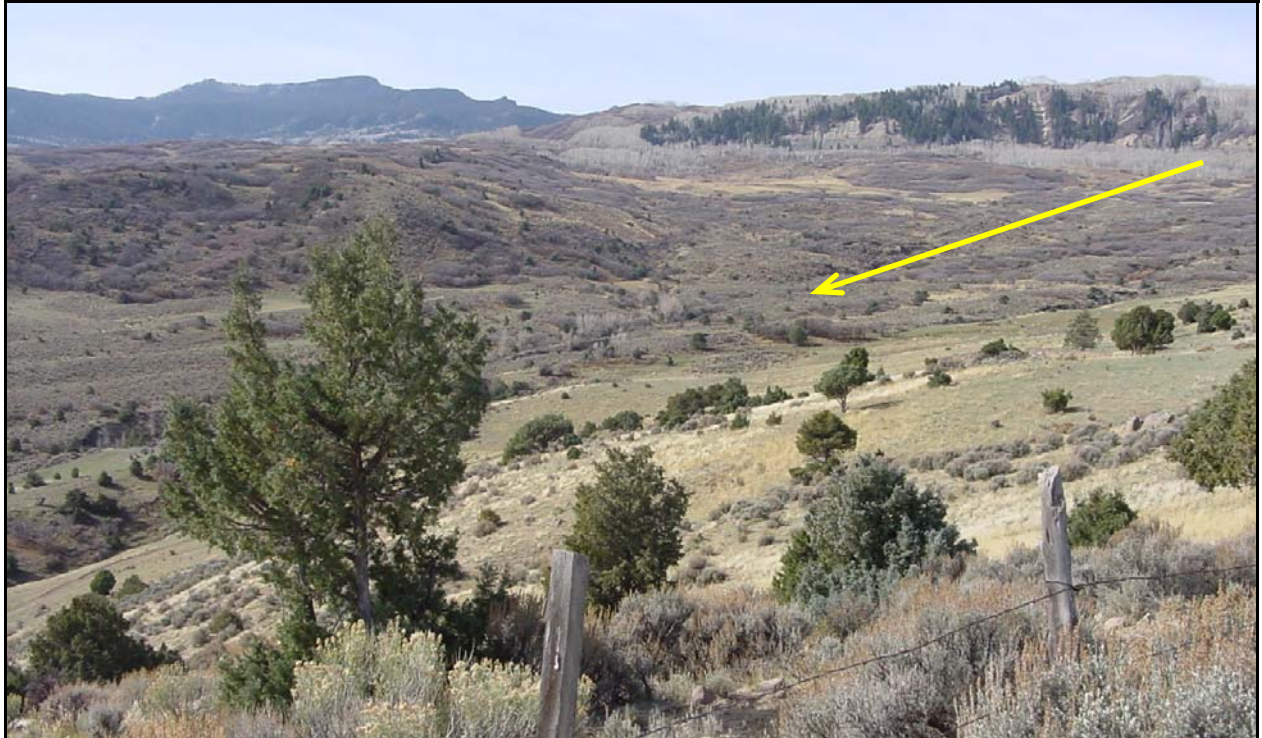
Figure 14. Photo. Cimarron Slide, Owl Creek, CO.

The Cimarron River valley elevation is between about 2,100 m (6,930 ft) and 2,800 m (9,240 ft) above sea level. The lower valley slopes are vegetated with grass and sagebrush, and other limited woody vegetation. The upper slopes contain aspen and conifer trees. The lower valley slopes are gently sloped and undulating, and the upper slopes are notably steeper, in many places consisting of bedrock outcrop. A recent photo of the slide is provided in Figure 14, with the slide location indicated by the yellow arrow.

- Image Coherence: The Cimarron slide is similar to Prosser in that the slope face is characterized by dry grasses and sparse shrubs. Unlike Prosser however, the Cimarron area also contains some stands of conifers and deciduous trees (mostly aspen and scrub oak as seen in the upper left of Figure 14). These forested regions will make phase unwrapping challenging for summer SAR acquisitions because it will create patches of low coherence. This problem should be reduced in the fall and spring when leaves are absent from the deciduous trees. Based on the above, the site is considered a reasonable candidate for producing good coherence of large portions of the SAR image from spring to summer to fall. However, due to snow cover in the winter, monitoring during these months will not be possible. A test InSAR pair captured at a 24-day interval early in this monitoring program revealed good coherence over much of the image, with low coherence patches, as shown in Figure 15. The slide area of interest is outlined by the black polygon in the figure, with the roads shown as red lines. Since this pair was captured in the fall, this coherence represents the best-case scenario, and lower coherence should be expected for summer intervals.
