CHAPTER 2 – CULVERT ASSESSMENT TOOL

SUMMARY OF ASSESSMENT TOOL

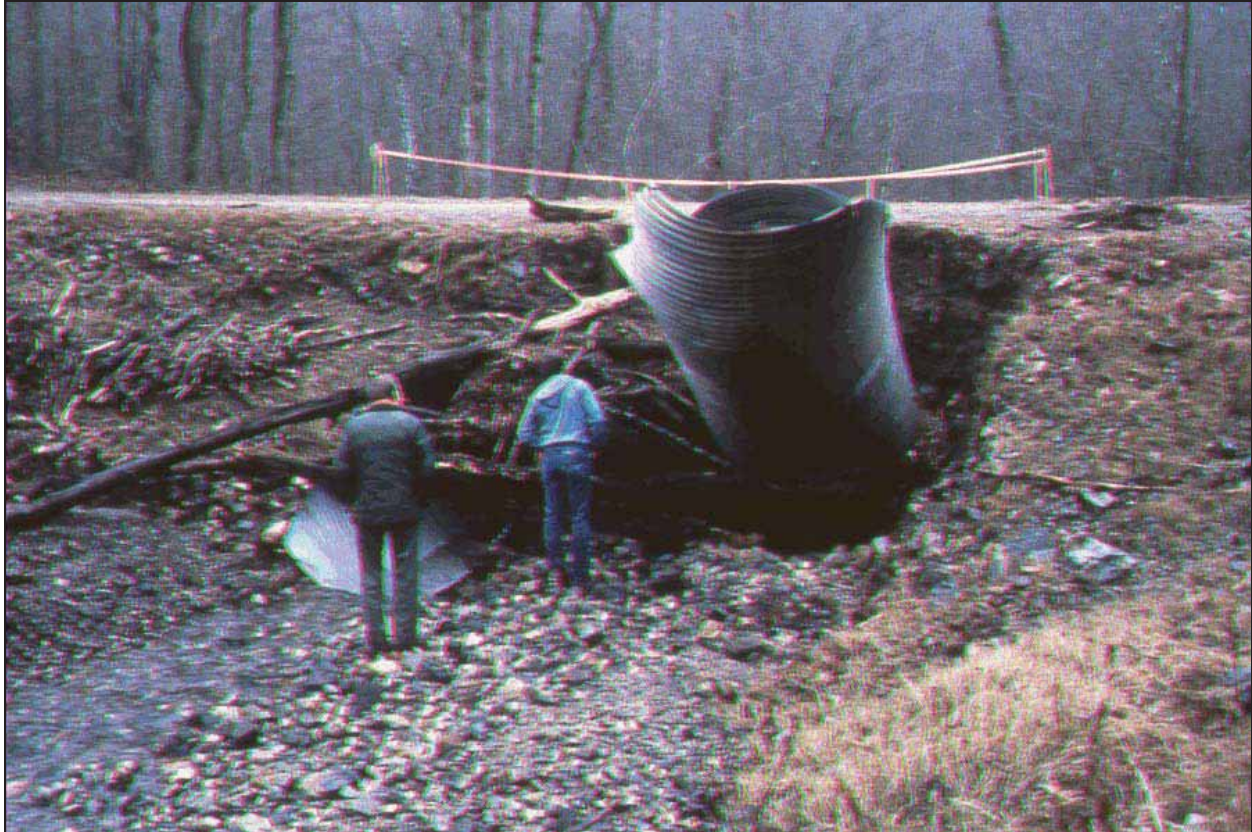
Figure 4. Photo. Example of severe buoyancy uplift (FHWA/NHI training materials).⁽²⁾

Buoyancy can cause damage to the inlets of a large corrugated metal culvert with a projecting inlet (the pipe projects out from the road embankment). This problem should be noted as present if the projecting segment of a CMP has noticeably lifted above the streambed. The problem should lead to a Level 1 recommendation for repair of the culvert via the decision-making tool (e.g. repair damage and add headwall, slope pavement anchor or terminal end section as appropriate). The following Figure 4 shows an example of extreme buoyancy uplift.

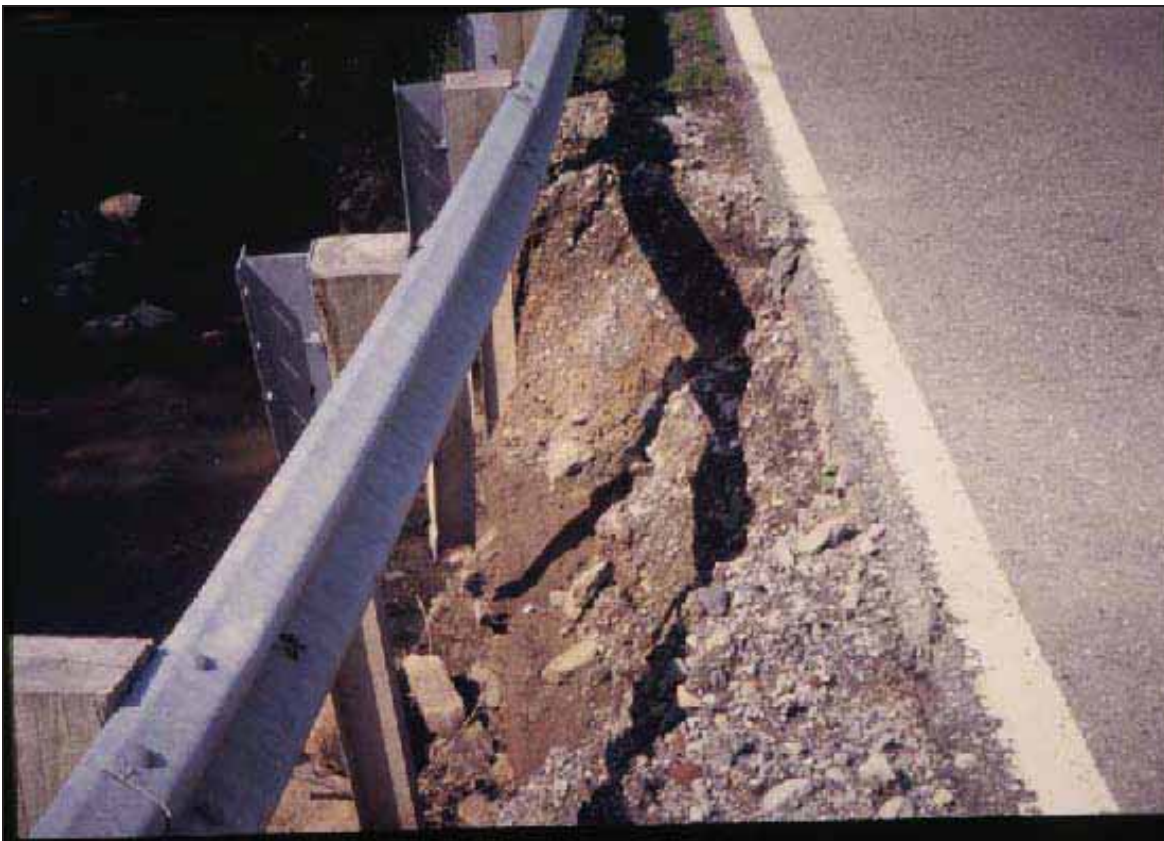
Figure 6. Photo. Erosion damage to downstream embankment slope and shoulder from previous overtopping.⁽³⁾

Embankment damage at the culvert site may be present because of previous overtopping, potentially due to inadequate hydraulic capacity. Indicators of overtopping could include, but are not limited to, drift hanging on guardrail above the culvert, extensive erosion of the downstream embankment, often accompanied by loss of the pavement section along the downstream edge. The most likely location of overtopping is at the low point in the road profile, which may be offset from the culvert crossing location. Overtopping indicators, if present, should lead to a Level 1 recommendation for maintenance (to repair any related erosion damage) and potentially a recommendation to add erosion protection to accommodate future overtopping. If the client reports that overtopping is known to be frequent at the culvert and if the condition rating is poor or critical, then the culvert should be replaced with an adequately sized structure, determined through hydrologic and hydraulic analysis. The following Figure 6 shows an example of erosion damage to the downstream embankment slope and shoulder from previous overtopping.

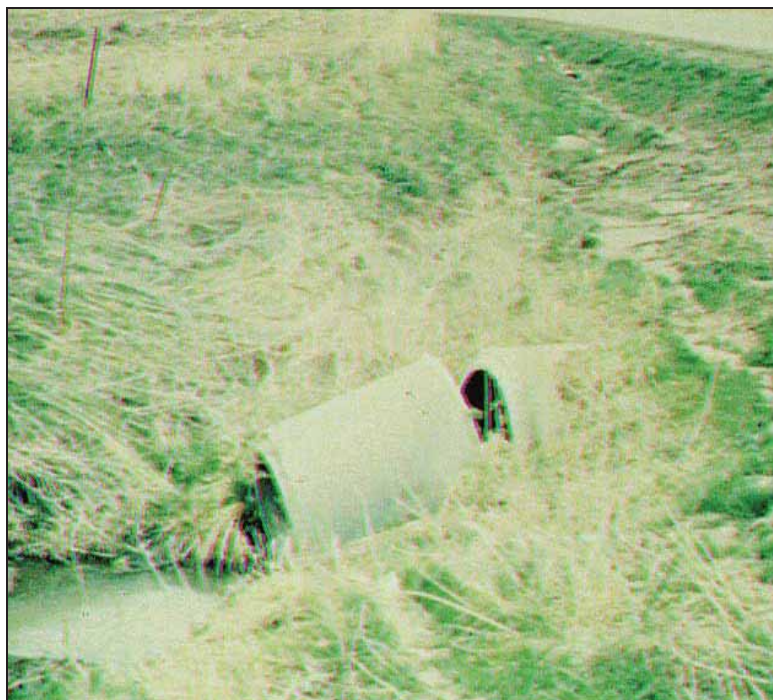
Figure 8. Photo. RCP culvert damaged by scour.⁽²⁾

Most culverts have some degree of scour at the outlet. This problem should be noted as present if a very large and noticeable scour hole is observable at the inlet or outlet, as illustrated in Figures 7 and 8 below, and it is causing damage to the culvert, headwall, wing walls or road embankment. Such problems should lead to a Level 1 recommendation for installation or repair of outlet protection, as determined in the Decision-Making tool (e.g. line existing scour hole with riprap). A local scour hole is different from a head cut in that the scour hole is a localized depression with excavated bed material often mounded not far downstream from the hole, while the stream bed affected by a headcut extends at a generally uniform slope elevation for a significant distance downstream of the headcut.

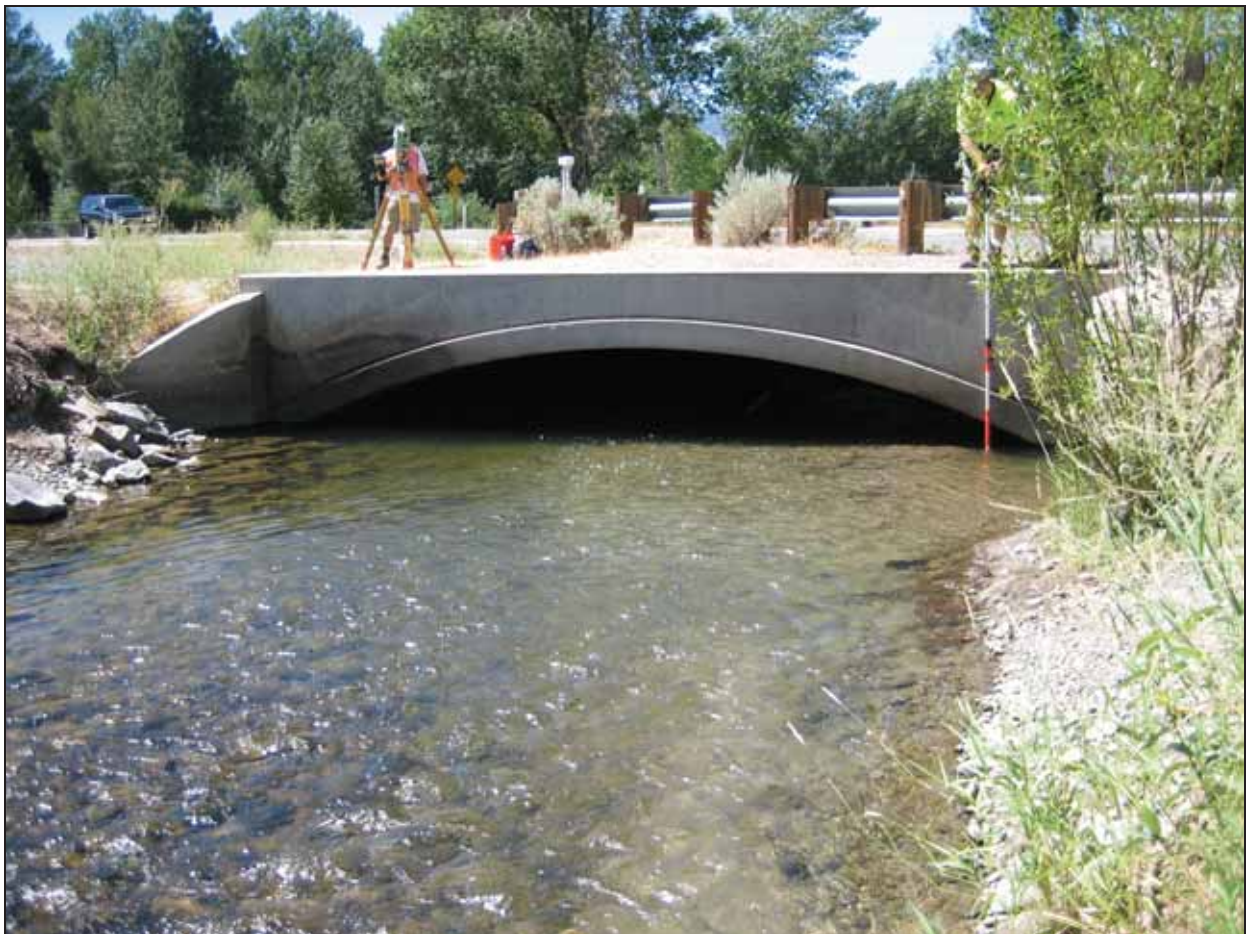
Figure 15. Photo. Example of an open-bottom culvert.

Many culverts have natural streambed sediments at the bottom, either because the bottom of the structure is open, or because the bottom of the culvert structure has been intentionally set below channel grade to promote AOP/fish passage. Open-bottom culverts, an example of which appears as Figure 15 below, often have shallow foundations that can be undermined by scour within the culvert barrel. Open-bottom culverts, if they are to be rehabilitated because of a condition rating of Poor or Critical, should receive a Level 2 hydraulic investigation in order to ensure that the rehabilitation does not increase the risk of undermining the foundations. Note that cattle pathways and farm road underpasses can be confused with flood plain relief culverts and may appear as bottomless culverts, although they are not as much of a concern for undermining and scour. A cattle pathway or farm road underpass in Poor or Critical condition should receive a Level 2 hydraulic investigation, unless it is obvious to the assessor that runoff is not conveyed.
