**DOT/FAA/TC-12/28**

# **Airport Surface Event Analysis for Airport Design January 2006—September 2011**

June 2012

Final Report

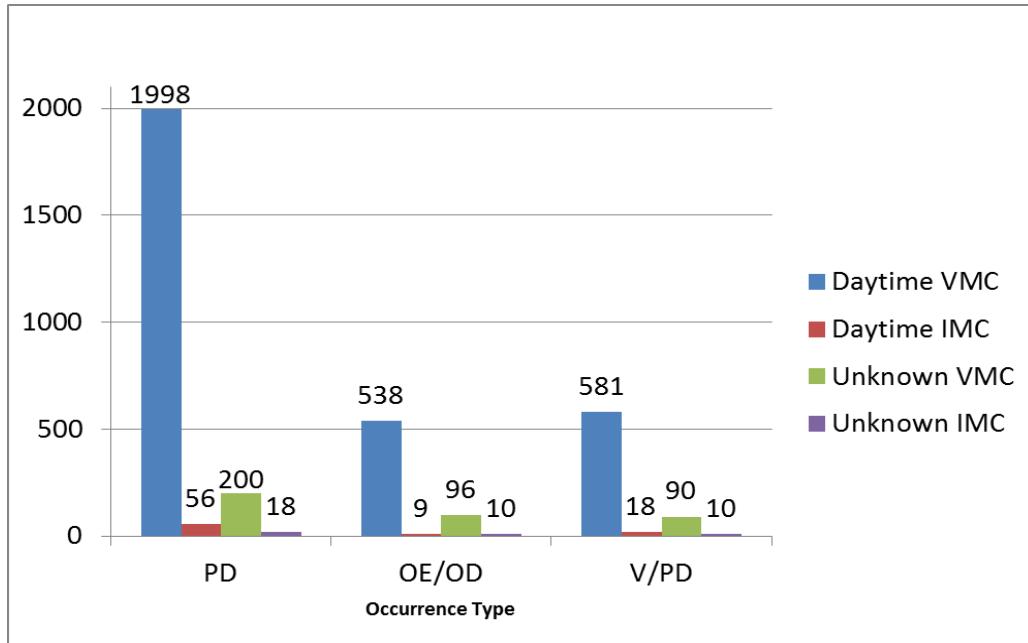
Figure 5. Runway Incursions by Occurrence Type and Weather Conditions

Figure 5 shows PDs occurring in daytime visual meteorological conditions (VMC) are the most common. The highest number of OE/OD and V/PD runway incursions occurred during daytime VMC as well. Because not all incursion reports identified the time of day, the time of day in many reports was categorized as unknown.

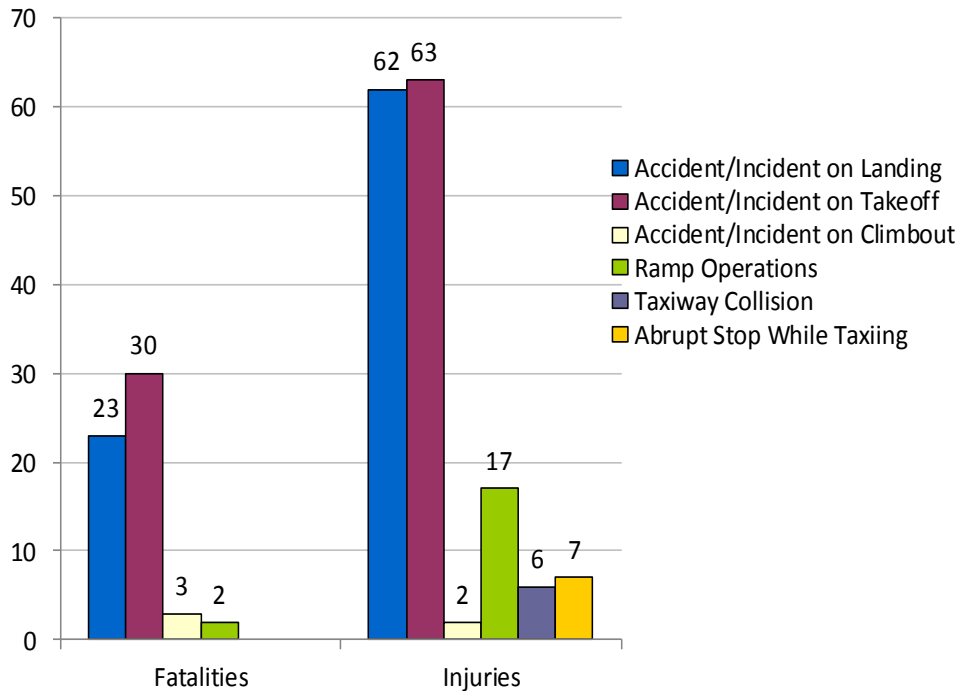
Figure 8. Fatalities and Injuries by Phase of Flight

Figure 8 shows that the majority of fatalities and injuries occurred during accidents and incidents during the takeoff phase for the data collection period. The majority of these accidents and incidents were caused by a loss of aircraft control or mechanical failure.
