U.S. OFFICE OF
SPECIAL COUNSEL
WASHINGTON, D.C.

Re: OSC File Numbers DI-11-2238 and DI-11-2709

Please find FAA Inspector Daniel Mirau and my written Supplemental response to the OSC Supplemental data you forwarded to us for comment. Attached, please find our Supplemental Response document dated April 23, 2012. It includes five (5) attachments.

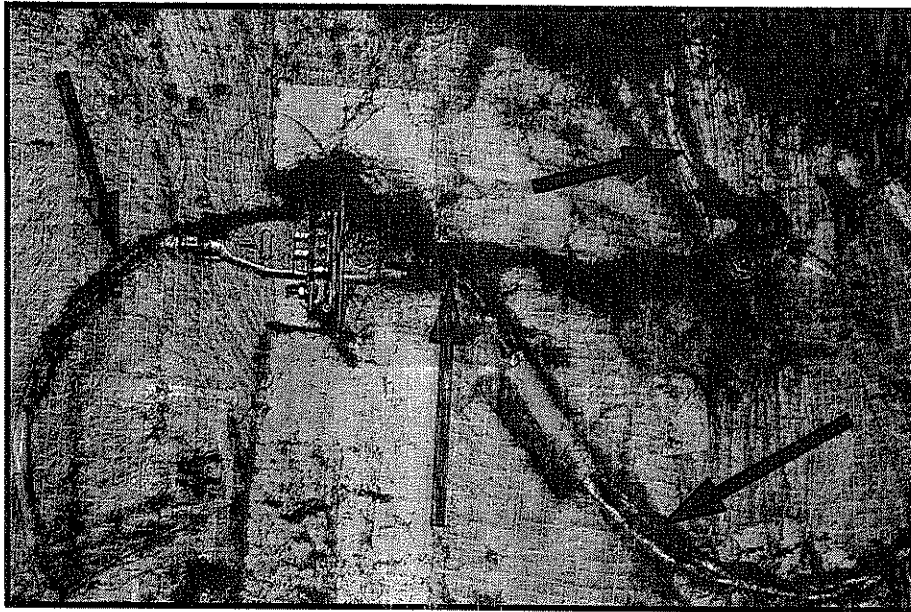
Figure 1: EWIS Contaminated with Dust and Dirt

b. Levels of Inspection Applicable to EWIS. Though the term "detailed visual inspection" remains valid for a detailed inspection using only eyesight, this may represent only part of the inspection called for in EWIS ICA used to establish an operator's maintenance program. We recommend that the acronym "DVI" not be used because that term may exclude tactile examination, which is sometimes needed. Instead, we provide the following definitions. See figures 1 and 2 for examples of EWIS that are contaminated. Such contamination could cause EWIS component degradation and also prevent an effective GVI or DET inspection if it were not cleaned. Additionally, depending on the type and amount present, contaminants may also be combustible and sustain a fire should electrical arcing occur.

(c) The area to be inspected should be clean enough to minimize the possibility that collected dirt or grease, or other contaminants, might hide unsatisfactory conditions that would otherwise be obvious. For any cleaning considered necessary, you should use the airplane manufacturer's procedures or other methods, techniques, and practices acceptable to the FAA. The cleaning process itself should not compromise the integrity of EWIS. Avoid using high pressure cleaning and abrasive materials that could damage wire insulation and other EWIS components.

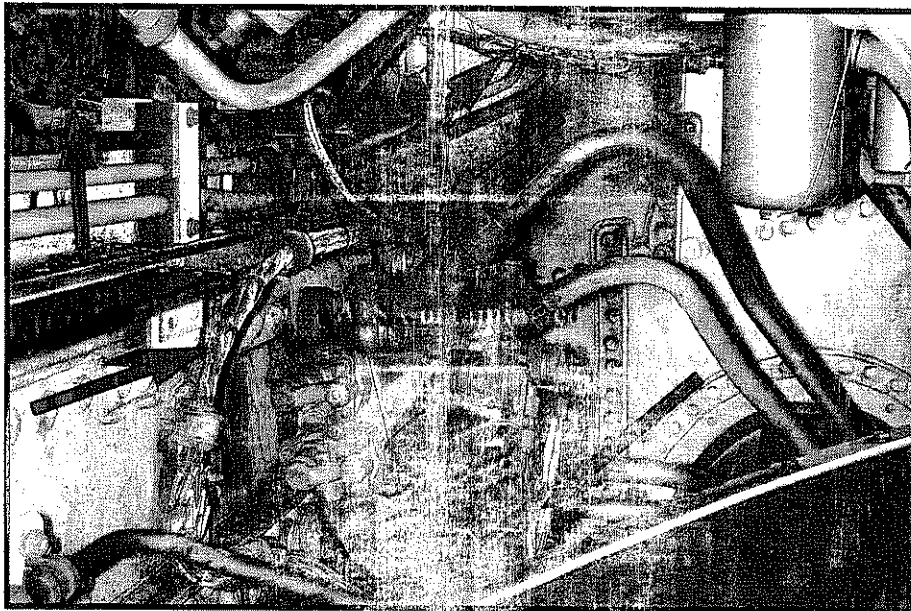
Figure 2: EWIS Contaminated with Grease
