**Airport Traffic Control Tower (ATCT)
Mold/Water Incursion Inspections**

**Final Report
Volume 1**

**NISC Prime Contract Number
DTFAWA-08-C-00009
Task Order WESH802A**

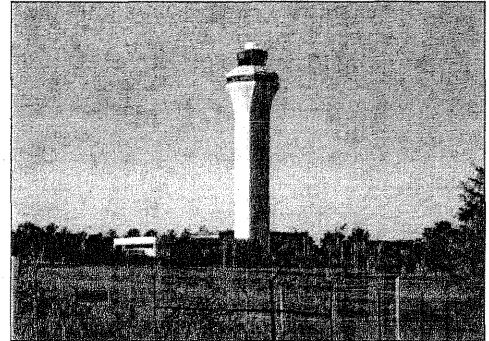
2.1.1 Tower Description

The MCI ATCT was constructed during the 1994-1995 time period, and is a standard 300-foot major level ATCT designed by the Leo A. Daly Company. The tower is a 15 story structure with an overall height of 249 feet to the top of the ASDE penthouse. The cab of the tower is an 850 ft², eight sided, major activity level cab. The tower shaft bellow the cab is unoccupied, with the exception of an electronics equipment room and a mechanical equipment room on the sub-junction level, and a smoking room, office, break room and mechanical equipment room on the junction level. The tower shaft is served by a geared traction elevator, and a single, pressurized exit stairway. The ATCT is connected to the base building via a 2 story link structure.

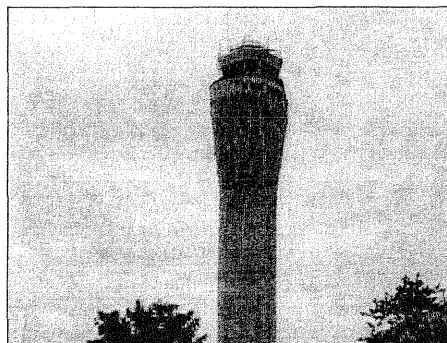
3.1.1 Tower Description

Construction of the SEA ATCT was started in 2000, and the tower was commissioned in 2004. It has a total height of 265 feet, with 15 levels, and was designed by URS Greiner/Woodward Clyde. The tower's exterior consists of a shaft constructed of pre-cast concrete panels, topped by an oval-shaped junction and cab structure of fiberglass-reinforced panels. The east face of the tower includes a translucent, indented, luminous glazed panel that serves as a backdrop for flags from the United States, Washington State, and Canada (the "flag pavilion").

The ATCT is connected to the base building via a two story link structure.

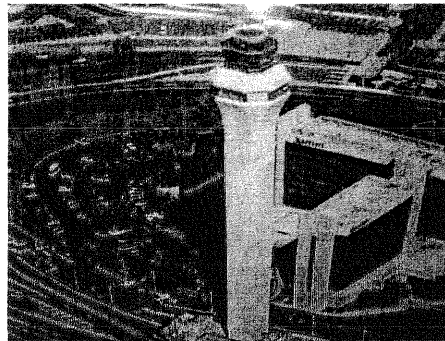
4.1.1 Tower Description

Construction on The EWR ATCT was completed in 2002, and the tower was initially occupied in 2003. It is a standard major level ATCT of the Leo A. Daly design. The tower has 24 levels below the cab, and is connected to the base building on the ground floor level.

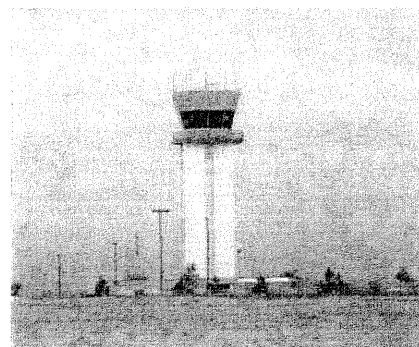
5.1.1 Tower Description

A review of as-built drawings of the Bob Hope Airport (originally the Burbank-Glendale-Pasadena Airport until it's name change in 2003) indicates that the tower is a "Low Activity Level" ATCT with a 350 ft² cab. The tower was originally designed in 1989 by the Leo A. Daly Company, Omaha, Nebraska. The BUR ATCT consists of nine levels connected to a base building.

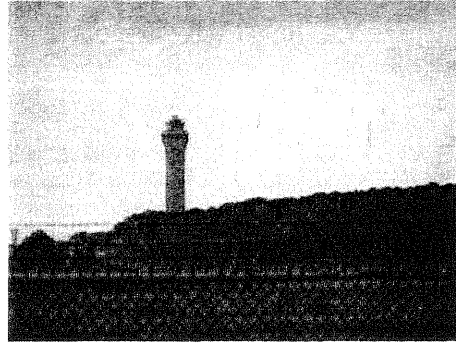
6.1.1 Tower Description

The tower was opened in 1997, and consists of 18 floors, not including the mechanical penthouse above the cab level. The tower shaft exterior is constructed of pre-cast concrete panels, which flare out to a maximum diameter at the junction level. The cab level and penthouse level exteriors are constructed of metal insulated panels. The original roof is present, and is constructed of a rubber membrane and metal flashing. The roof has a reported lifespan of 20 years. The tower shaft contains functional space, which includes several offices, a fitness room, and a smoking room. Each occupied space within the tower shaft was provided conditioned air by a ceiling mounted AHU. In addition to functional space, each floor of the tower shaft contained an electrical chase room, and a pipe chase room.

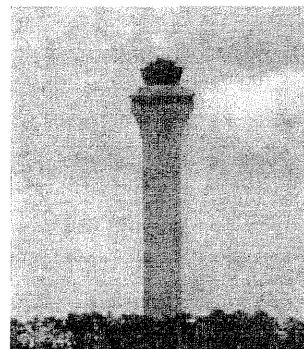
8.1.1 Tower Description

The DFW Airport has two towers designated MA2 (east) and MB2 (west). The MA2 tower consists of 13 levels; not including a penthouse mechanical room. The tower was opened in 1994. The tower shaft exterior is constructed of pre-cast concrete panels which flare out to a maximum diameter at the junction level. The cab level and penthouse level exteriors are constructed of metal insulated panels. The rubber membrane roof was replaced less than five years prior to the inspection date. All finished tower interiors including the cab level were remodeled in 2007. The tower shaft from the 10th floor to the 3rd floor contains unoccupied, unconditioned space, and each floor is divided into Rooms TS5, TS4, and TS3. TS3 contains an electrical and communication chase, TS4 contains a pipe chase, and TS5 is an empty room.

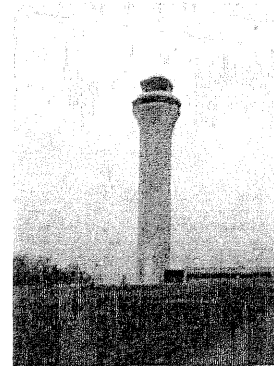
9.1.1 Tower Description

The CVG ATCT is a 15 story structural steel and concrete structure, with an ASDE penthouse level. The exterior of the tower shaft is bare concrete. The tower cab, junction, and subjunction levels of the tower are occupied. The other floors of the tower shaft are unoccupied. The tower shaft is served by a geared traction elevator and a single, pressurized exit stairway. The ATCT is connected to the base building via a two story link structure.

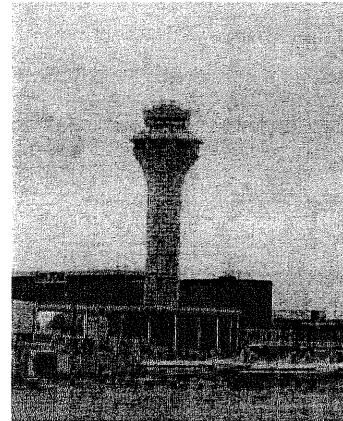
11.1.1 Tower Description

The ORD South ATCT is an 18 story structural steel and concrete structure, with a mechanical penthouse level. The exterior of the tower shaft is lined with glass panels to match the architectural style of the surrounding airport. The tower exterior above the junction level is constructed of metal insulated panels. On the cable access level, AHUs provide heated air to the cavity between the exterior metal insulated panels and the interior insulation. The purpose of the heated panels is to reduce the likelihood of snow and ice accumulations falling and potentially harming those below. The interior of the cavity is composed of metal studs, fiberglass batting, and a plastic sheet vapor barrier. Unlike many other Leo Daly towers inspected, the microwave balcony or junction level balcony is not present, and the area is enclosed within the building.

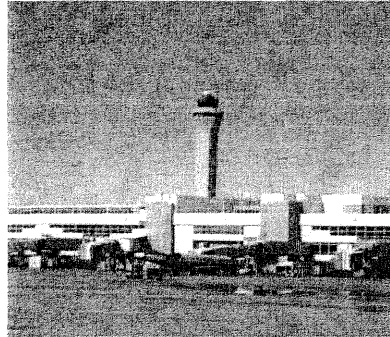
12.1.1 Tower Description

The DEN ATCT was designed by the Leo A. Daly Company and served as a prototype for future tower construction. Construction of the tower began in May 1991, and was finished in November 1992. The tower was placed in operation in February 1995.

The tower consists of 18 floors; not including the mechanical penthouse above the cab level. The tower shaft exterior is constructed of pre-cast concrete panels which flare out to a maximum diameter at the junction level. The cab level and penthouse level exteriors are constructed of metal insulated panels. The cab, junction, and sub-junction levels are the only occupied areas within the tower. Each floor of the unoccupied tower shaft contains an unmarked empty room, electrical chase room, electrical chase room vestibule, stairwell vestibule, and a corridor connecting the rooms. No conditioned air is provided to any floors within the tower shaft below the sub-junction level, except for the ASDE-X room on the 10th floor.

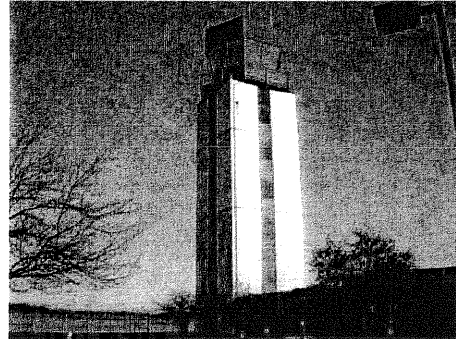
13.1.1 Tower Description

The Waukegan Regional Airport is a general aviation facility characterized by the FAA as a “reliever airport” for Chicago O’Hare International Airport. The UGN ATCT is a Leo A. Daly design, with a 250 ft² cab at a height of 68 feet (ground to cab floor). It is designated as a “low activity” ATCT. The tower was commissioned in 1988.

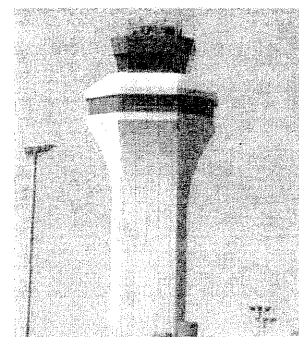
15.1.1 Tower Description

A review of as-built drawings of the Lambert-St. Louis International Airport ATCT indicates that the tower is a "Major Activity Level" ATCT originally designed in 1994 by Holmes & Narver of Orange, California. The drawings reflect a revision date of February 1999, and an "as-built" date of November 1998. The STL ATCT consists of eleven levels below the cab, and it is connected to a base building.
