DAM SAFETY

Chena River Lakes Flood Control Project

U.S. Army Corps of Engineers, Alaska District

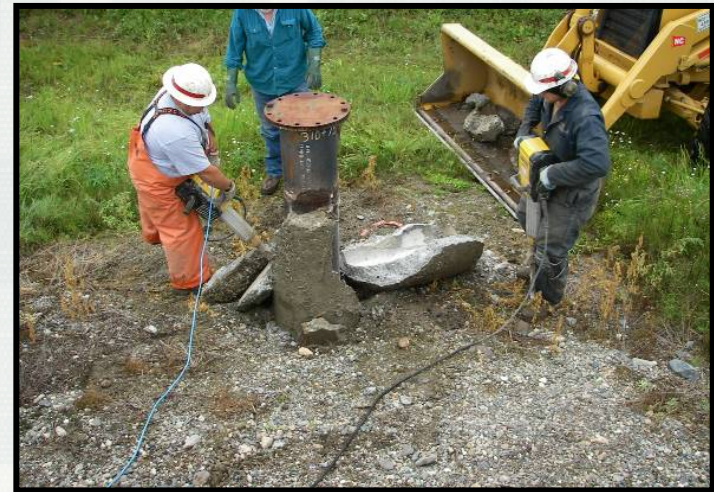
Relief wells are subject to damage by frost action and have required continual maintenance or replacement

- Absence of a complete cut-off to prevent water from seeping beneath dam
- Relief well performance
- Excessive vegetation

6. Provide vehicle mounted lighting for flood monitoring
 - Installed on project related vehicles by May 2010
7. Improve relief well performance
 - 149 relief wells were inventoried, cleaned, and repaired in 2009
 - Adequacy (pump) testing in Summer 2010
