### Clearwater Major Rehabilitation Study (2003) Clearwater Lake Inflow Design Flood (Developed 1979) 20% PMF Computed from IDF

CLEARWATER MAJOR REHABILITATION STUDY  
2003  
HIGH POOL SEEPAGE DAM FAILURE PROFILES

LOW POOL SEEPAGE DAM FAILURE PROFILE

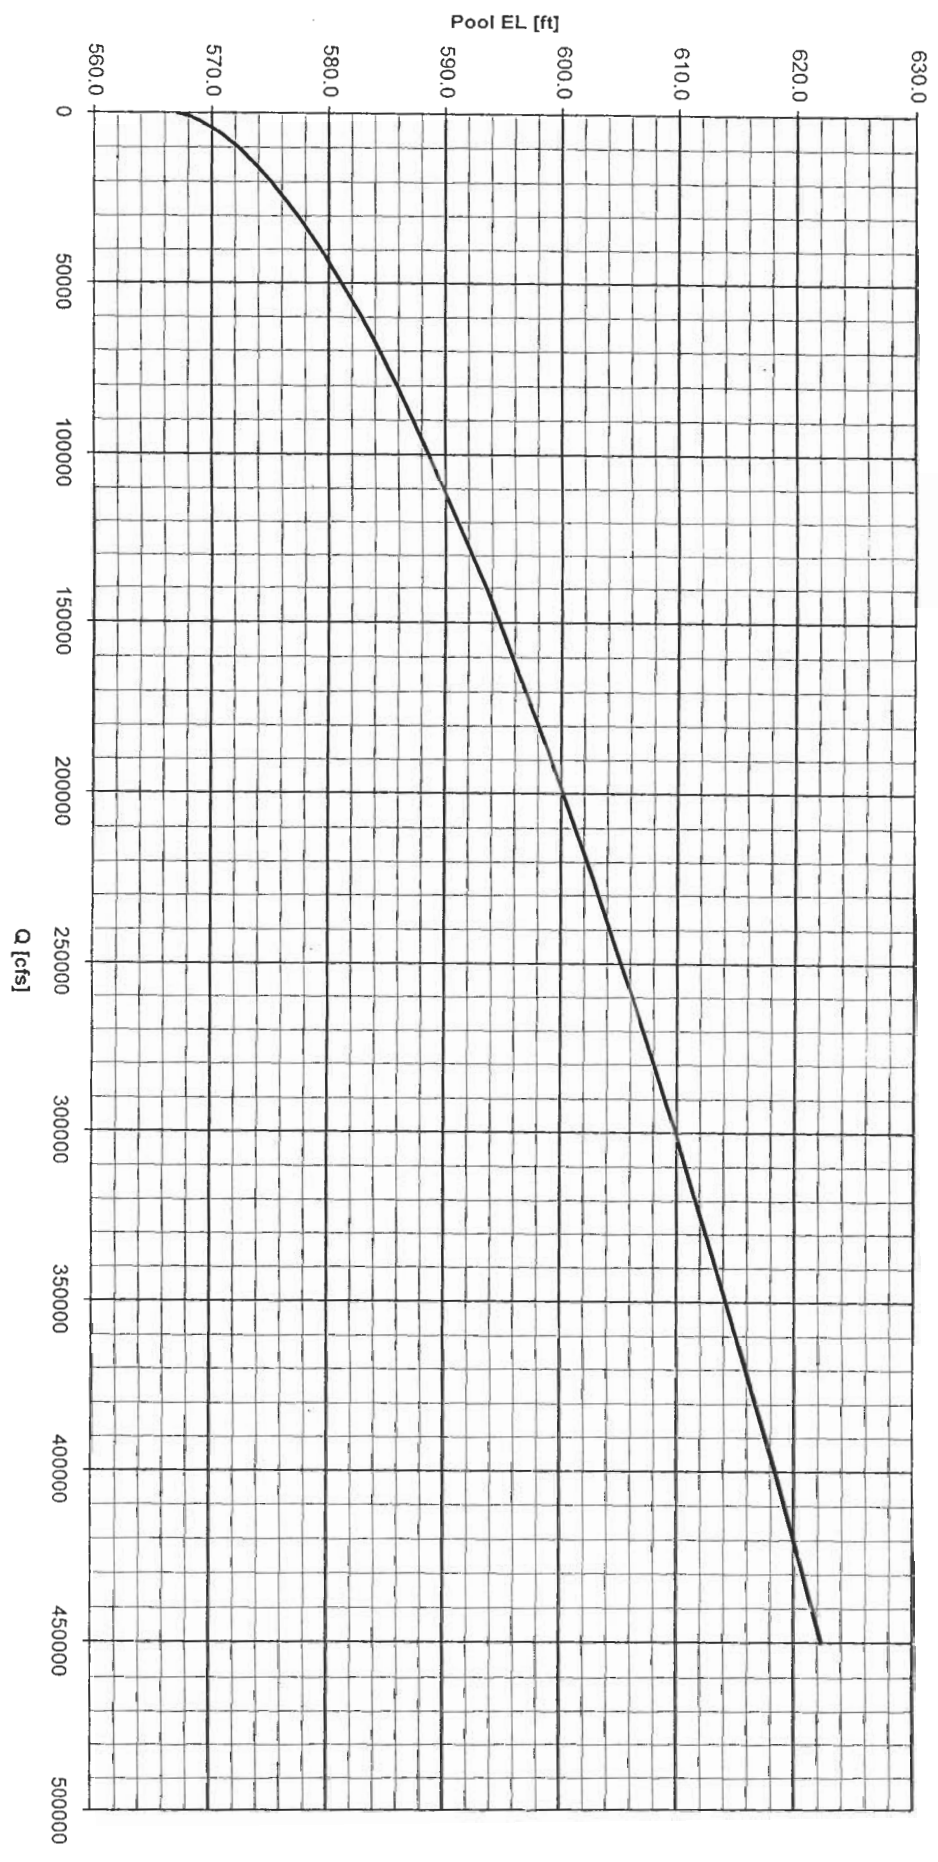
### Clearwater Major Rehabilitation Study (2003) Existing Condition Spillway Discharge Rating Curve

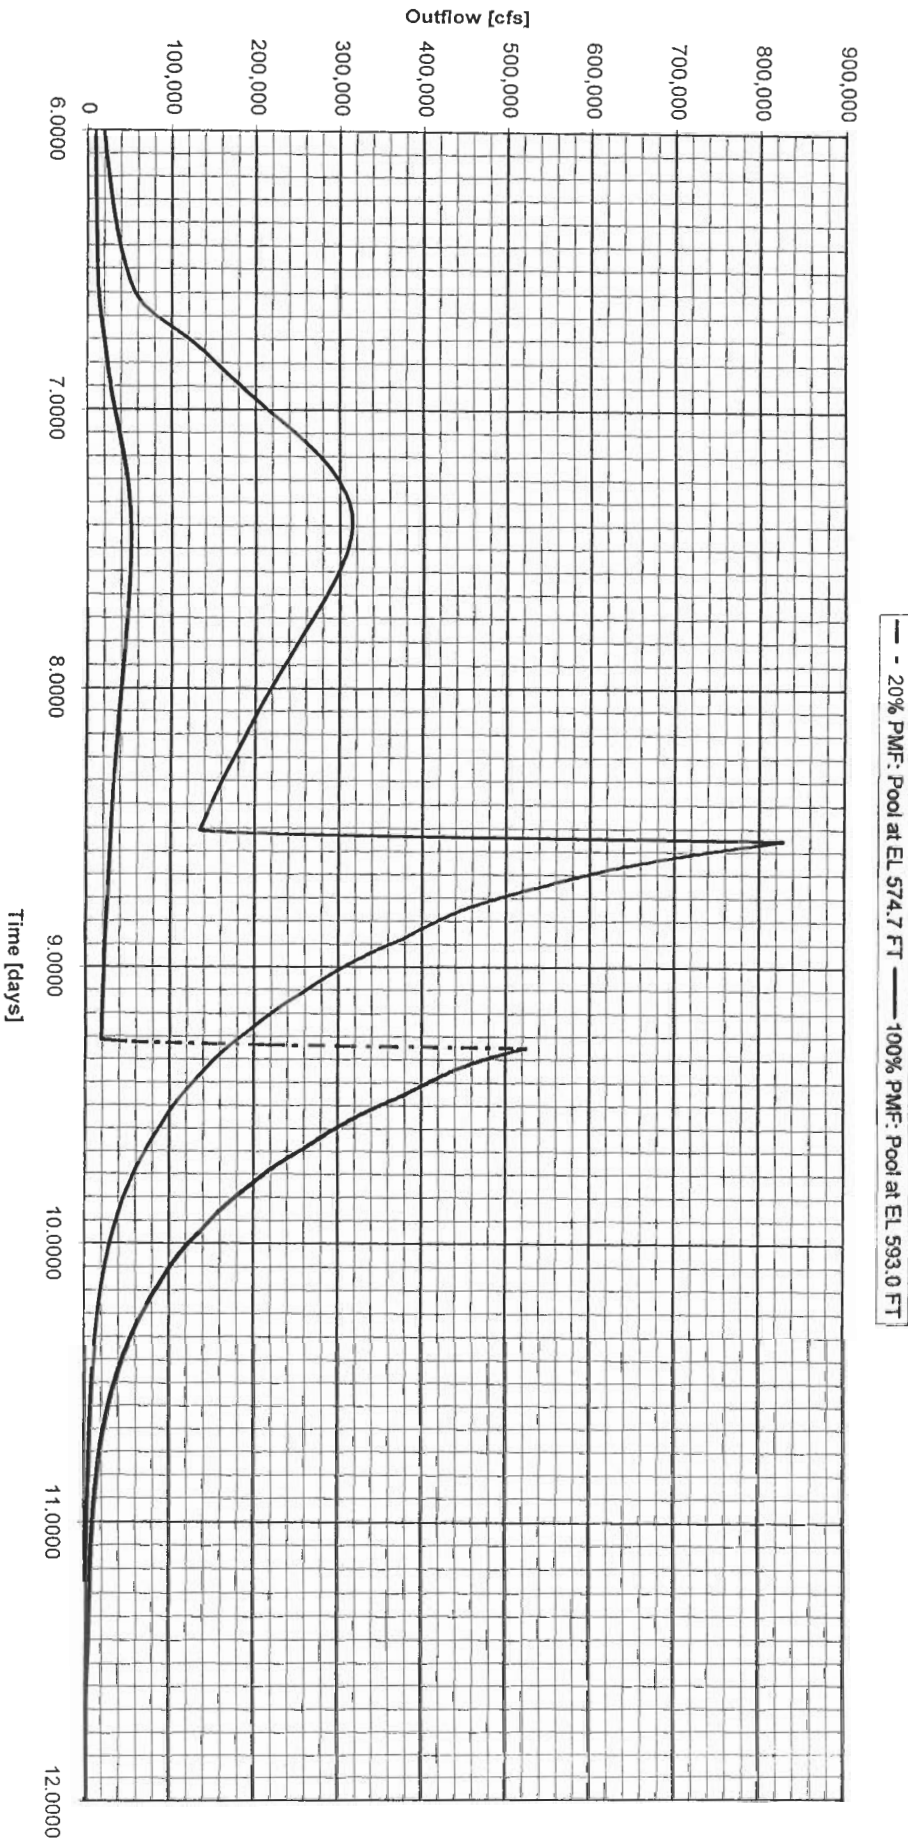
# Clearwater Major Rehabilitation Study (2003) High Pool Seepage Dam Breach Failure Outflow Hydrographs

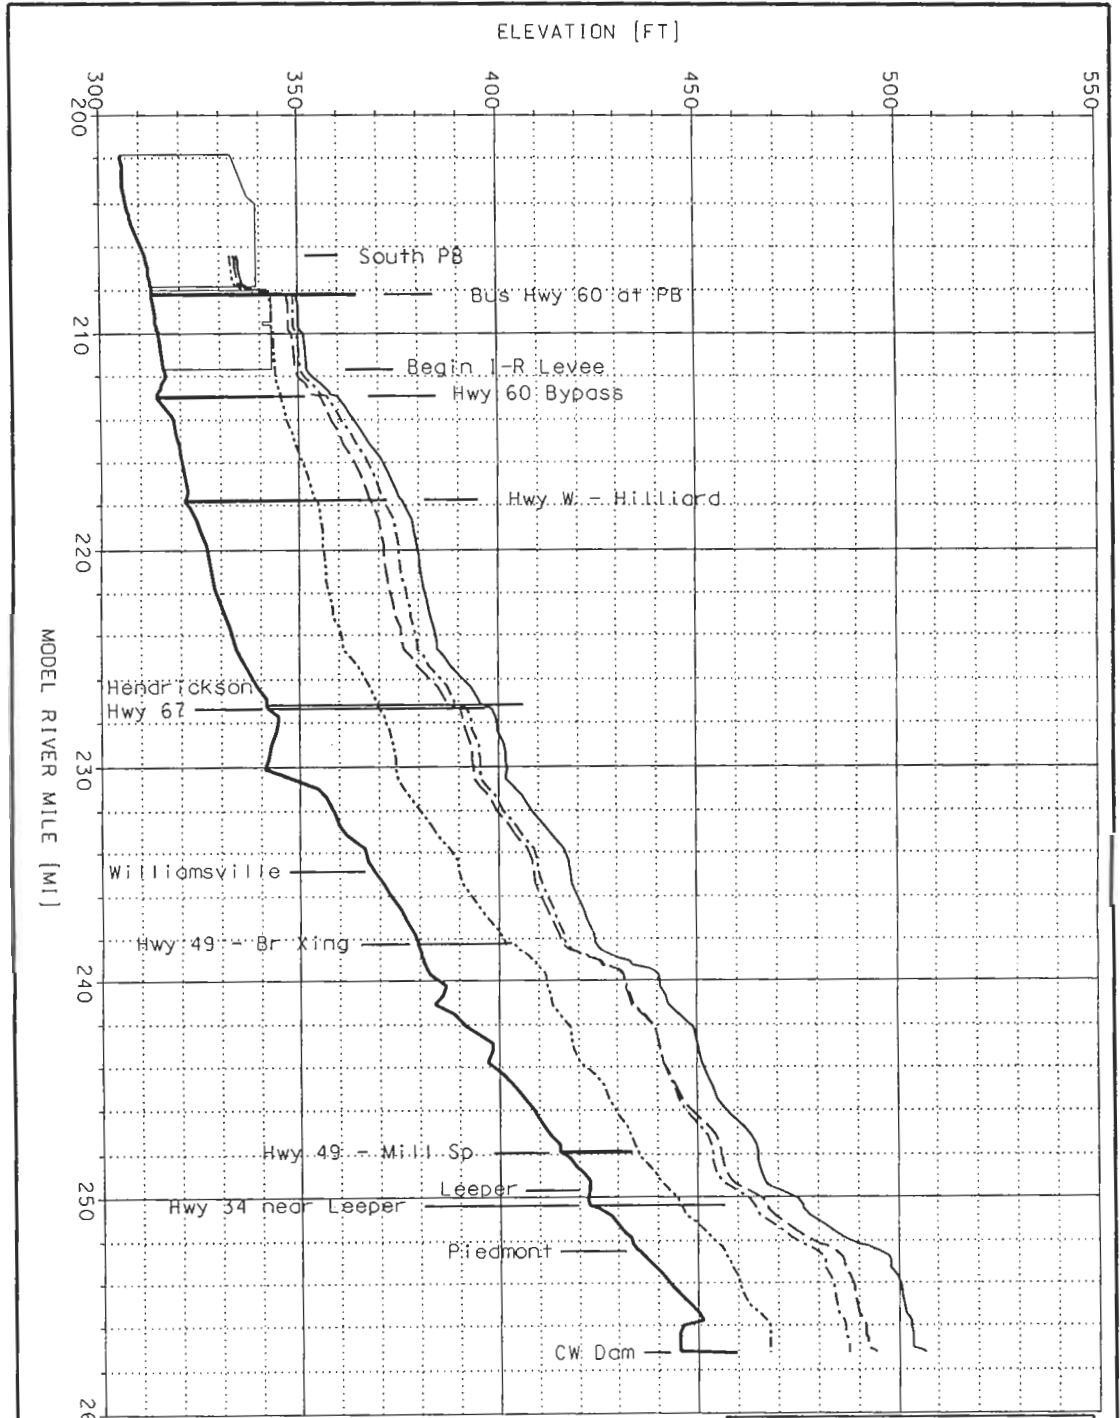
PLATE  
C-5

Legend	
Max WS - 100% PMF W/ Fail	(dash-dot line)
Max WS - 20% PMF W/ Fail	(long-dashed line)
Max WS - 100% PMF W/O Fail	(dotted line)
Max WS - 20% PMF W/O Fail	(dashed line)
Thalweg	(solid line)

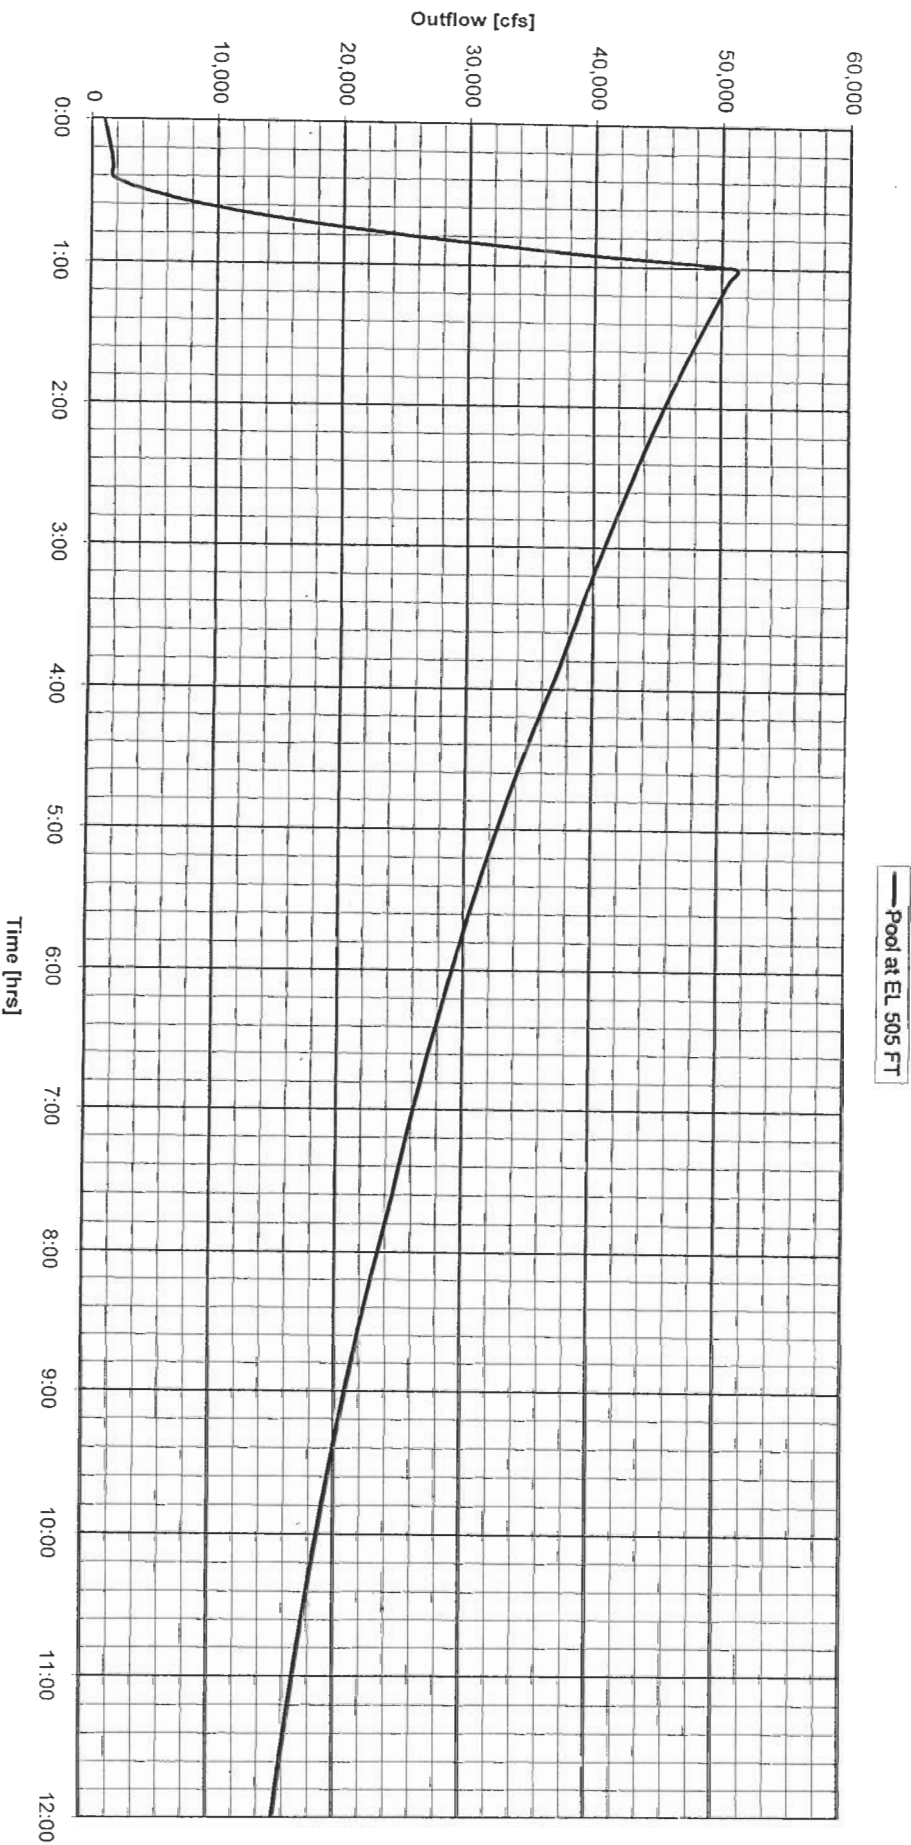
# Clearwater Major Rehabilitation Study (2003) Low Pool Seepage Dam Breach Failure Outflow Hydrograph

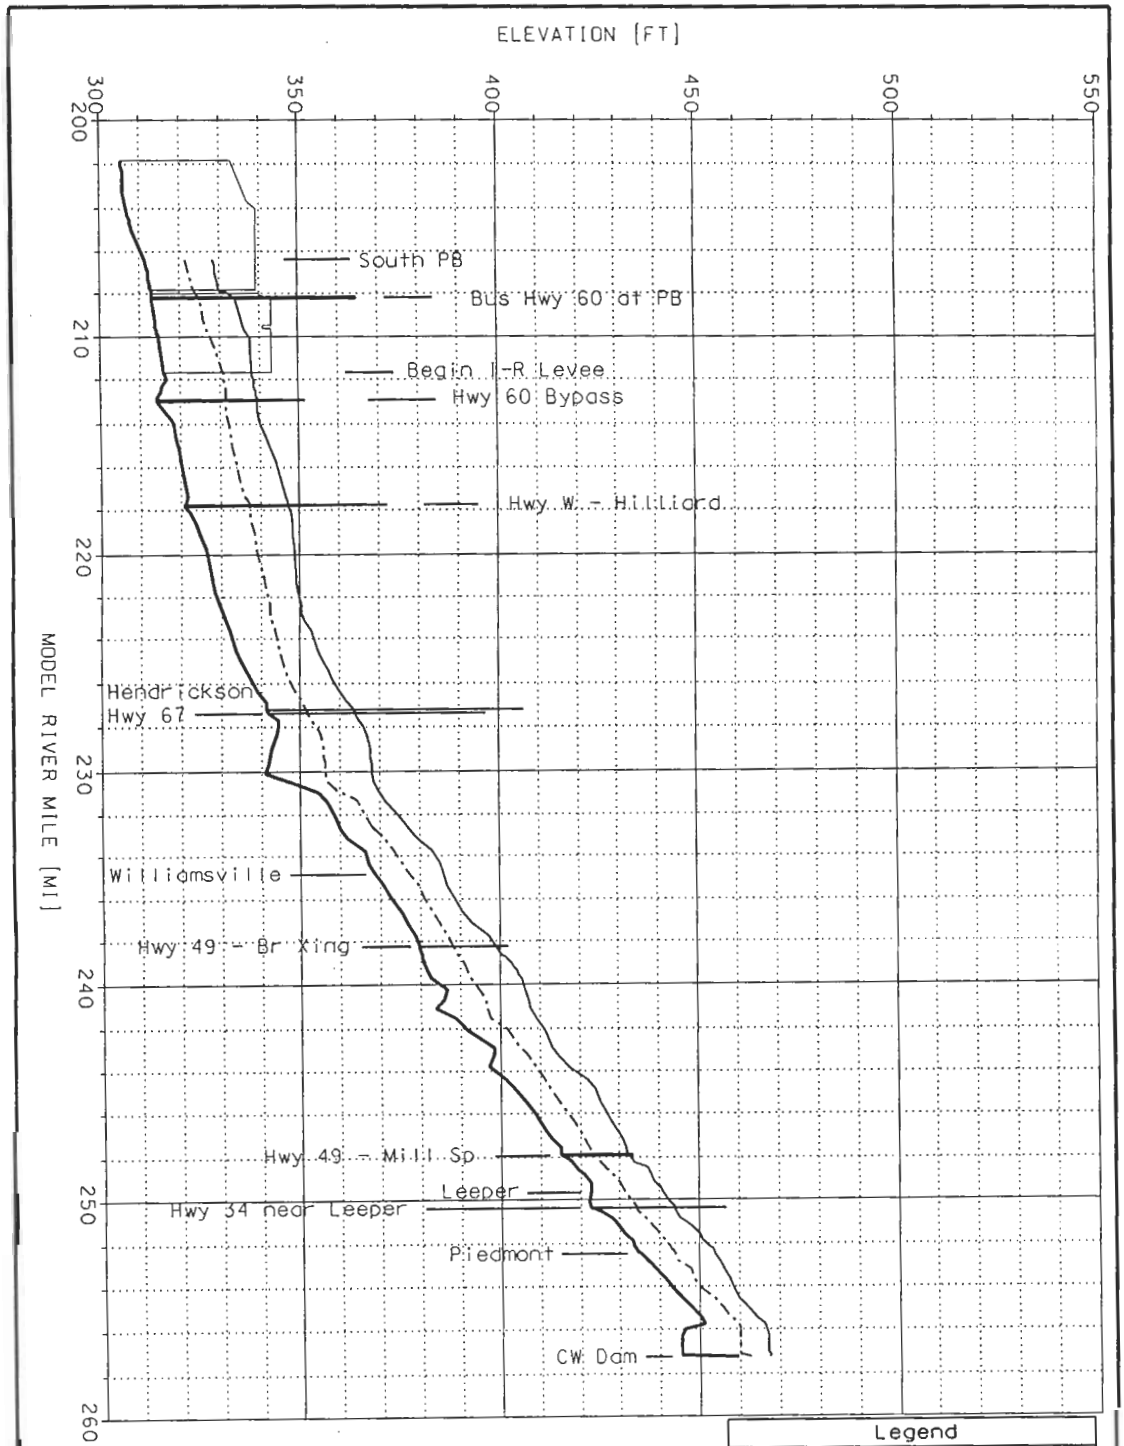
PLATE C-7

Without failure profile representative of lake release controlled to channel capacity at Poplar Bluff - about 4500 cfs.

Legend	
	Max WS - Pool at EL 505 FT With Failure
	Max WS - Without Failure
	Thalweg

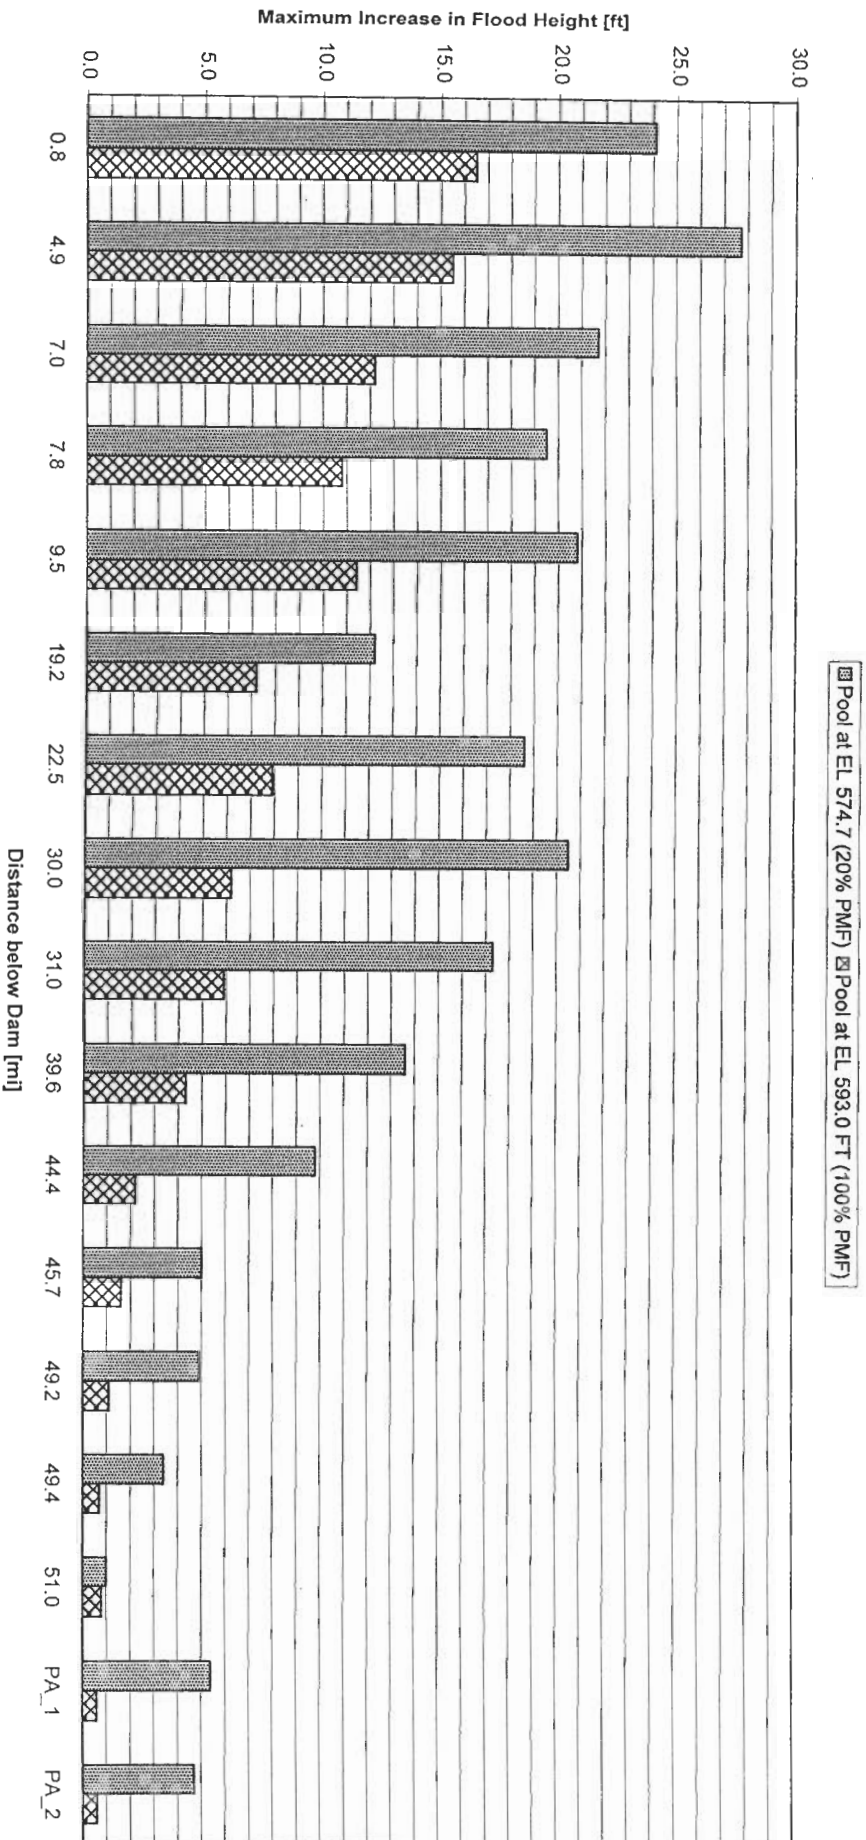
**Clearwater Major Rehabilitation Study (2003)  
 High Pool Seepage Dam Breach  
 Maximum Increase in Flood Heights: Failure vs. Existing Condition Without Failure  
 (Breach Occurs with Pool in Recession)**

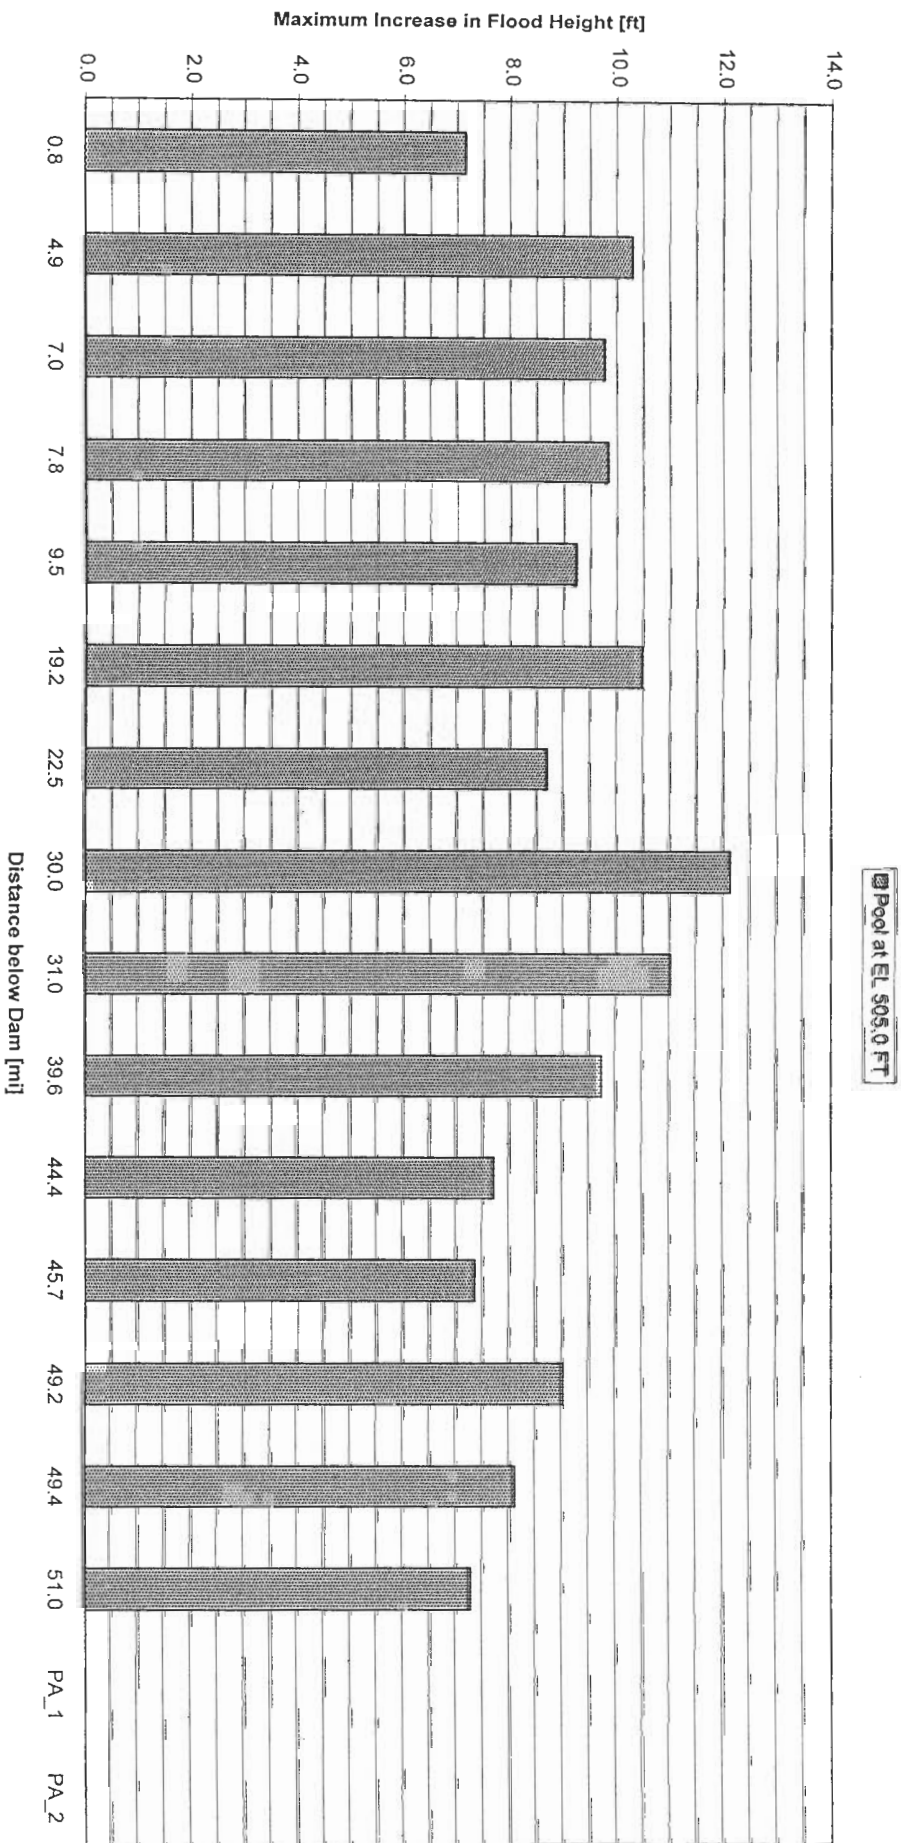
### Clearwater Major Rehabilitation Study (2003) Low Pool Seepage Dam Breach Maximum Increase in Flood Heights: Failure vs. Existing Condition Without Failure

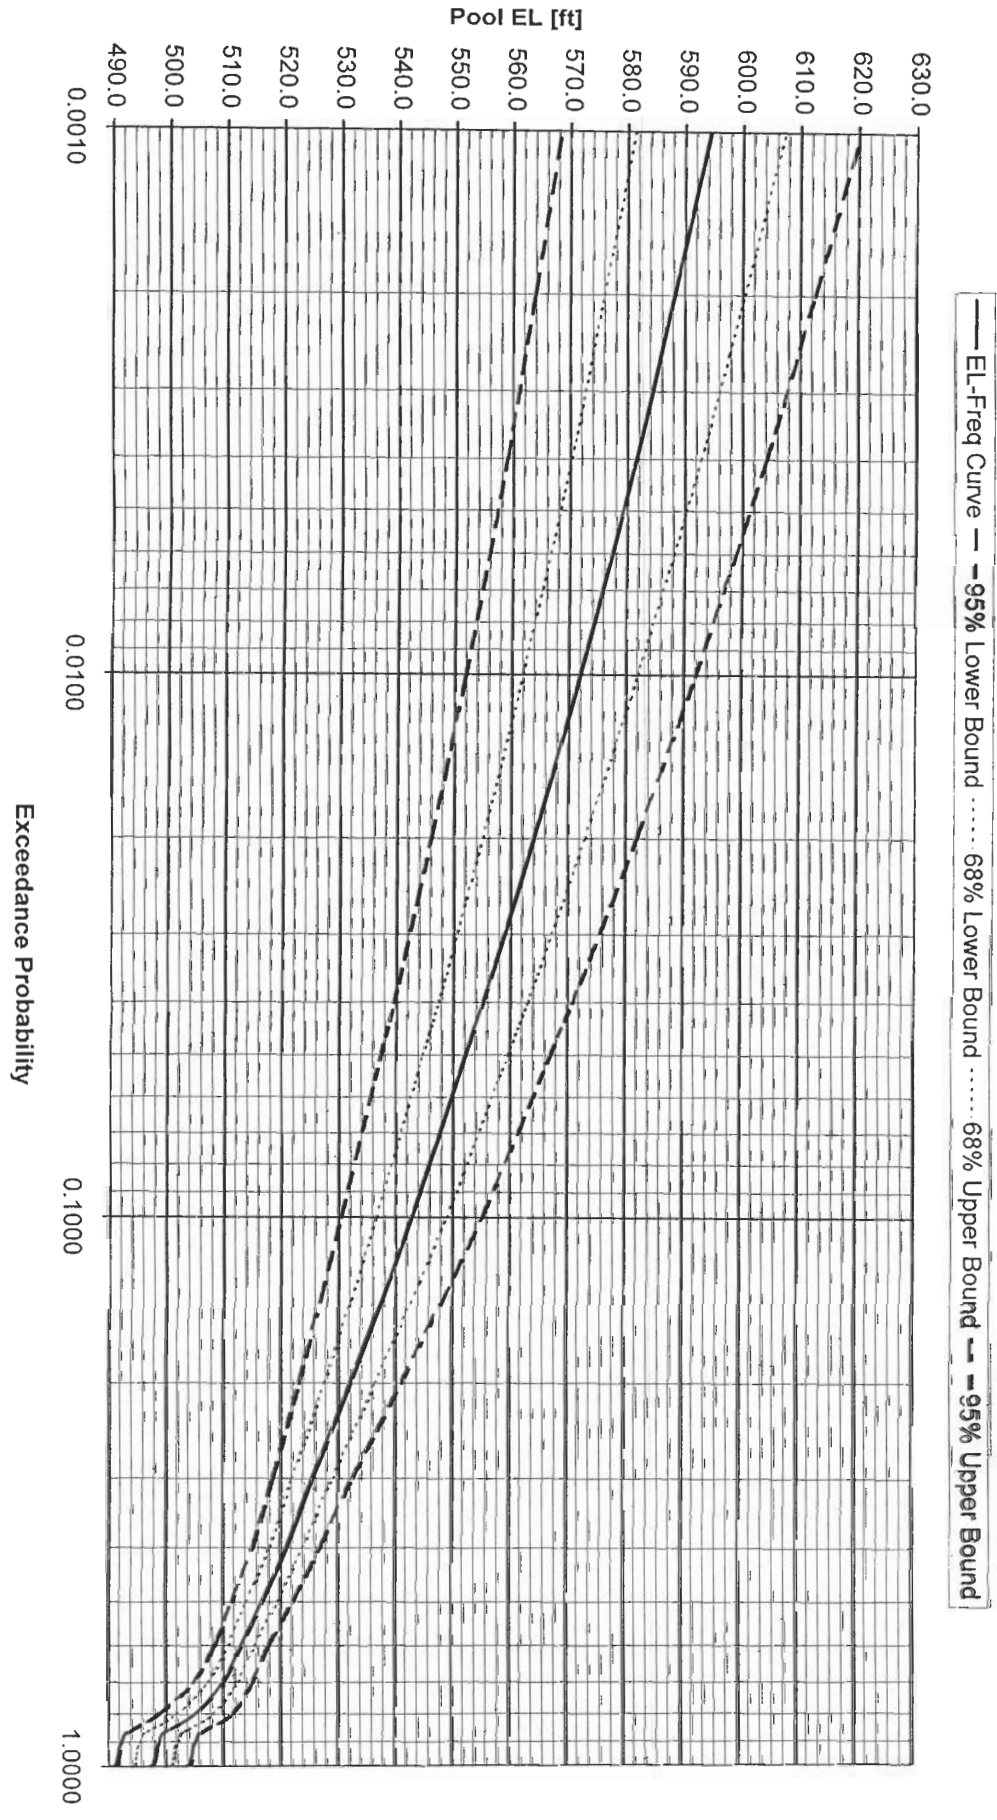
### Clearwater Lake Major Rehabilitation Study (2003) Pool Elevation-Frequency Curve With Confidence Limits

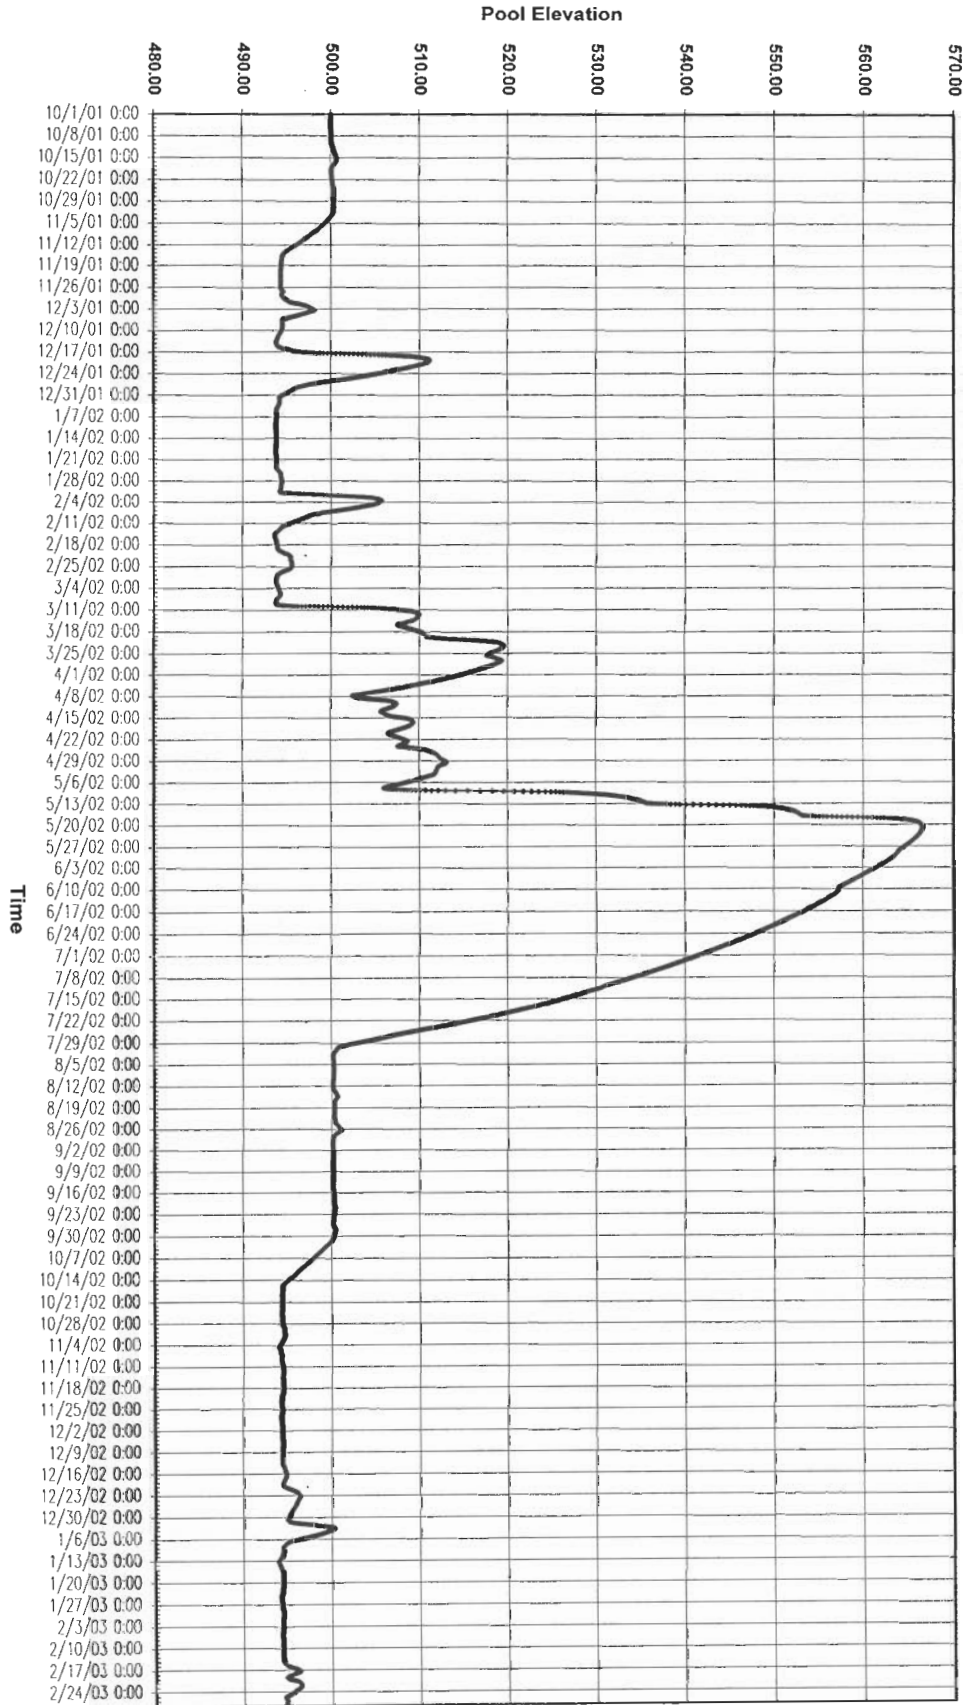
Clearwater Pool Elevations

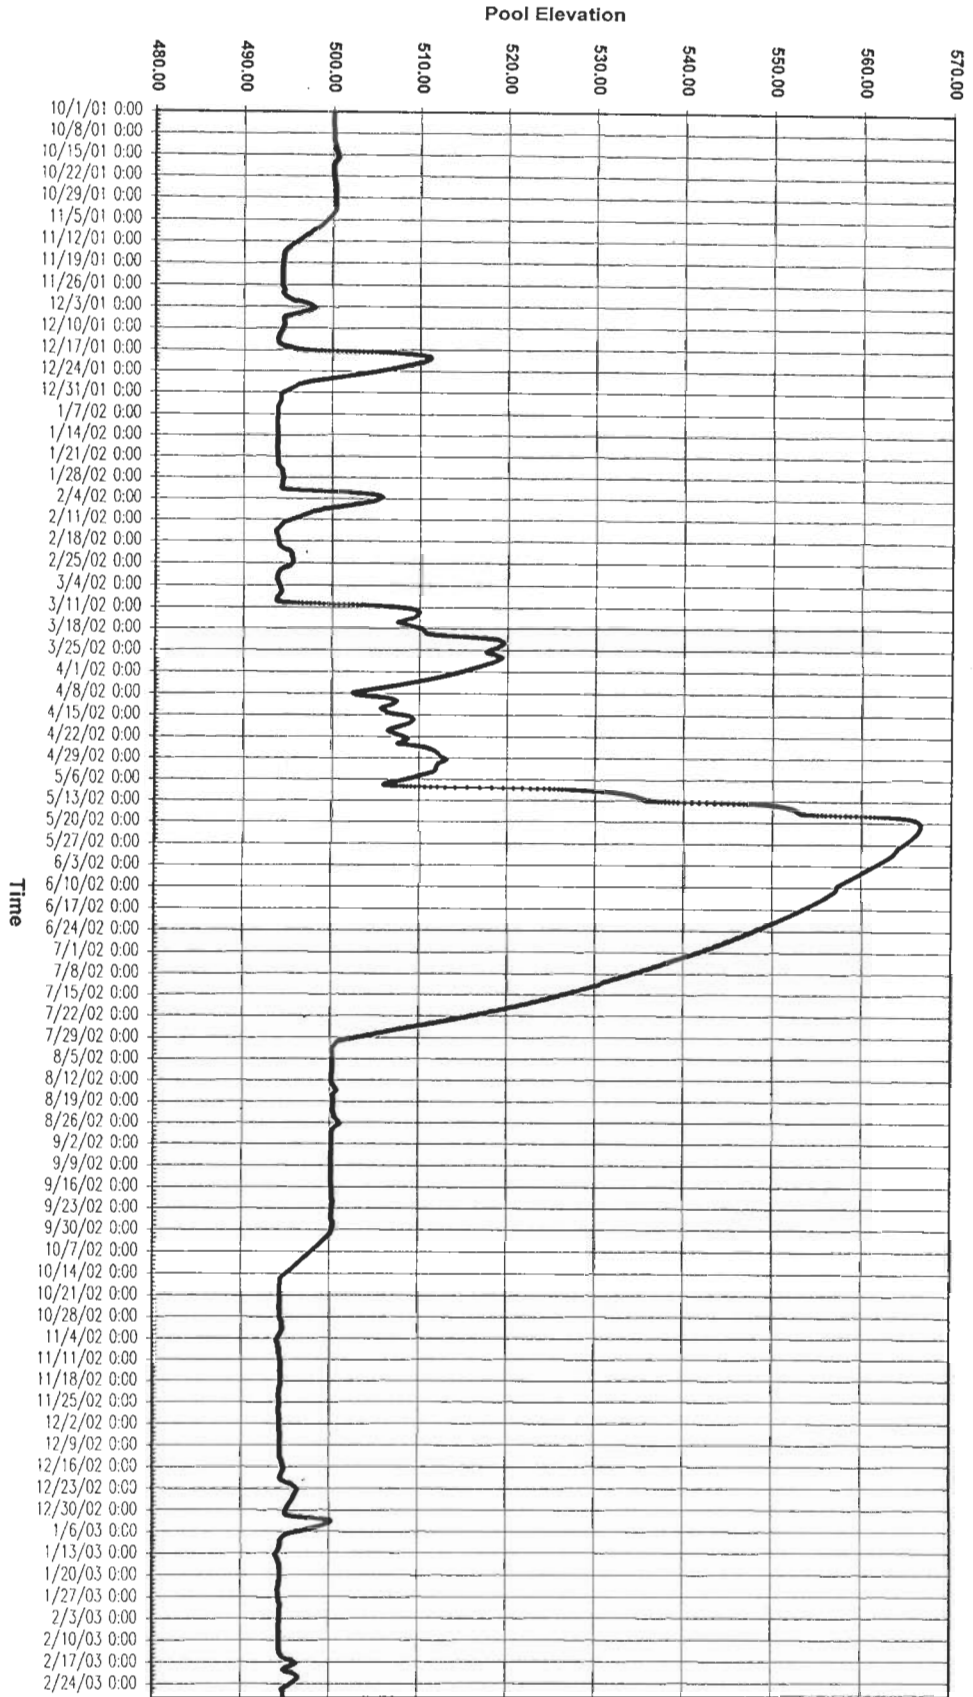
Clearwater Pool Elevations
