INDIAN BEND WASH 3 LEVEE SYSTEM
MARICOPA COUNTY, ARIZONA
NLD SYSTEM ID # 3805020007

PERIODIC INSPECTION REPORT NO. 1
GENERALIZED EXECUTIVE SUMMARY

FINAL SYSTEM RATING: MINIMALLY ACCEPTABLE
FINAL RATING DATE: AUGUST 28, 2015

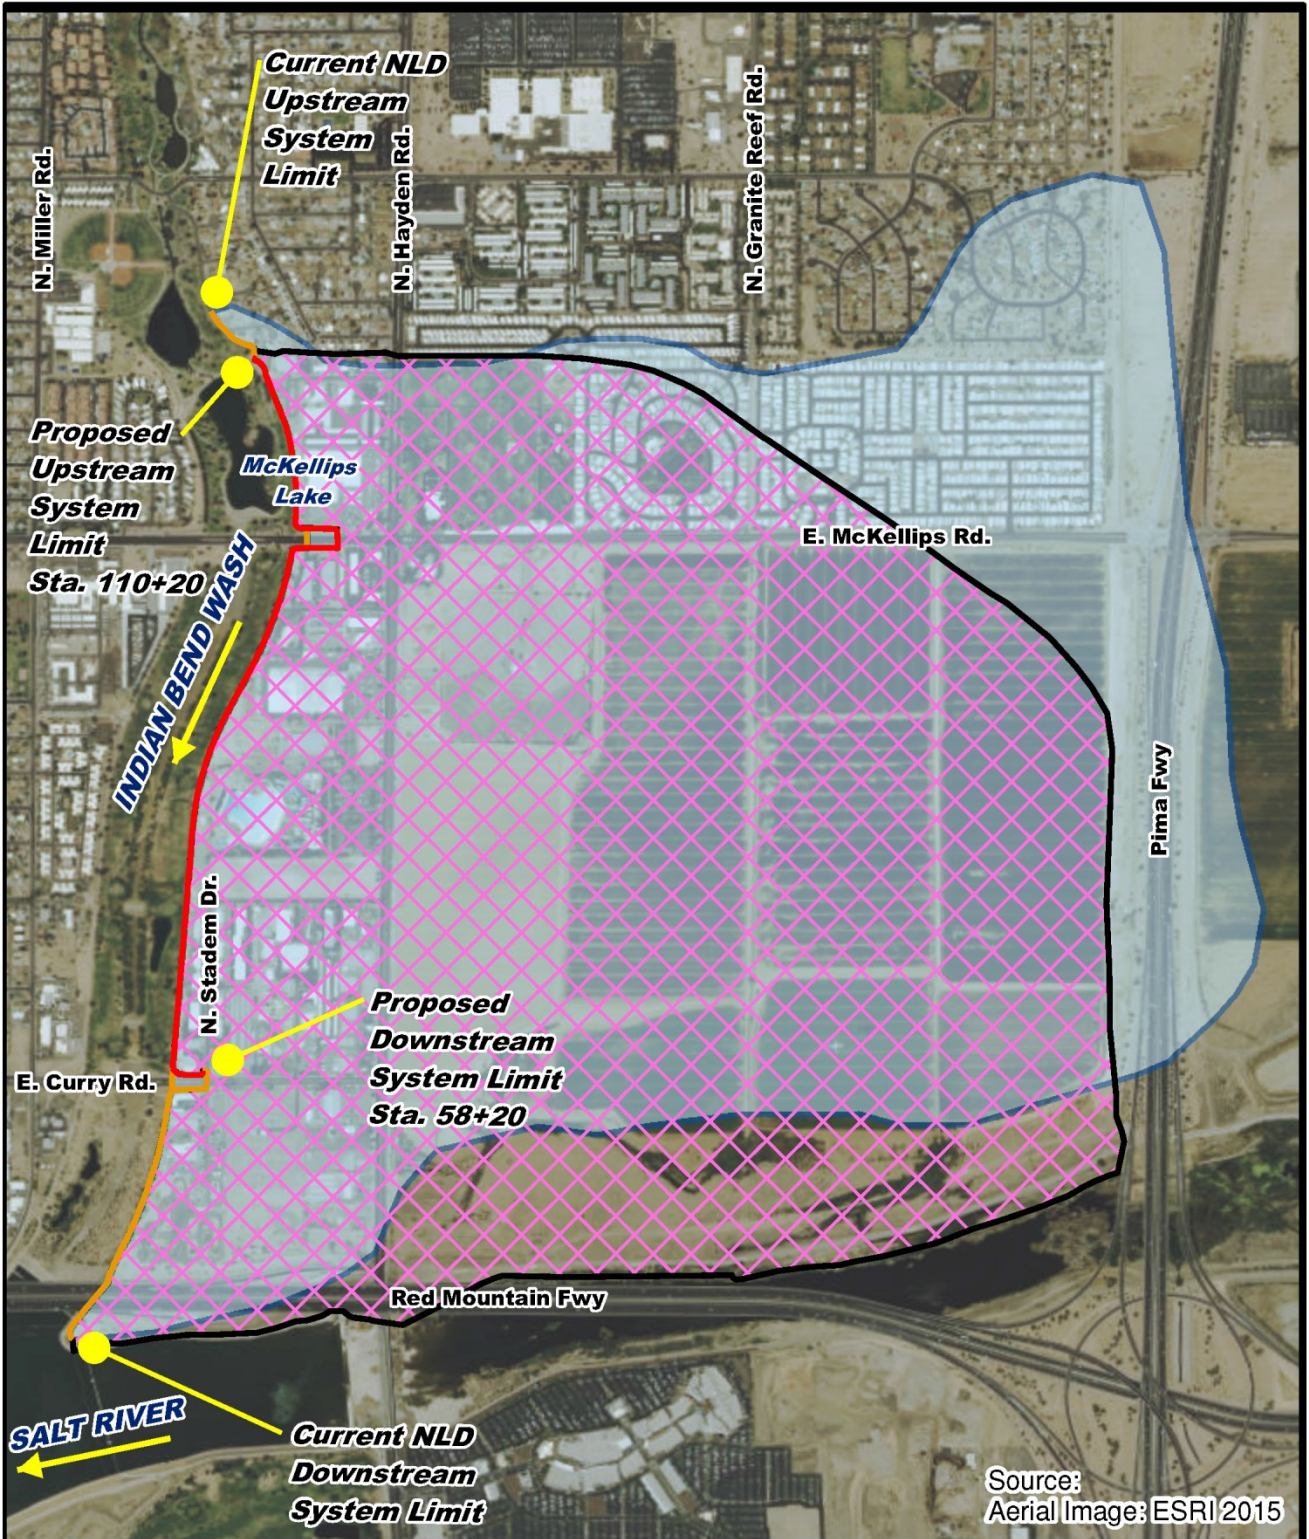
Source:
Aerial Image: ESRI 2015

URS was asked to confirm the upstream and downstream limits proposed in the *Trip Report* or to recommend a modified limit and conduct the current PI on the basis of URS' recommendations. URS was not tasked with reviewing the full extent of the portions of levee proposed for deletion, only with observing whether the endpoints appeared reasonable based on the available information and observations in the field. Based on the PI observations and other information, URS agrees closely with the upstream and downstream limits of the levee system proposed in the *Trip Report*. The extent of the levee system and leveed area recommended by this PI is shown on Figure 1.
