**LYTLE CREEK – ISLAND
LEVEE SYSTEM
SAN BERNARDINO COUNTY, CALIFORNIA
NLD SYSTEM ID # 3805010072**

**PERIODIC INSPECTION REPORT NO 1
GENERALIZED EXECUTIVE SUMMARY**

**FINAL SYSTEM RATING: MINIMALLY ACCEPTABLE
FINAL RATING DATE: SEPTEMBER 23, 2013**

PERIODIC INSPECTION REPORT PREPARED BY TETRA TECH
FOR THE U.S. ARMY CORPS OF ENGINEERS, LOS ANGELES DISTRICT

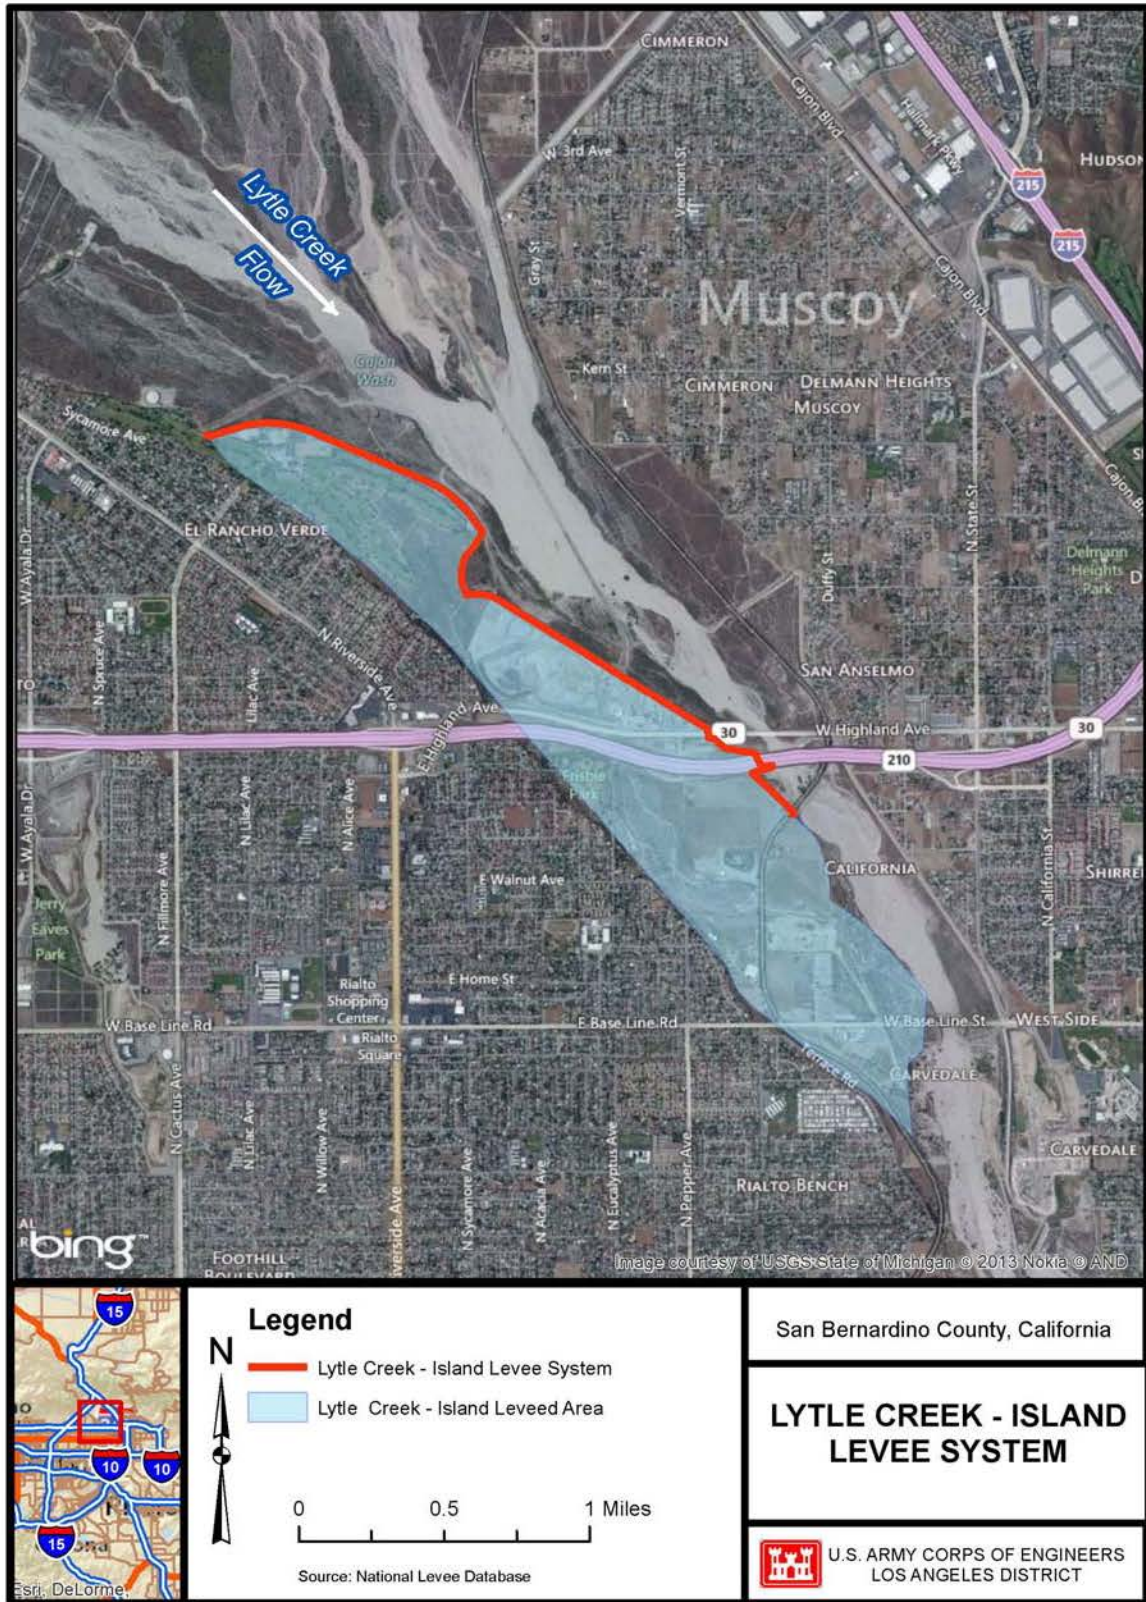
Figure 1: Lytle Creek – Island Levee System

Note: This NLD Leveed Area supersedes the leveed area shown in the PI Report.

On June 13, 2013, the leveed area was revised per signature of the Levee Safety Officer and is shown on Figure 1. This leveed area supersedes the leveed area in the Periodic Inspection Report No. 1.
