Stop Signal Overrun Investigation
Washington Metropolitan Area Transit Authority
(WMATA)

FINAL REPORT

Federal Transit Administration
U.S. Department of Transportation
1200 New Jersey Avenue, SE
Washington, DC 20590

August 15, 2016

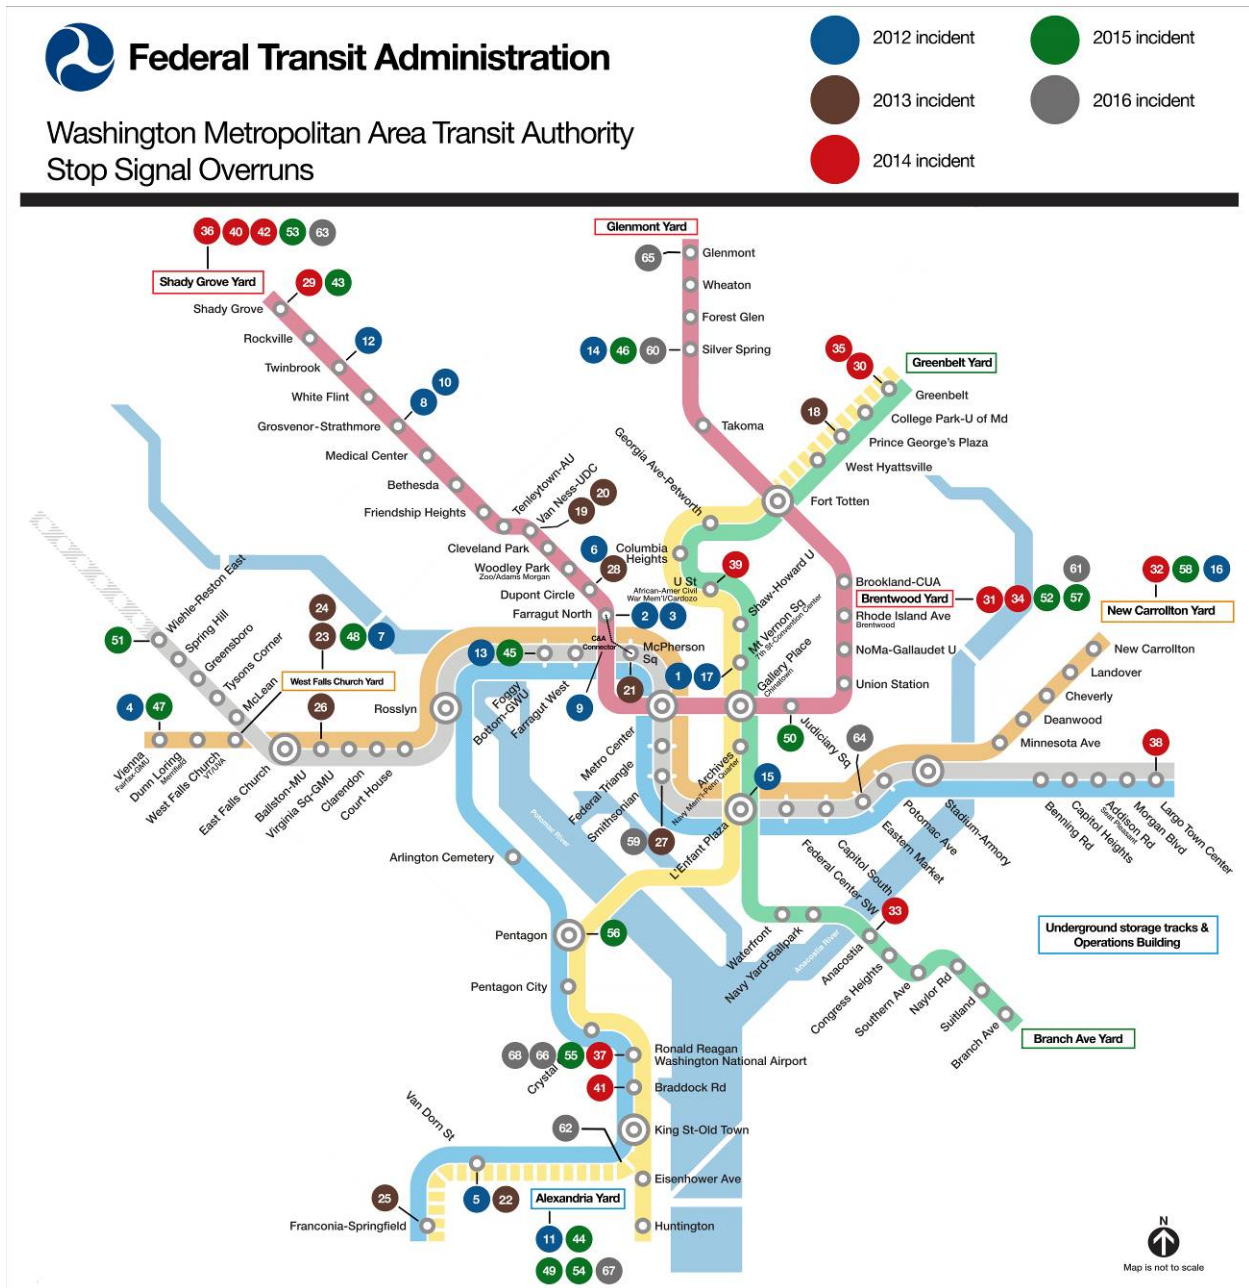
Figure 2 identifies the location of all stop signal overruns on the WMATA Metrorail system by year.

Figure 2: WMATA Stop Signal Overruns and Rate by Location and Year, 2012 through July 31, 2016

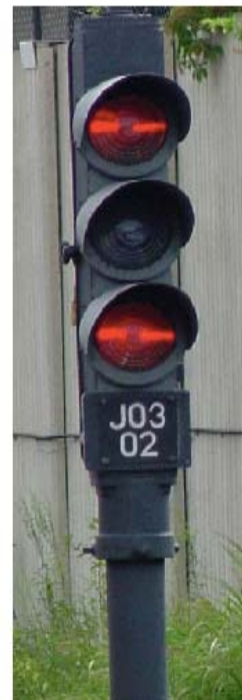
As depicted in Figure 4, signals are mounted on pedestals alongside the track or mounted on the wall of a tunnel. Figure 5 shows an outdoor signal, fitted with hoods to improve daylight viewing. When the top and bottom lights are red, as indicated in Figures 4 and 5, the train operator is facing a stop signal, and is required by WMATA operating rules to bring his or her train to stop no less than 10 feet in advance of the signal (see section 3.2.1 below).

Each interlocking has a signal associated with it, and all signals are referred to by an alphanumeric code. To identify a particular signal at which a train is standing, the interlocking code and signal number are both used. In Figure 5, the interlocking code is J03 and the specific signal number is 02.

Figure 5: Typical Outdoor Stop Signal

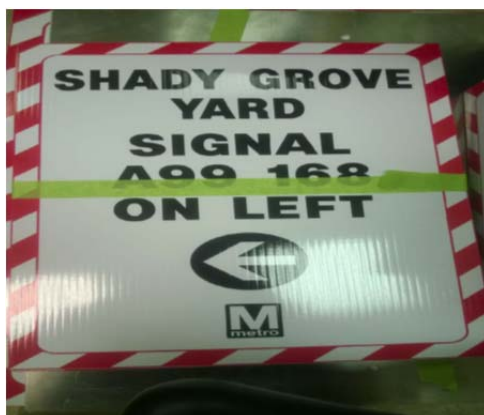
In addition to the added rules, WMATA developed two visual aids for operators. As a result of a stop signal overrun in the Shady Grove Yard in January 2014, WMATA developed a sign notifying train operators of signals placed to the operator's left. WMATA surveyed each yard and installed signage to indicate locations where a signal occurs in that atypical location.

Figure 6: Picture of Installed Signage at Shady Grove Yard

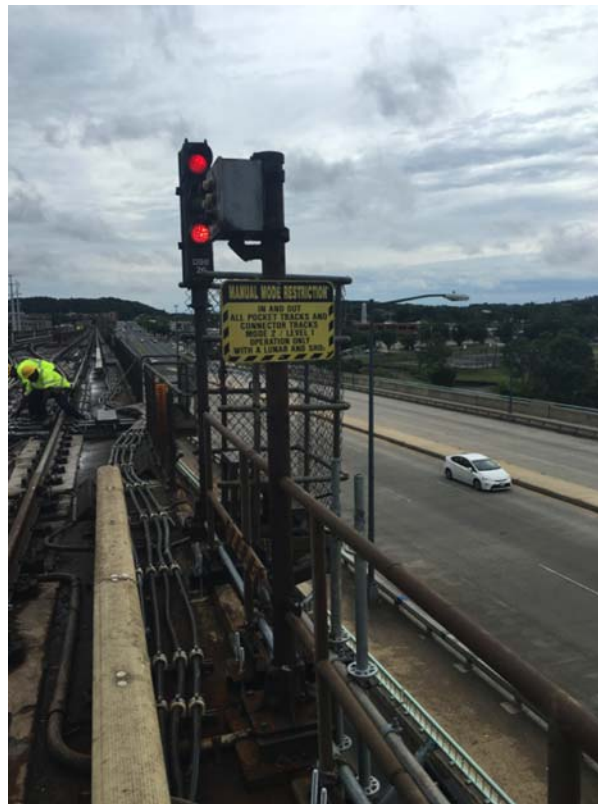
Also, following a stop signal overrun at a pocket track in 2012, WMATA installed a sign to remind train operators of the manual mode restriction in and out of all pocket tracks and connector tracks.

Figure 8: Sign installed near D&G Junction

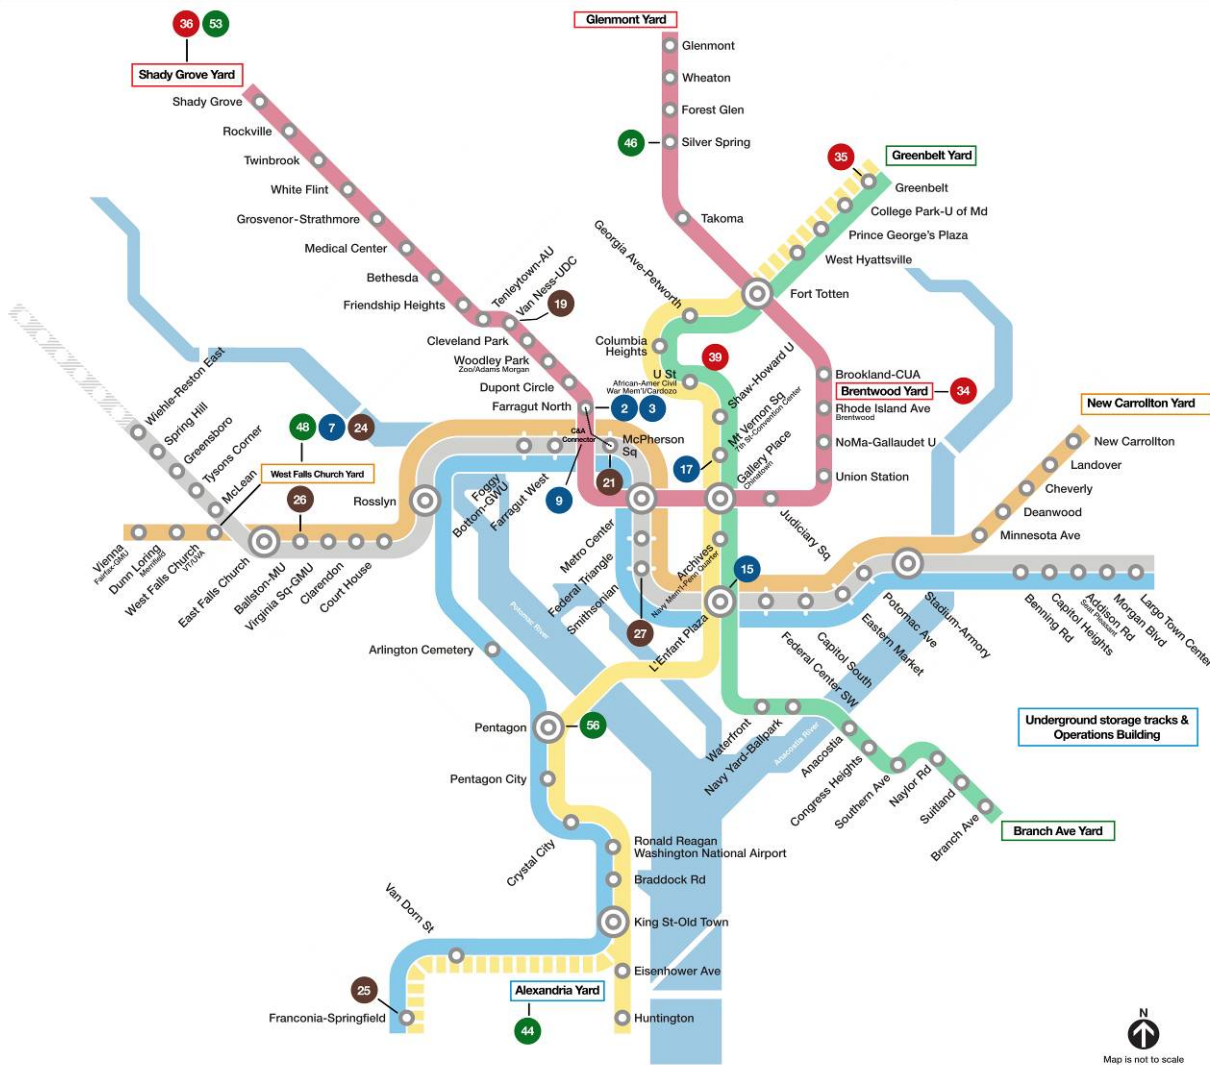
Category 1: Mainline and Yard Familiarity

- 2012 incident
- 2015 incident
- 2013 incident
- 2016 incident
- 2014 incident

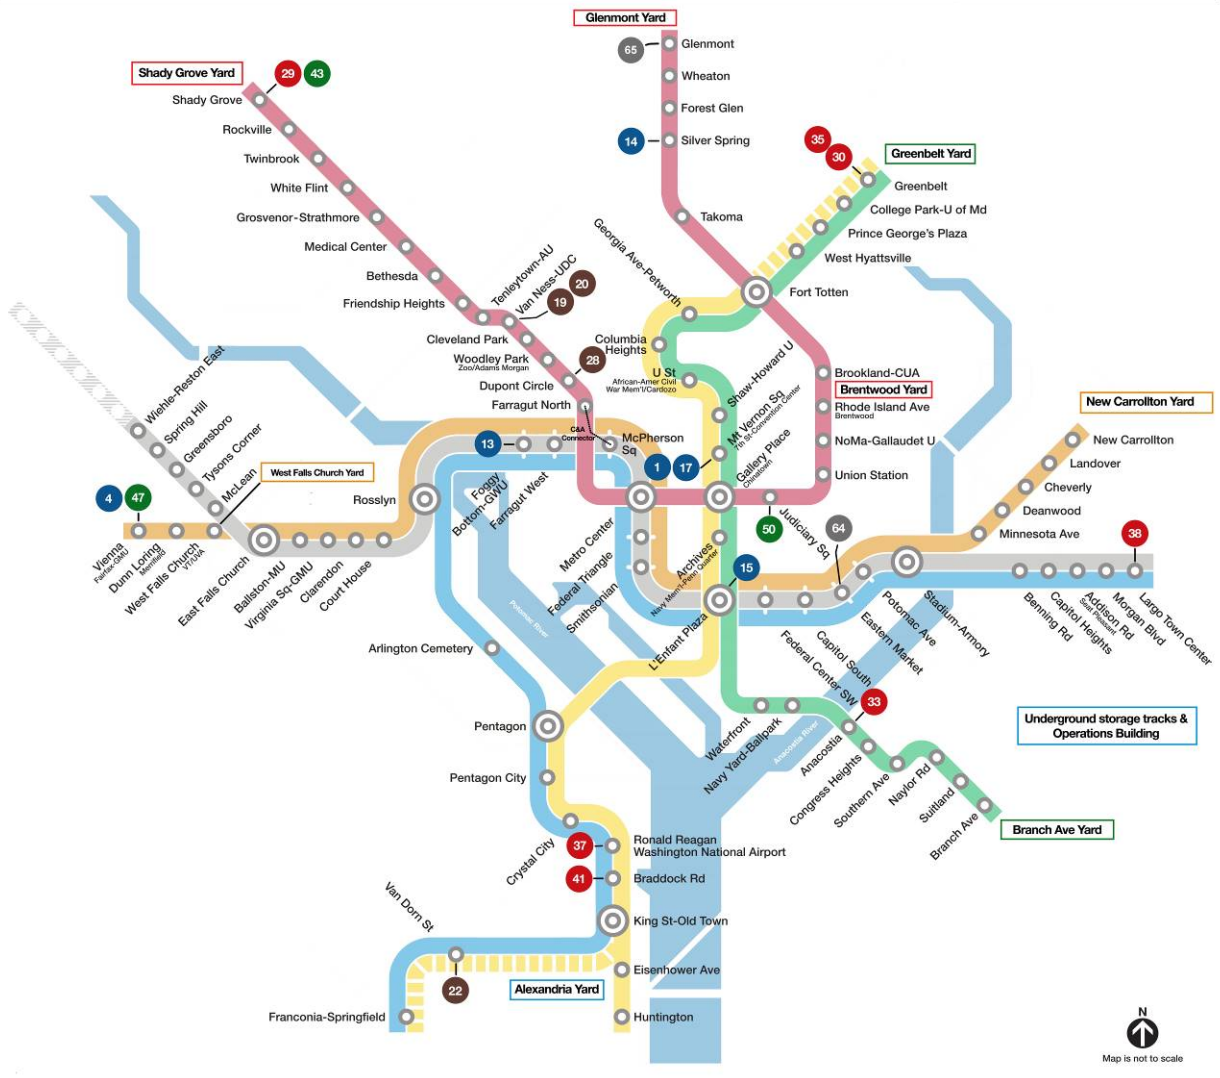
Washington Metropolitan Area Transit Authority
 Category 2: Departure from Stations and Terminals And Movement with Zero Speed Commands

- 2012 incident
- 2015 incident
- 2013 incident
- 2014 incident
- 2016 incident

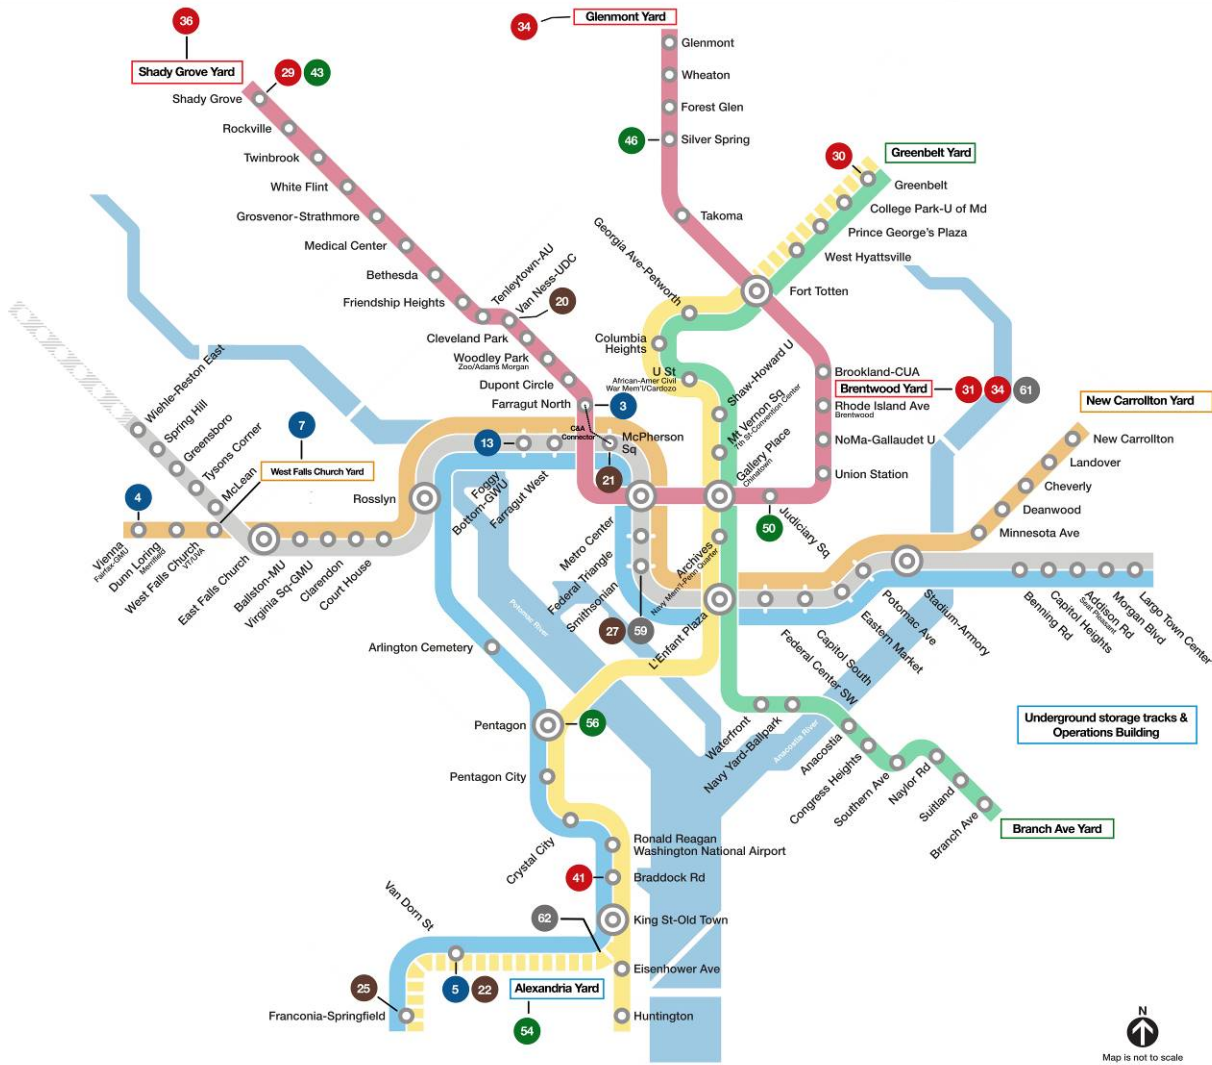
Washington Metropolitan Area Transit Authority
 Category 3: Communication with ROCC and Interlocking Operators

- 2012 incident
- 2015 incident
- 2013 incident
- 2016 incident
- 2014 incident
