# Using Long Range Ultrasonic Inspection for Challenging ECDA Situations

- > DOT R&D Forum  
New Orleans, LA  
February 7, 2007

Daniel Ersoy  
R&D Director  
Delivery Sector  
Gas Technology Institute (GTI)

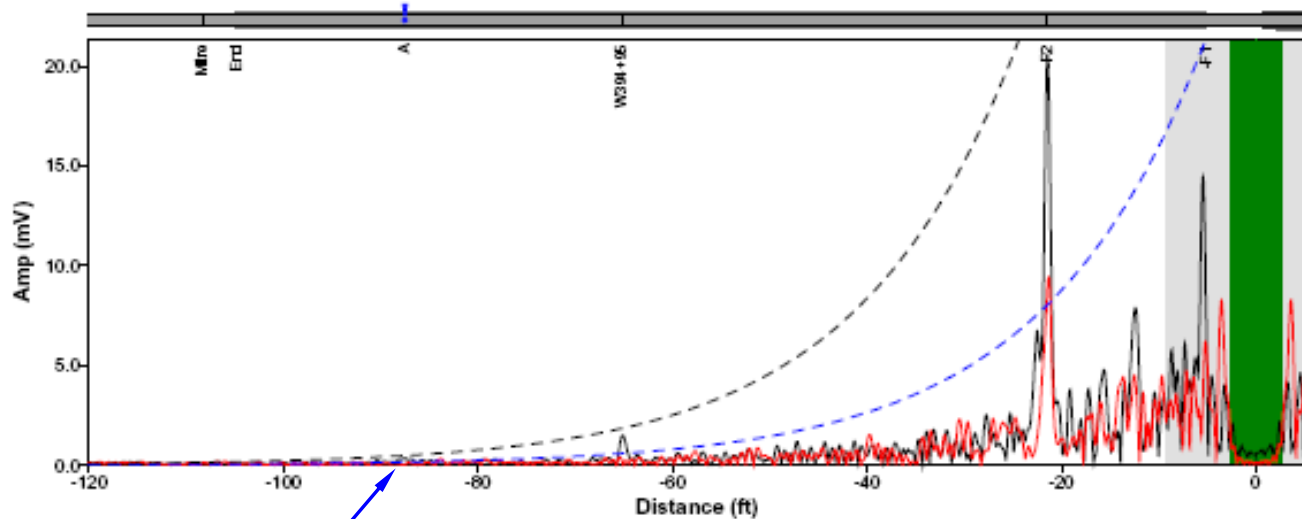
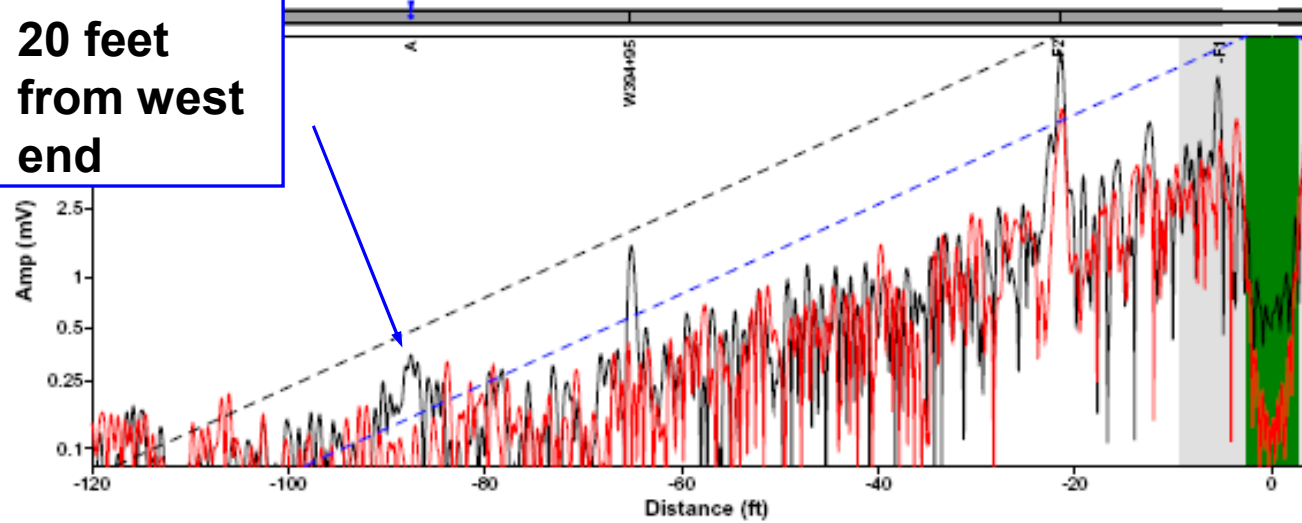
# Linear vs. Log Display

Feature at 20 feet from west end

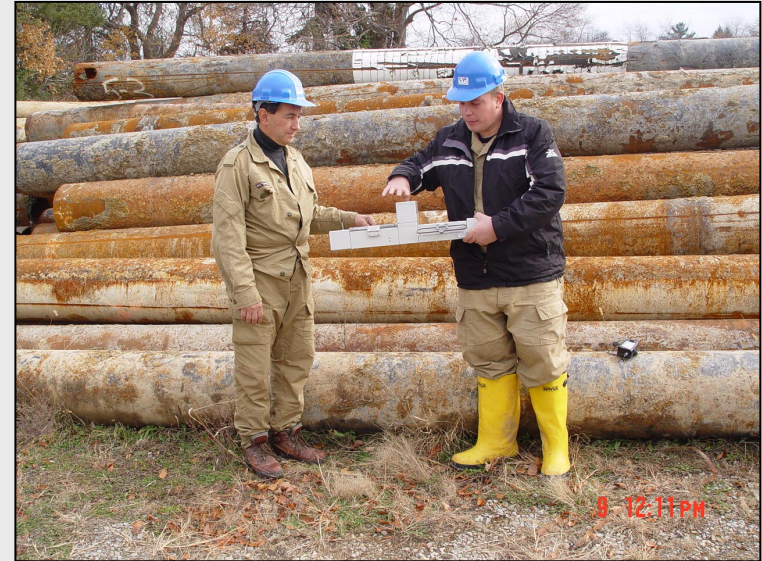
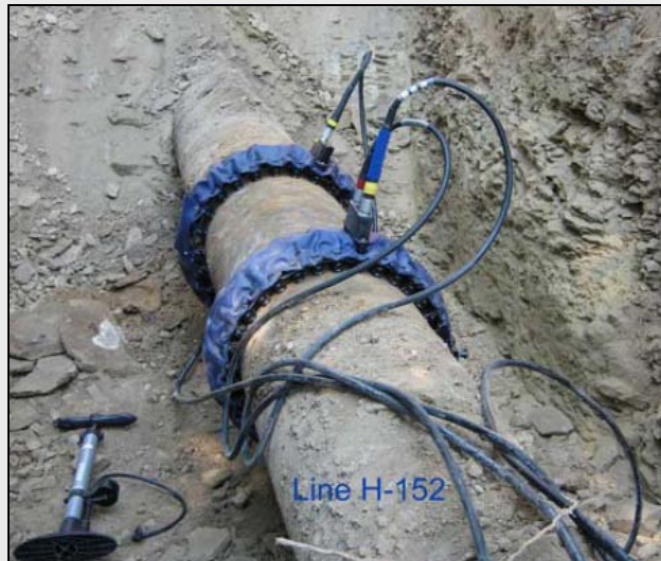
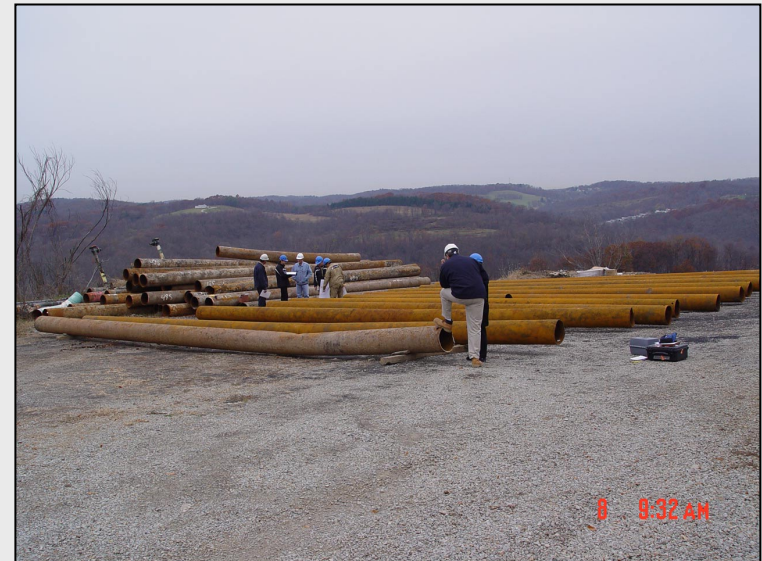
# ECDA Gaps/Challenges – Bare Pipe

- > Bare Pipe: *Pitch-Catch* UT; Magnetic Tomography; and Direct Exams.
- > Initial results of LRUT indicate good correlation with direct exams but limited range of effectiveness due to attenuation of signals on rough pipe in clay soils.
- > Magnetic Tomography performance results are currently mixed.
- > Shielded, disbanded coatings field work is planned for early 2007.

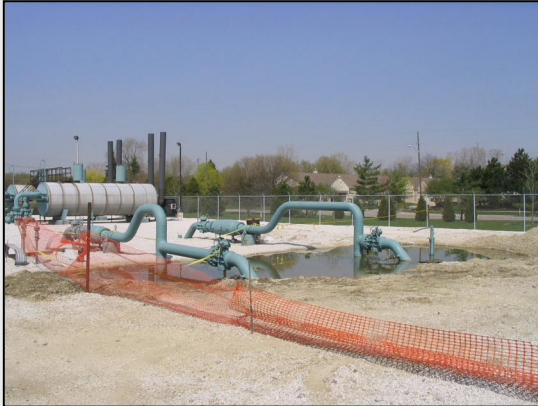
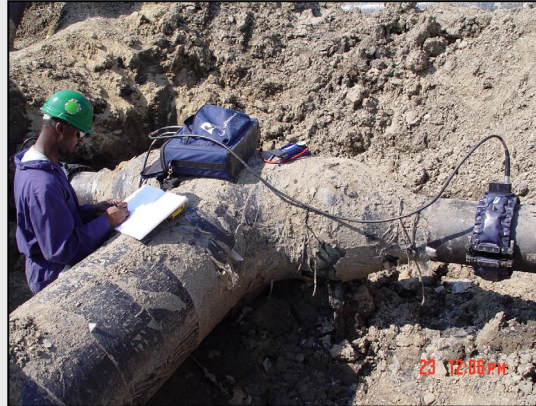
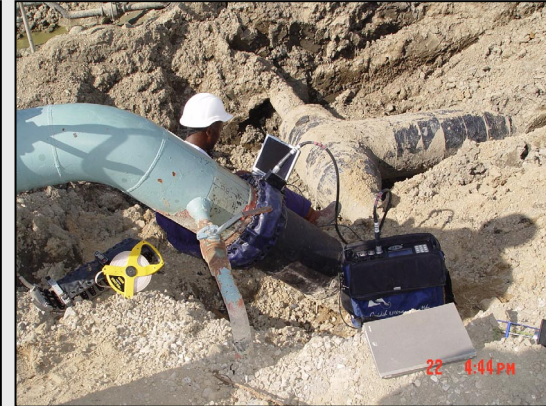
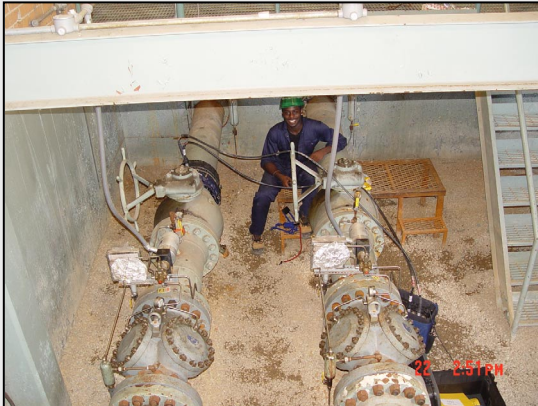
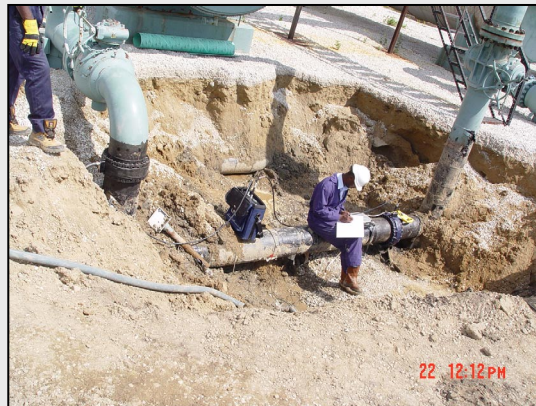
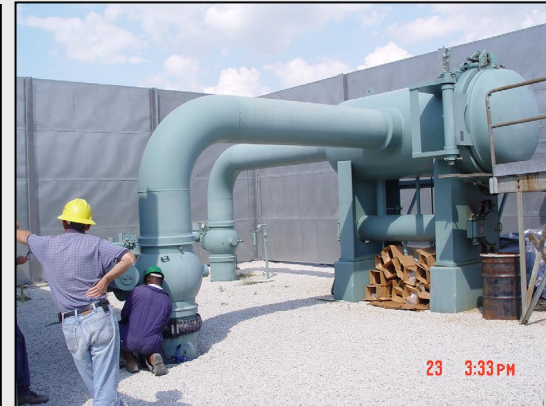
# ECDA Gaps/Challenges – Crowded Areas – City Gate (Meter/Regulator) Stations

- > City Gate Station – Recently used pitch-catch across tee's and wall penetrations with good success. Initial comparison against radiography, magnetic particle inspection, and portable/direct contact beta scan (UT) have confirmed inspection results.

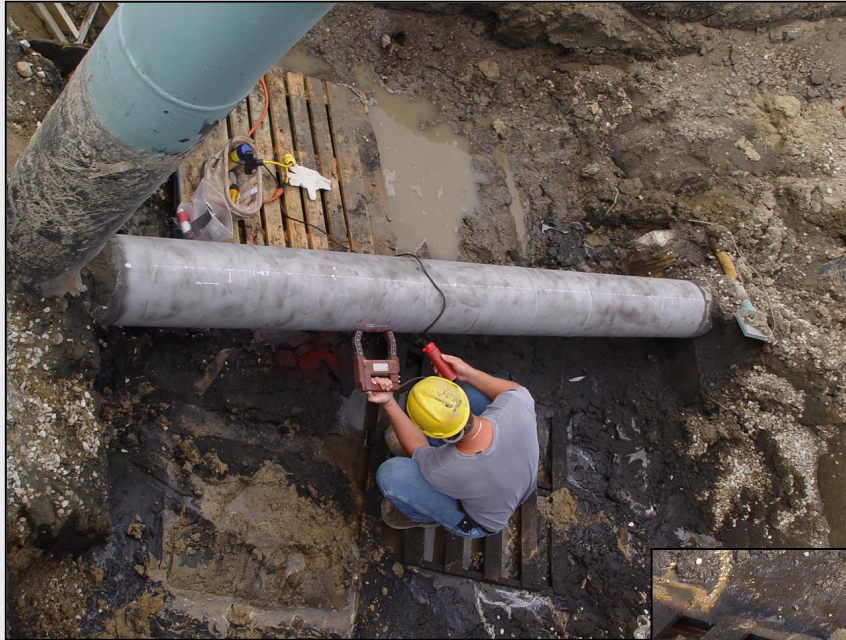
# ECDA Gaps/Challenges – Crowded Areas – City Gate (Meter/Regulator) Stations

- > Direct Exam with Magnetic Particle Inspection - Welds and Pipe Surface.

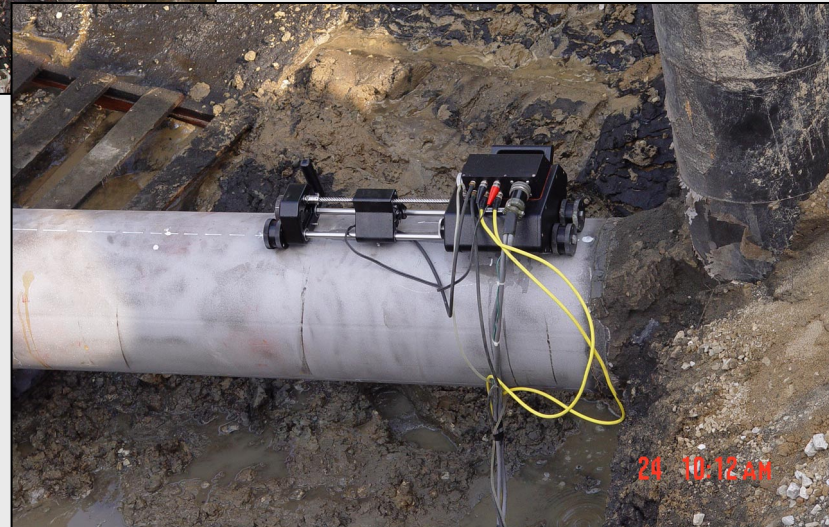
- > Direct Exam of Pipe Wall with Portable Ultrasonic Beta Scan Unit.

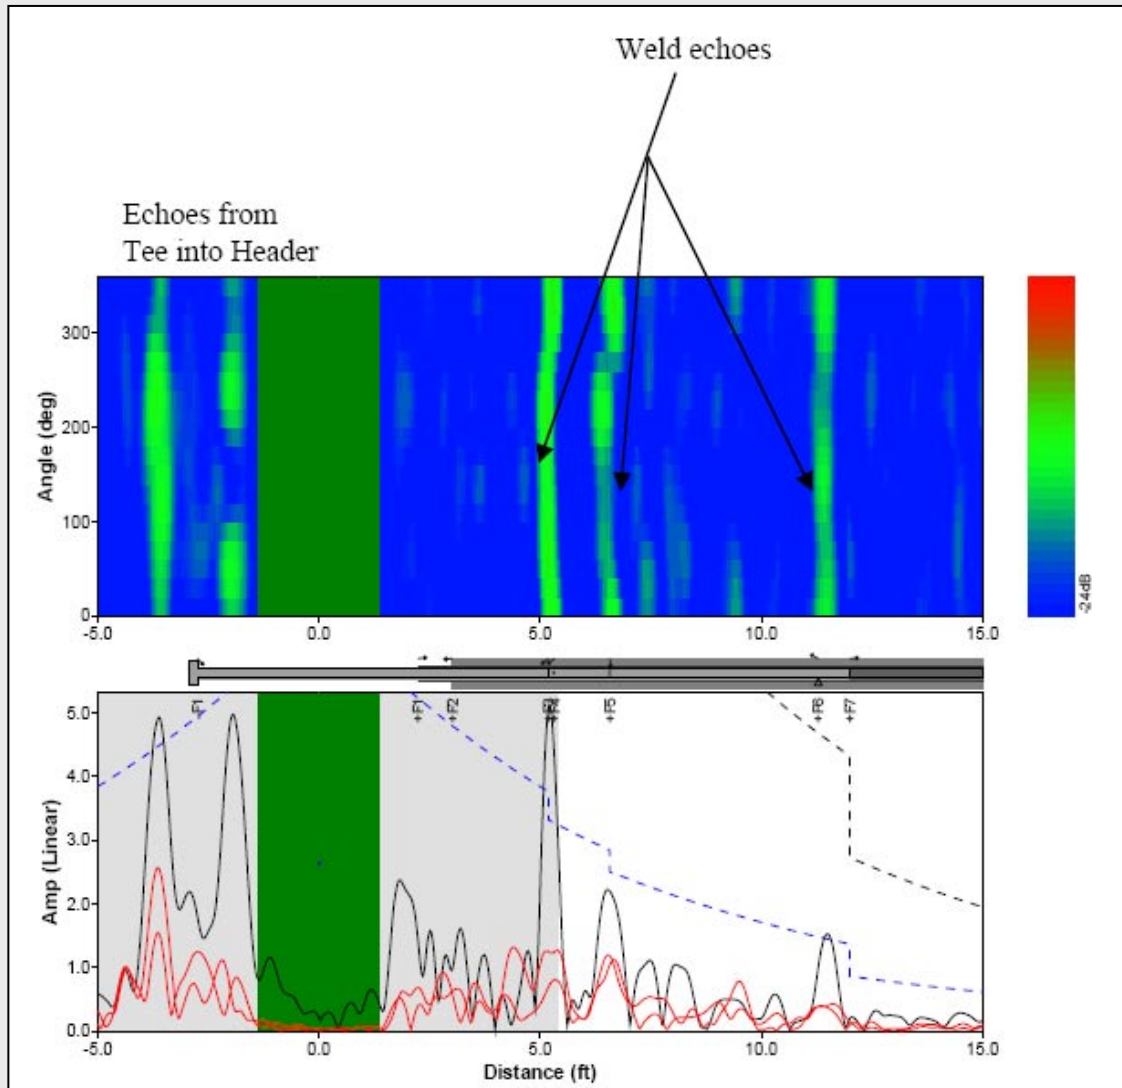
# Guided Wave C-Scan Presentation

- > C-Scan (focusing technology) result on 12" buried pipe.
- > Circumferential location of indications can be displayed.
- > Initial comparison with direct exam is promising.
- > This inspection correctly predicted no defect.

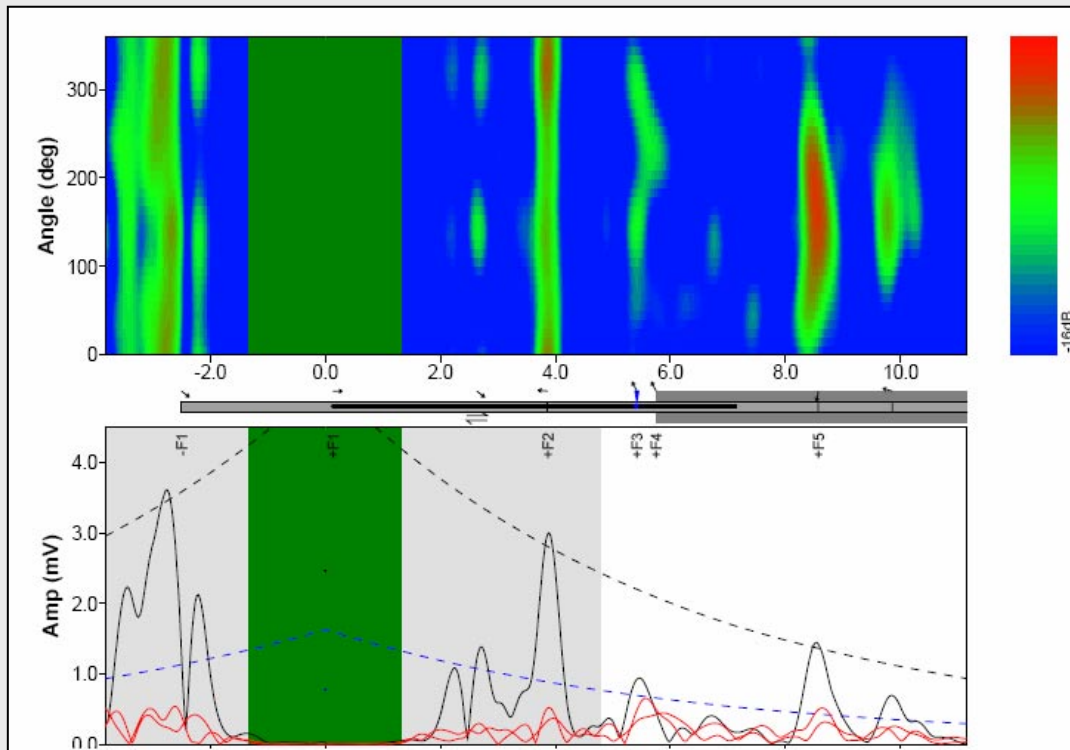
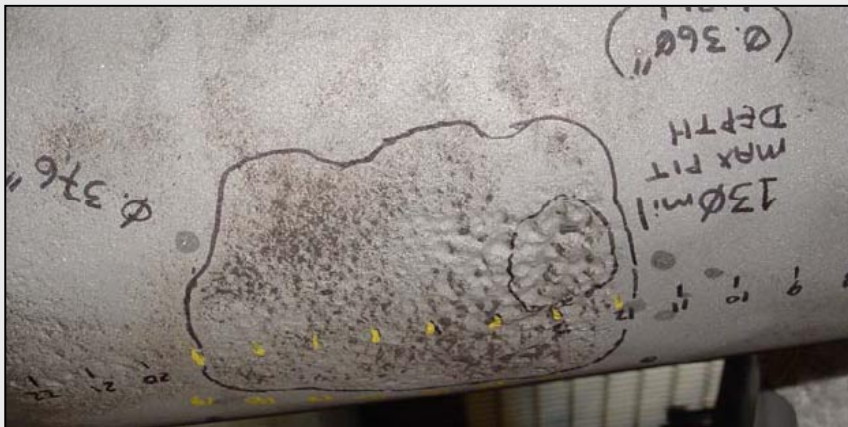
# C-Scan of Corroded Area #1

- > C-Scan *focused* presentation of the reflections from the area just before a Link seal are localized towards the bottom of the pipe (at an angle of about  $180^\circ - 240^\circ$ ).
- > In particular, the reflection at about 5ft 6inch from the transducer ring is concentrated and was confirmed as corrosion.
- > Picture (to the left) of the corrosion from the 4 o'clock position looking in the positive direction from the transducer ring (about  $230^\circ$ ).

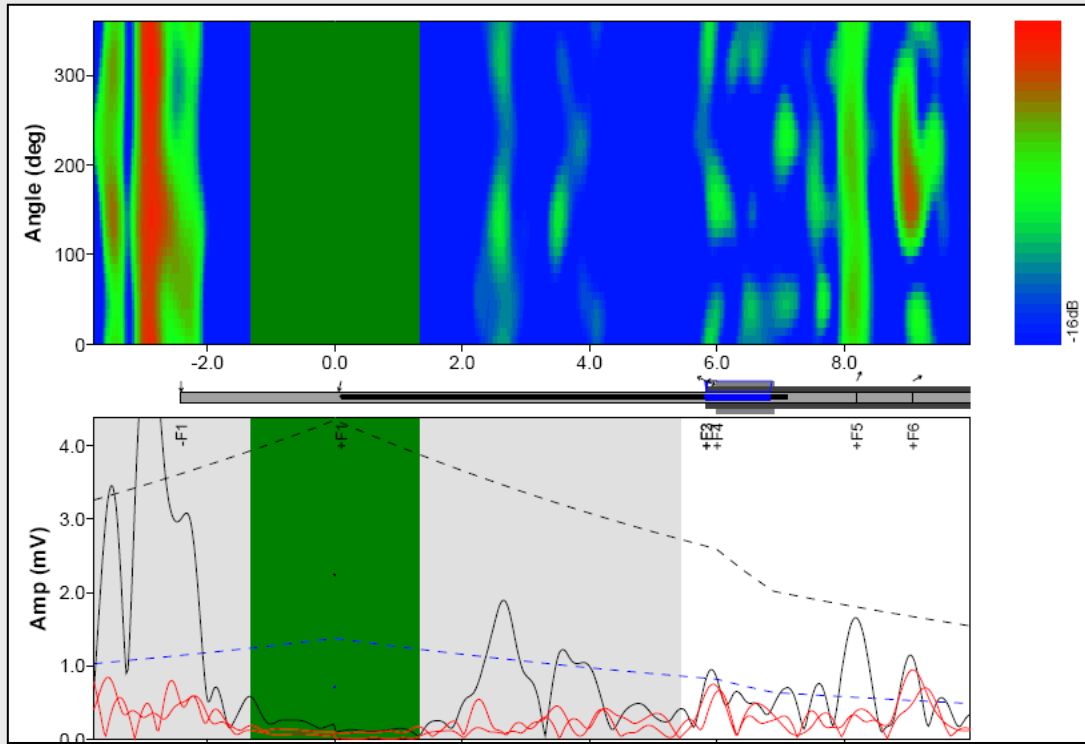
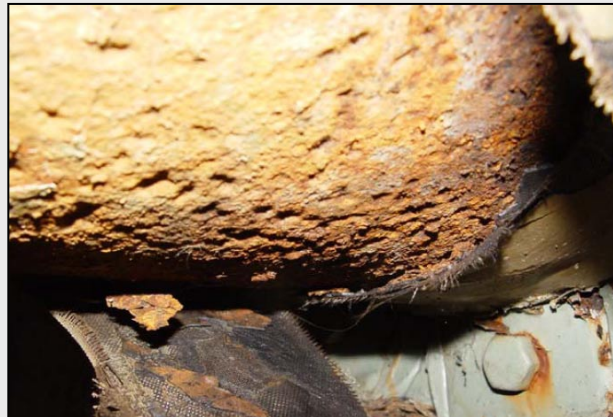
## C-Scan of Corroded Area #2

- > The reflections from the Link seal area are localized towards the bottom of the pipe (at an angle of about 160° - 240°).
- > In particular, the reflection at the entrance is concentrated and could be visually seen to be corrosion during the subsequent direct exam.
- > Picture of the confirmed corrosion from TP6 (5C) at the 6 o'clock position or bottom of the pipe (about 180 deg).

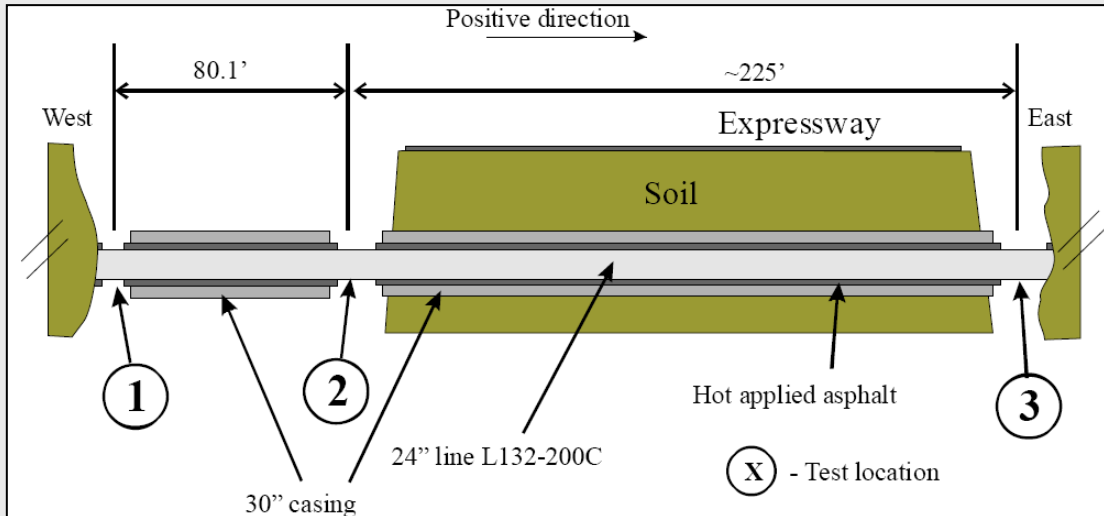
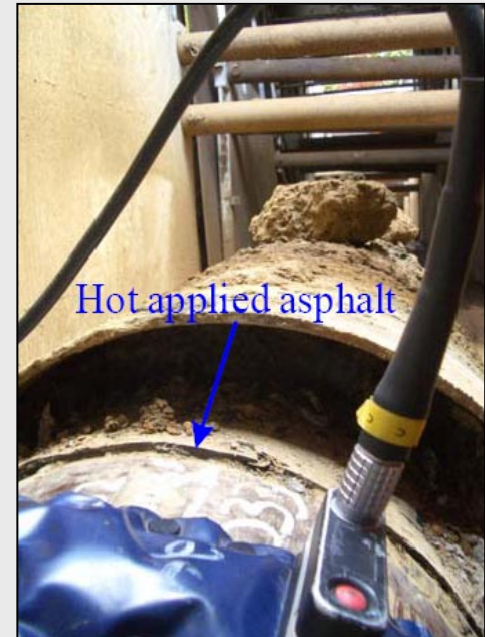
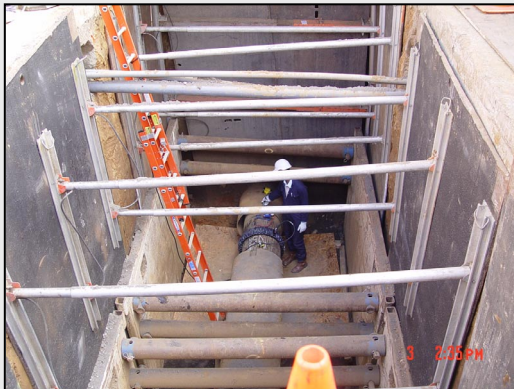
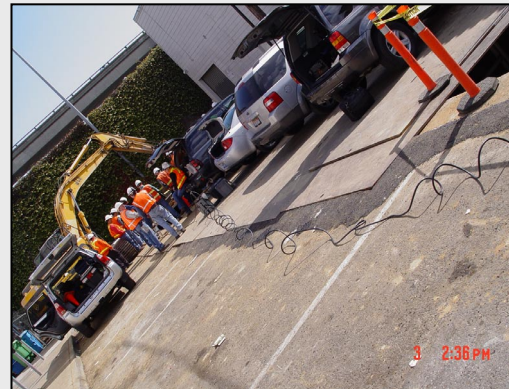
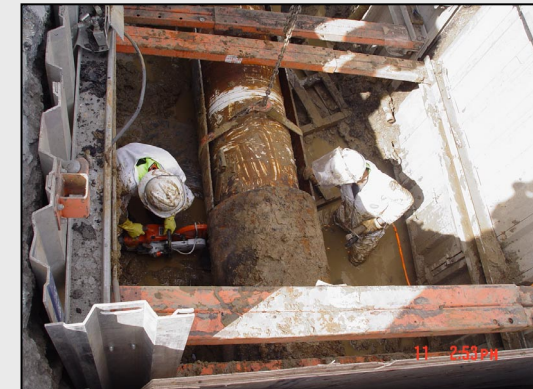
# ECDA Gaps/Challenges – Cased Crossings

- > Continues to be a challenging situation based on range, signal strength, sensitivity, etc. More work planned in 2007 in class 4 locations.
