PHMSA R&D Forum

Enbridge Pipelines Inc.

Enbridge Pipelines Liquid System

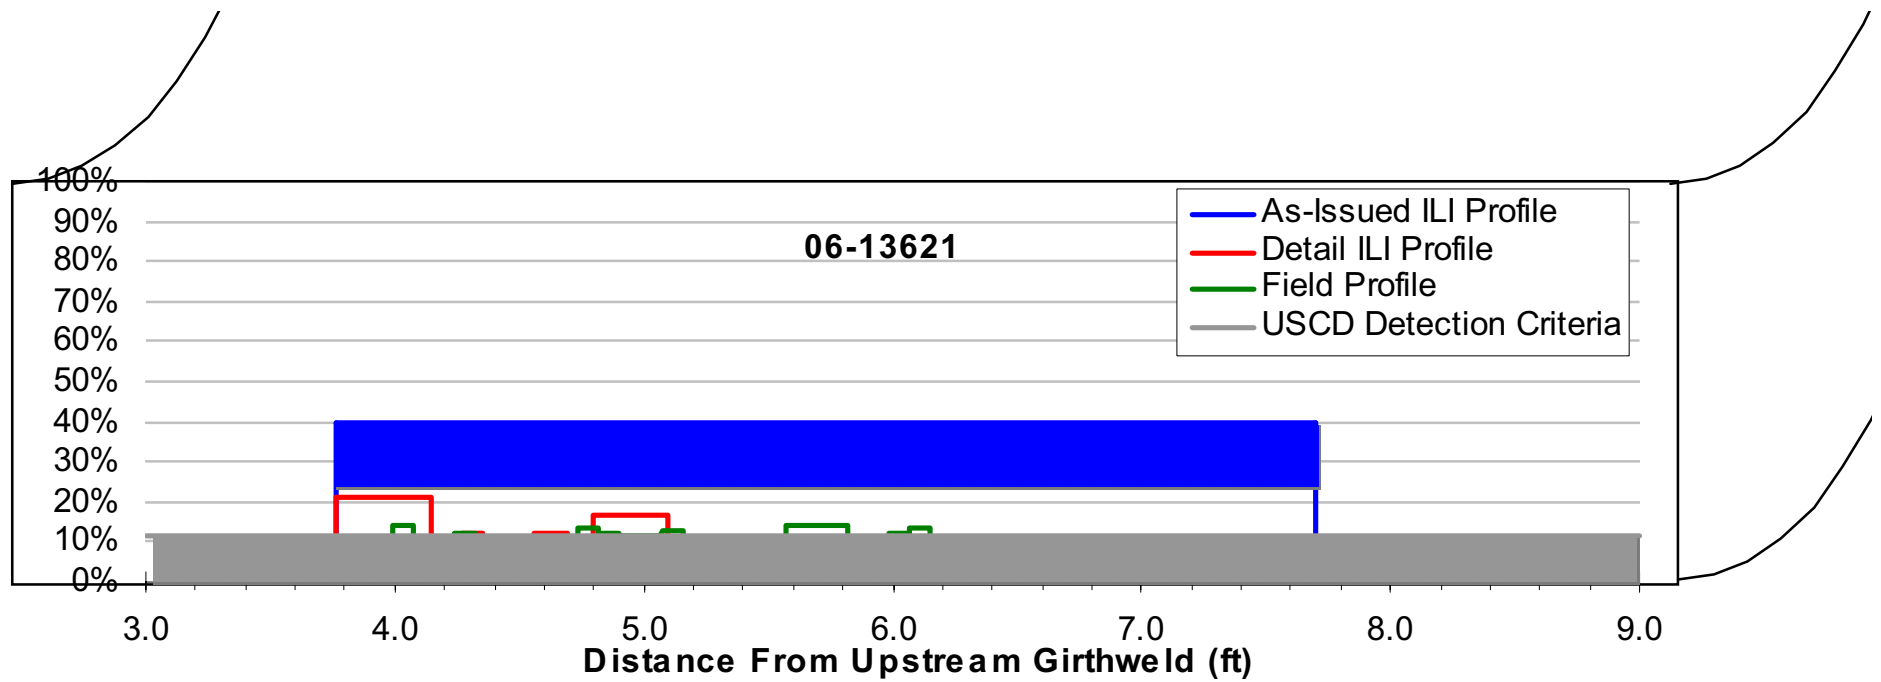
Crack Inspection Field vs. ILI Result

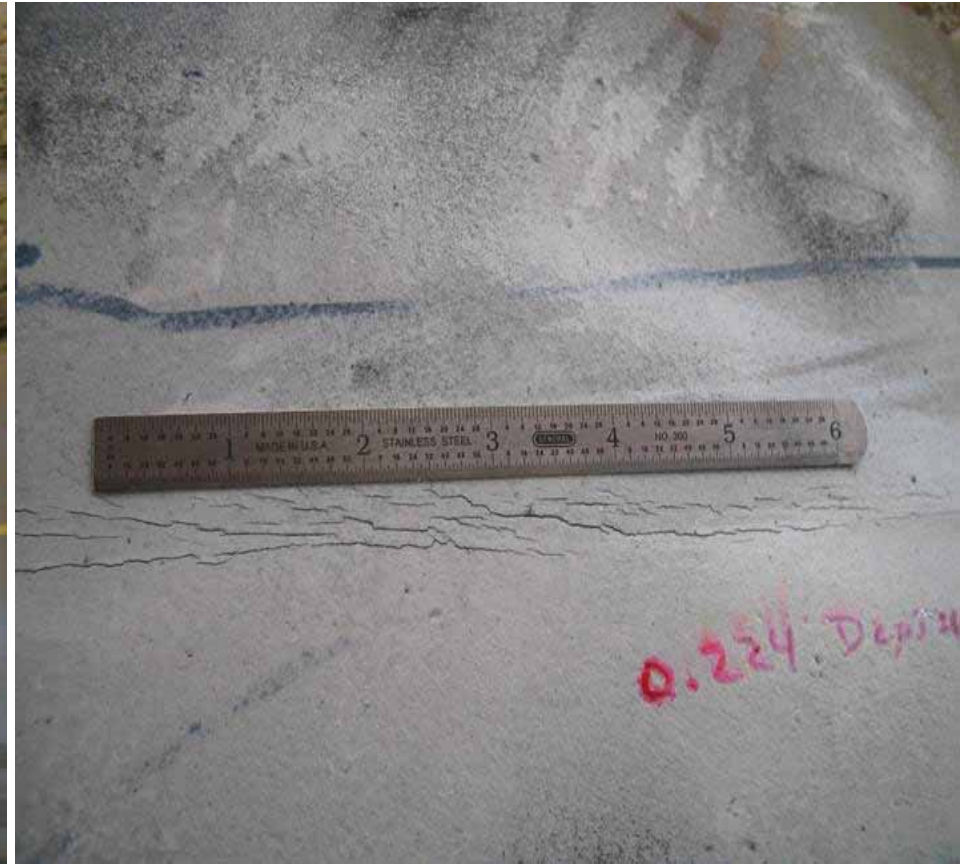
Interesting Field Results More Questions than Answers

Top of Pipe Mechanical Damage/Gouge Multiple Dents
