# An Examination of Safety Reports Involving Electronic Flight Bags and Portable Electronic Devices

**Final Report — June 2014**

DOT-VNTSC- FAA-14-12

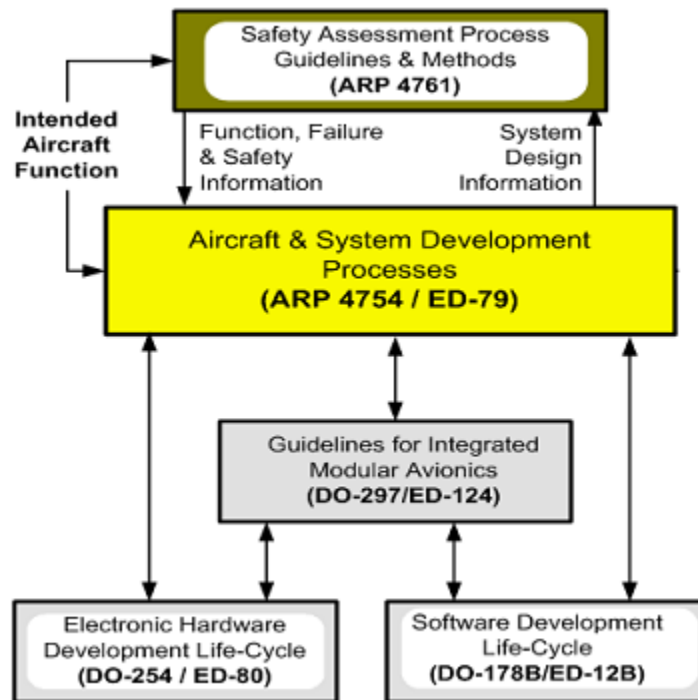
**Figure 1. Guideline Documents Covering System Development. Reprinted with permission Copyright (c) 2010 SAE International. No further copying or distribution is permitted without permission from SAE.<sup>1</sup>**

In addition to the human factors and user interaction issues discussed in the previous section, the FAA was also interested in conducting a separate analysis examining the reports from a software engineering perspective to see if we could provide input as to whether the software related issues reported by pilots are due to an error in the specification of the system requirements or an error in the software processing. The distinction between systems development and software processing is described in Figure 1 below; this figure was excerpted and reprinted with permission from SAE ARP 4754A.

The figure highlights that there are two different roles. One is focused on system design (the top half of Figure 1), and the other is focused on the software development (the bottom half of Figure 1). Per RTCA DO-178B, *Software Considerations in Airborne Systems and Equipment Certification*, software requirements are used to develop a software design for implementation into source code (i.e., software programming). These requirements may include operational functions, user interface, system redundancy, security and maintenance. A *system requirement error* can be thought of as any incorrect or incomplete system requirement. As noted in the figure, SAE ARP (Aerospace Recommended Practice) 4754A, *Guidelines for Development of Civil Aircraft and Systems*, proposes one such method for validation.

<sup>1</sup> Note that Figure 1, excerpted from SAE ARP 4754A, references RTCA DO-178B, but that document has since been revised. The latest version is RTCA DO-178C.

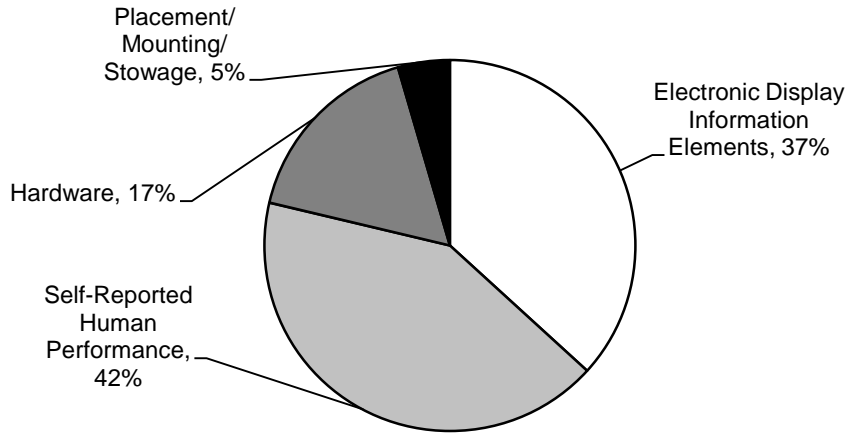
**Figure 2. Percent Part 91 Human Factors Concerns Reported.**

Overall, 37% of human factors concerns were related to *electronic display information elements* concerns, 19% involved *hardware* concerns, 40% were related to *self-reported human performance* concerns, and 5% involved *placement/mounting/stowage* concerns. Figures 2, 3 and 4 show the breakdown for each of the main categories by operation type.

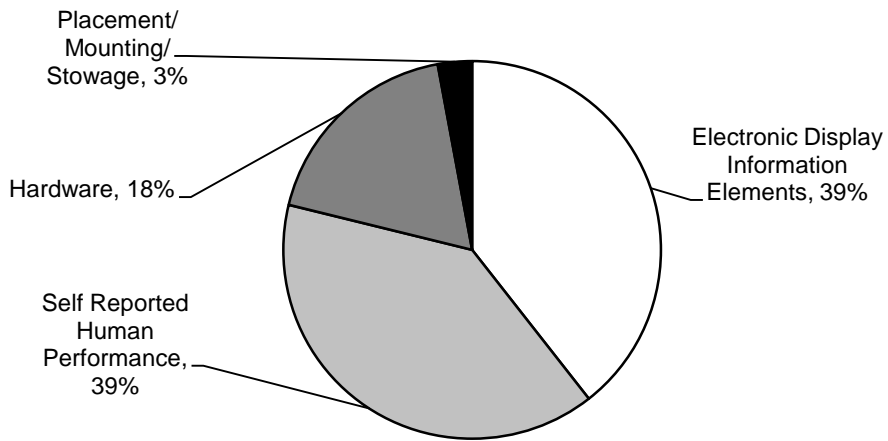
**Figure 3. Percent Part 121 Human Factors Concerns Reported.**

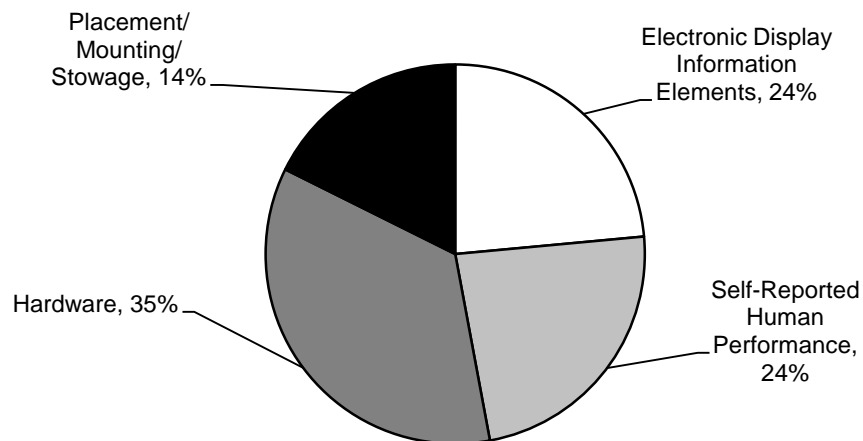
**Figure 4. Percent Part 135 Human Factors Concerns Reported.**

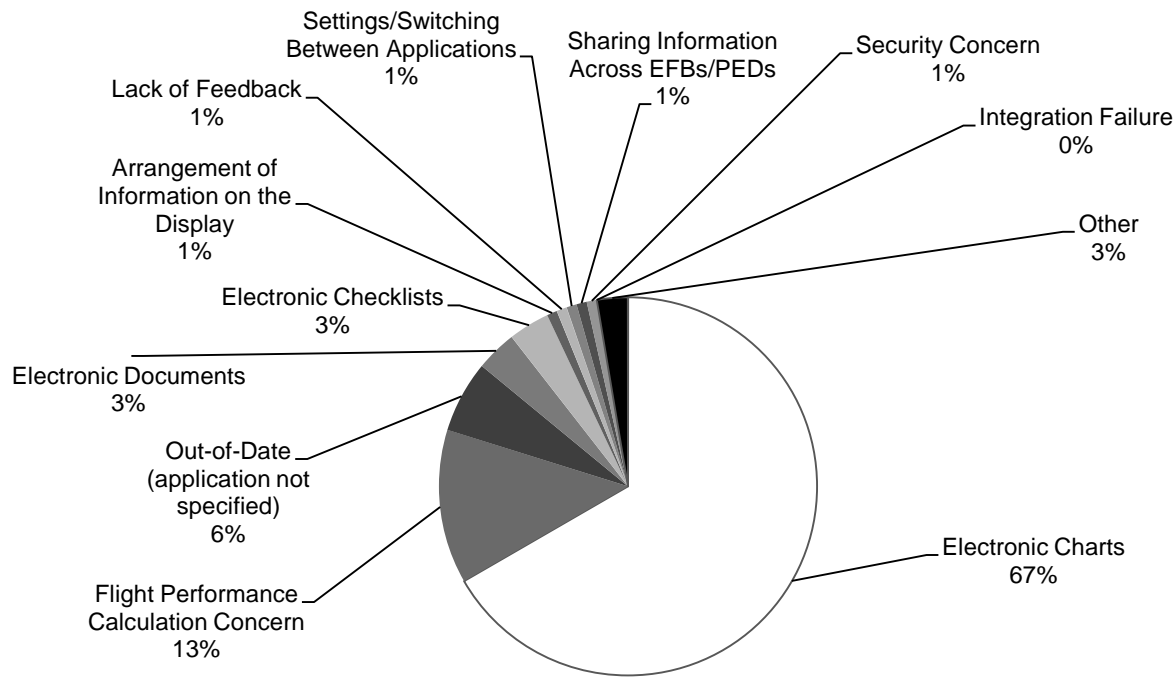
Electronic display information elements concerns address accuracy and currency of displayed information, feedback, and settings. The overall results are shown in Figure 5 (see Table 5 for concerns reported by Part 91, Part 121, and Part 135 pilots).

**Figure 5. Percent of Electronic Display Information Elements Concerns Reported.**

Reports related to *electronic charts* accounted for 67% (76 reports) of all *electronic display information elements* concerns. This category relates to concerns encountered when pilots tried to retrieve and accurately decipher the chart, the way in which information is displayed on the chart, the accuracy and currency of the information presented, or manipulation of the display (e.g., scrolling/zooming).

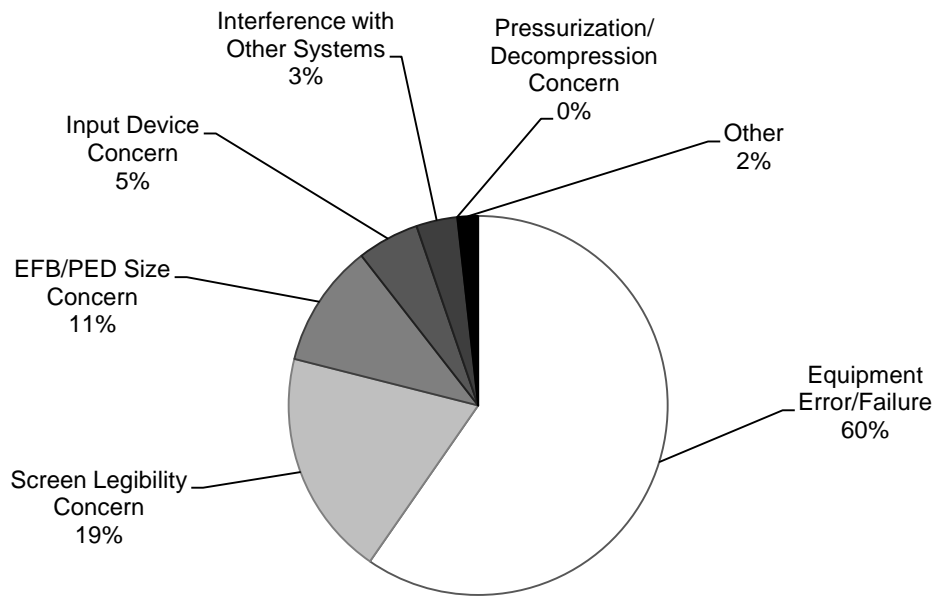
Fifty-seven *hardware* concerns were reported, accounting for 18% of the 309 concerns identified in the ASRS safety reports. Figure 6 shows the percent each *hardware* concern was reported overall (see **Error! Reference source not found.** for a complete list of *hardware* concerns by type of operation).

**Figure 6. Percent of Hardware Concerns Reported.**

As Table 6 shows, the hardware category includes *equipment error/failure* concerns (34), *screen legibility concerns* (11), concerns with the *size of the EFB/PED* (6), *input device concerns* (3), *interference with other systems* (2), and one concern, classified as *other* that described difficulty in starting up a laptop. Overall, approximately half of the *hardware* concerns were reported by Part 91 pilots (46%), followed by 44% by Part 121 pilots, and 11% by Part 135 pilots.

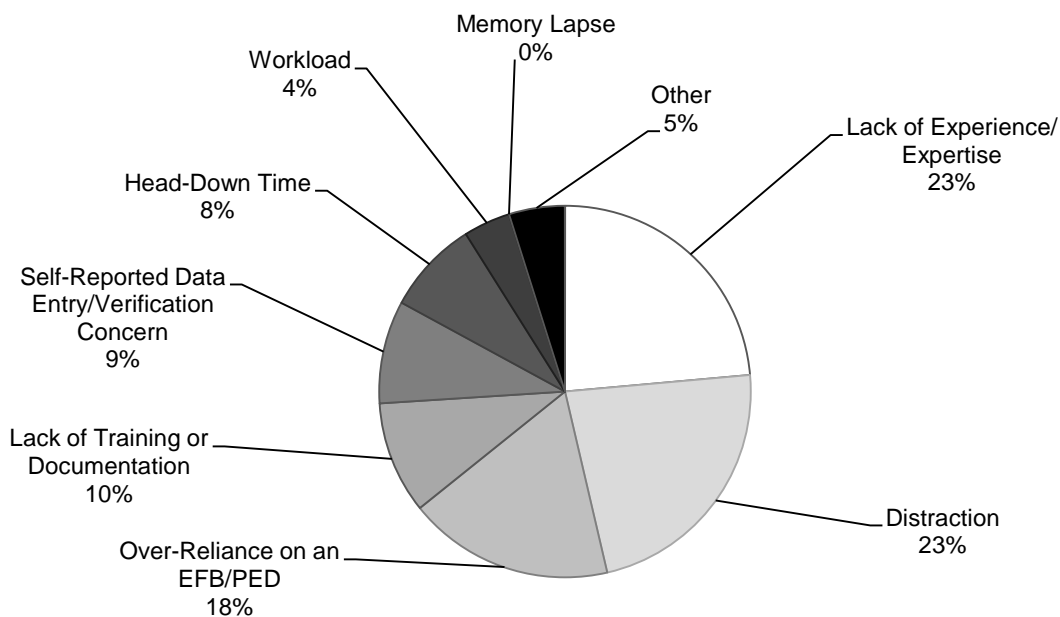
This category captures undesirable effects on human performance associated with the use of an EFB or PED being used as an EFB, as well as *self-reported human performance* concerns associated with entering data in the EFB/PED. Figure 7 shows the percent of *self-reported human performance* concerns reported overall. Table 7 shows concerns reported by Part 91, 121 and 135 pilots.

**Figure 7. Percent of Self-Reported Human Performance Concerns Reported.**

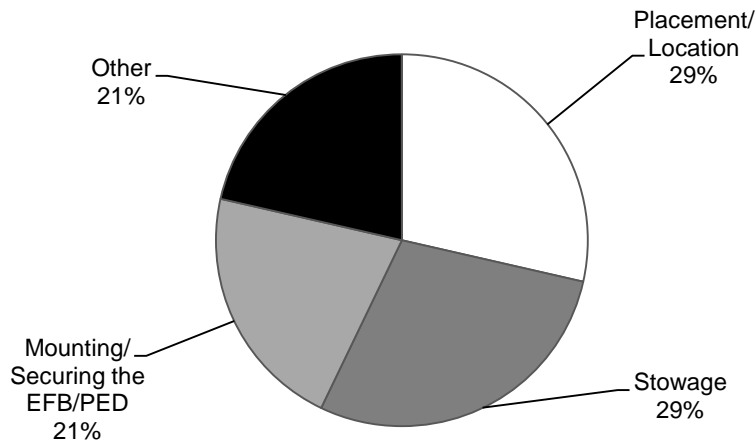
Figure 8 shows the percent of these concerns reported overall (see Table 8 for concerns as reported by Part 91, 121 and 135 pilots).

Figure 8. Percent of Placement/Mounting/Stowage Concerns Reported.

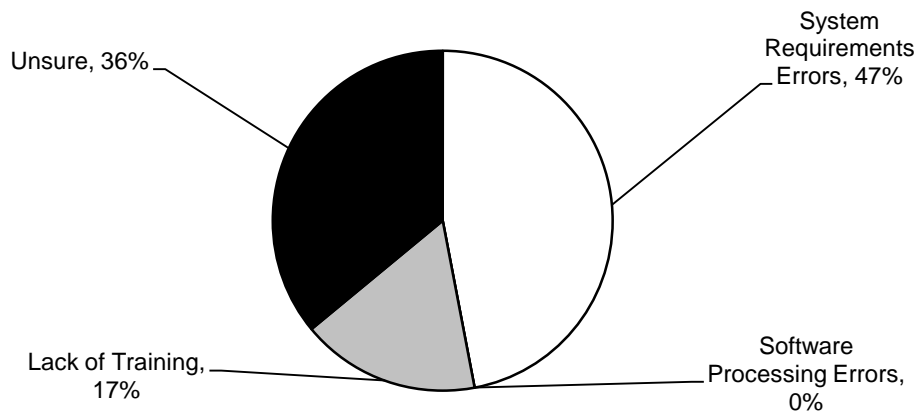
Forty-one reports were classified as *unsure* because the report did not give enough information. Nineteen reports were coded as *lack of training* because the report included wording related to the pilot’s inexperience with the EFB. No reports met our criteria for a *software processing error*. See Figure 9 for a graphical representation of the findings.

Figure 9. Percent of Potential Software Error Sources Identified.

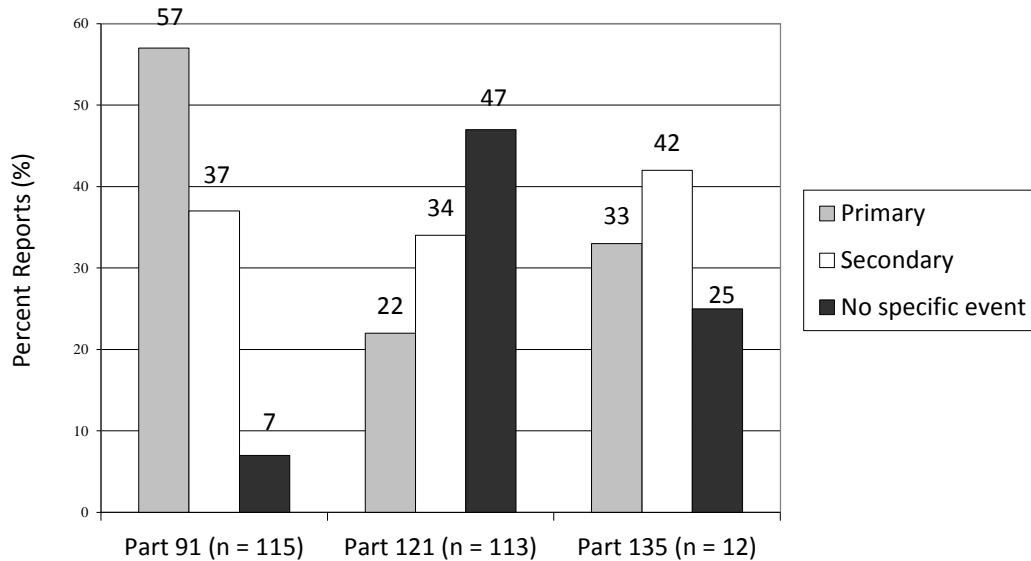
Figure 10 shows the percent of Part 91, 121 and 135 reports that involve an EFB or PED used as an EFB as a primary factor (i.e., having a direct influence on the outcome of the event), or a secondary factor (i.e., having an indirect influence on the event and only exacerbating or contributing to the event). In some cases, reports described general safety concerns and did not result in a negative outcome. These reports were captured as *no specific event*.

Figure 10. Percent Part 91, 121 and 135 Reports with EFB or PED as A Primary or Secondary Factor.

For Part 91 operations, the EFB/PED was a primary factor in 57% (65) of these reports and a secondary factor in 37% (42). General safety concerns were reported in 7% (8) of the reports. In Part 121 reports, the EFB/PED was a primary factor in 19% (22) of the reports, and a secondary factor in 34% (38). Part 121 pilots also reported a general safety concern that did not lead to a negative outcome in 47% (53) of reports. The EFB/PED was a primary factor in 33% (4) of Part 135 reports, and was a secondary factor in 42% (5). Part 135 pilots reported a general safety concern that did not lead to a negative outcome in 25% (3) of reports. Refer to Table C-3 in [Appendix C](#) for a breakdown of EFB/PEDs as a primary or secondary factor by device type.
